Field cyclic loading test of a 3-story non-seismically designed existing concrete frame structure in Korea

*Ji-Eun Roh¹⁾ Sang-Hyun Lee²⁾ Tae-Won Park³⁾
Seung-Ho Cho⁴⁾ Lan Chung⁵⁾

^{1), 2), 3), 4), 5)} Department of Civil Engineering, Dankook University, Yongin-si 126, Korea

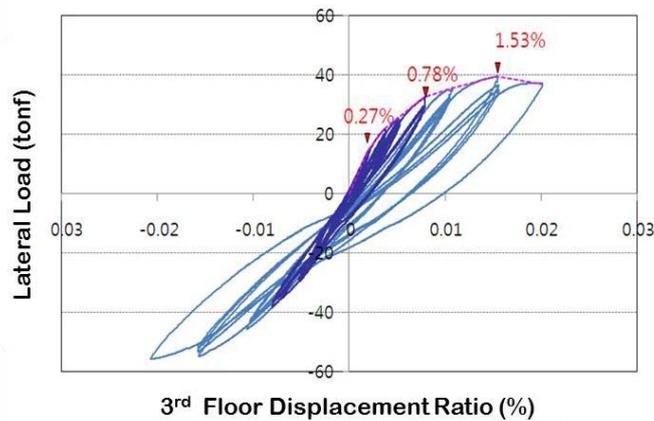
Fig.6 Force-displacement curve

Fig.6 shows the force-displacement curves obtained by cyclic loading test. The force is the resultant of the two actuators. Stiffness decrease was first observed at the 0.27% drift ratio and then stiffness degradation rapidly progressed to the 0.78% drift ratio. The frame reached to its ultimate strength at the 1.53% drift ratio, and then the strength started to degrade. After 1 cycle pushed to the 2% drift ratio, the test was terminated due to the risk of entire building collapse.

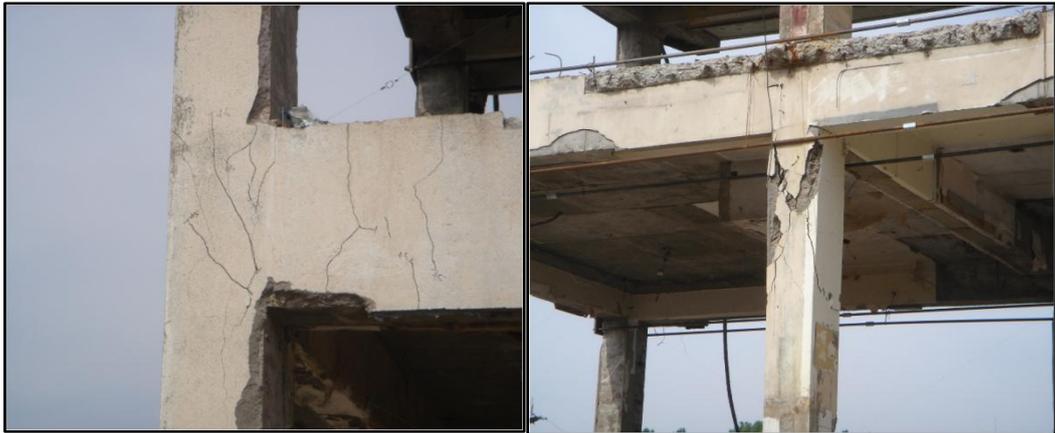
As shown in Fig.7, the first evident failure was observed in exterior beam-column joint of the third floor when the drift ratio reached to 0.78%. Diagonal cracks occurred at the joint and the frame stiffness significantly degraded. And then the diagonal shear failure occurred as shown in Fig.8 in the top of central column on the 2nd floor when the drift ratio reached to 1.53%. After this shear failure, the overall strength of the frame

started to decrease. Since the central column is constrained by two beams, the lateral stiffness of the central column is larger than those of outer columns, which resulted in larger shear force in the central columns. Among the two central columns, the column on the 2nd floor has less axial force than one on the 1st floor. This less axial force caused the less shear strength of the column on the second floor while the shear forces applied to the central columns on the 1st and 2nd floors are almost identical under the loading condition used for test.

Fig.7 Crack of exterior beam-column joint Fig.8 Central column failure

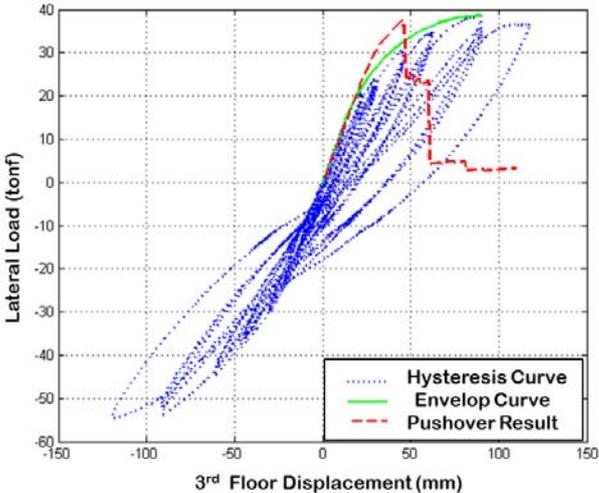
Fig.9 Comparison of Analytical and Experimental Results

Push-over analysis was performed and its results were compared to those from cyclic loading test. Plastic hinge models for beam and column presented by ASCE41-06 were used. The analysis estimated well the initial stiffness and the ultimate strength of the frame while the drift ratio at the ultimate strength was underestimated as shown in Fig.9.

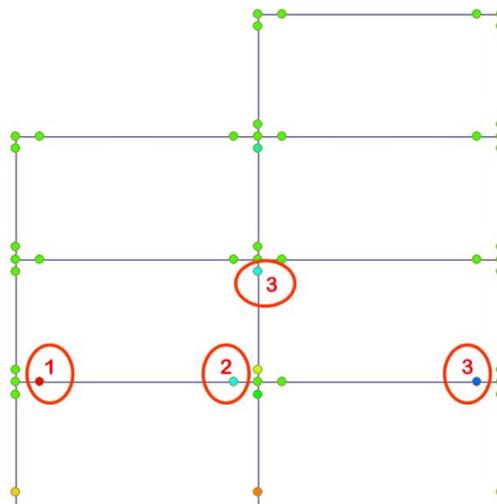
Fig.10 Sequence of Plastic hinge Development

Fig.10 shows sequence of plastic hinge development in analysis. After the first plastic hinge occurred at the end of beam, failure occurred in the top of central column on the 2nd floor as the experimental results. This analytical prediction about failure mode of frame corresponds with the test results that failure occurred in the central column on the 2nd floor which is subjected to the maximum shear force and the minimum axial load.
