Crack detection in composite bridges with relative displacement sensors

*Jun Li¹⁾ and Hong Hao²⁾

^{1), 2)} *Department of Civil Engineering, Curtin University, Kent Street, Bentley, WA6102*
¹⁾ junli@curtin.edu.au, ²⁾ hong.hao@curtin.edu.au

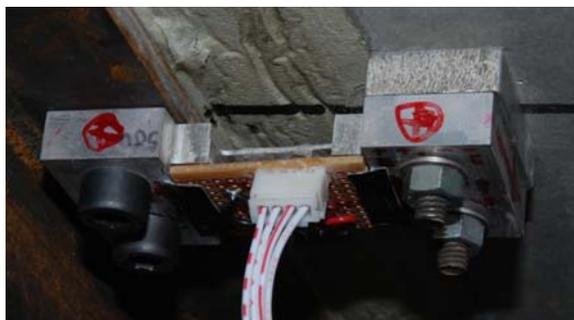
Fig. 2 A prototype of the developed relative displacement sensor

Four relative displacement sensors were fabricated and mounted on the bridge model. Fig. 2 shows a developed sensor prototype installed on the bridge, respectively. One end of the sensor is fixed on the steel girder, and the other end on concrete slab. Such installation manner is much easier than vision-based approaches, which need to setup a number of cameras or other optical devices, and easier than linear variable differential transformer (LVDT) measurement approach which needs a fixed reference point. Moreover, the inaccessibility of the interface between slab and girders makes the setup of cameras and LVDT difficult. This also demonstrates the advantages of the

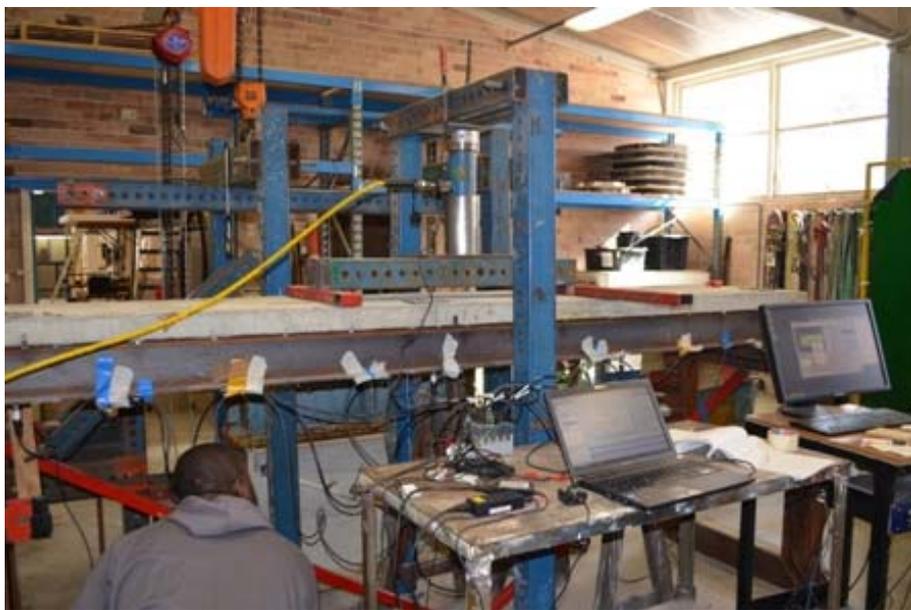
Fig. 4 Experimental setup for static loading

The composite bridge model was statically loaded until intensive cracks appear on the concrete slab. The loading force was applied with the two-point static load in the center of the bridge. Fig. 4 shows the experimental setup for these two loading scenarios. A 20ton load cell was used to measure the applied load. Three laser displacement sensors were placed to measure the vertical deflection of the bridge, and they are denoted as D1, D2 and D3. It should be noticed that D1, D2 and D3 were placed in the same cross sections as the relative displacement sensors S1, S2 and S3, as shown in Fig. 3. The vertical deflections of the bridge model and relative displacements between girder and slab were measured to check if these measurements can be used for detecting the crack occurrence.

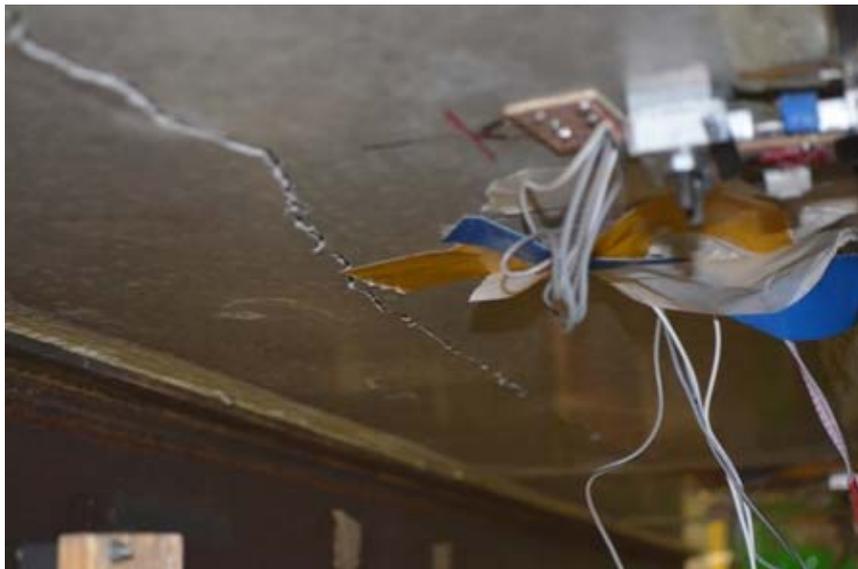
Fig.6 Observed crack in the testing
