## **2. MATERIALS AND METHODS**

### *2.1 Test set-up*

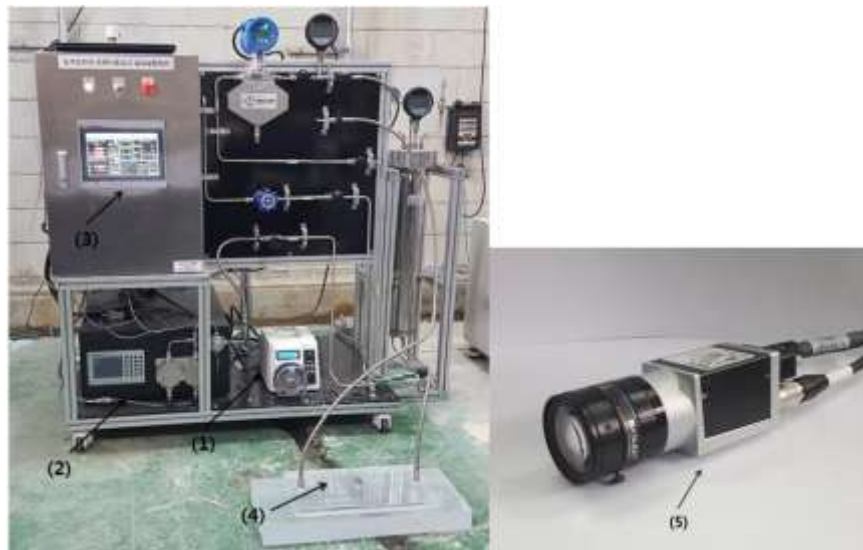
Fig. 1 shows an experimental set-up for grout injection and permeability test in deep underground conditions. It is composed of five parts which are syringe pump, high-pressure water pump, multichannel data acquisition, test section, and digital camera.

Fig. 1 Picture of experimental set-up. (1 – Syringe pump; Accurate high-pressure pump; 3 – Multichannel data acquisition and control box; 4 – Test section; 5 – Digital camera).

In this experiment, the syringe pump was used for injecting grouts into artificial fracture. The dynamic flow rate provided by the syringe pump could reach 6000 mL/min. High-pressure water pump was used to estimate permeability and waterproof efficiency after rock grouting. It can provide the high water pressure up to 100 bars. Multichannel data system was installed for controlling experimental parameters and acquiring data. Using display system, we regulated the injection conditions of pumps such as injection pressure and flow rate of fluid materials. Also, the feedback system can optimize and stabilize the injection condition. A digital camera was used to visually observe and record the penetration and distribution of injected grouts. This visual device has a display resolution of 4608 × 3288 (15 millions) and can record the moving images at 7 frames per second.

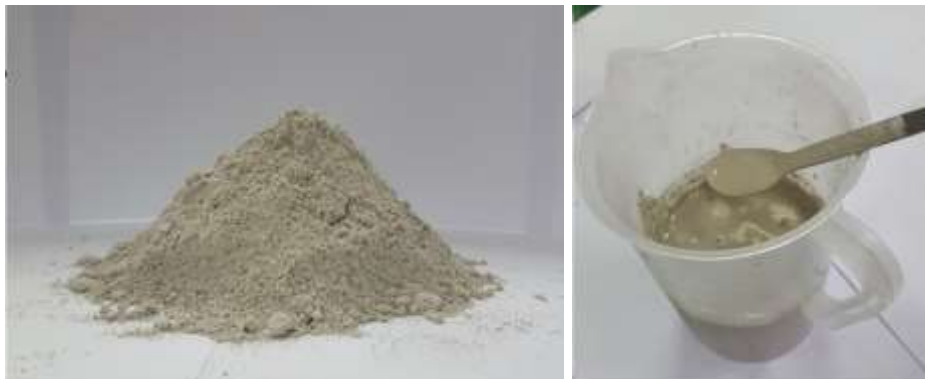
Fig. 3 Material (micro cement) used for grouting injection.

The micro cement used in this study has a  $D_{95}$  of less than  $16 \mu\text{m}$  from grain size distribution and specific gravity of 2.95. Water cement mixed ratio (W/C ratio) is important factor characterizing the viscous fluid flow in rock fractures. Previous studies mainly used the W/C ratio range from 0.5 to 1.0 (e.g., Chun 2005, Høien 2014, Rahman 2015). Considering the bleeding and fluidity of grouts, the W/C ratio was selected as 1.0 to have good fluidity in this study (Fig. 3). The chemical additives for hardening and improving grouts were not considered in this experiment.

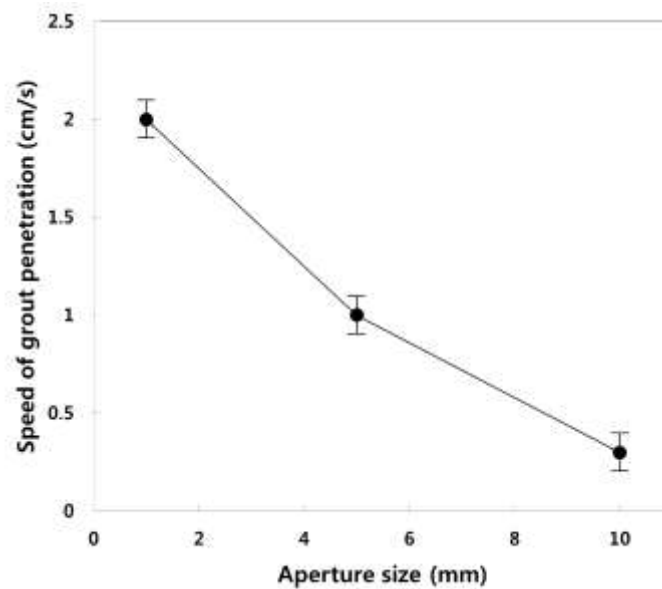
Fig. 6 Speed of grout penetration versus aperture size.

The speed of grout penetrations were 2 cm/s, 1 cm/s and 0.3 cm/s in cases of 1, 5 and 10 mm aperture sizes, respectively. Fig. 6 shows the speed of grout penetrations versus the various aperture-fractures. As the aperture size was increased, the speed of grout penetrations was decreased. The speed of grout penetration was inversely proportional to aperture sizes, which corresponds with the results of the analytical solution suggested by Gustafson (1996).

However, under the condition of constant grout injection rate (200 ml/min), the speed of grout penetrations showed clear distinction according to the aperture sizes. In each experimental case, the speed of grout penetrations was estimated using the penetration distance over the elapsed time.

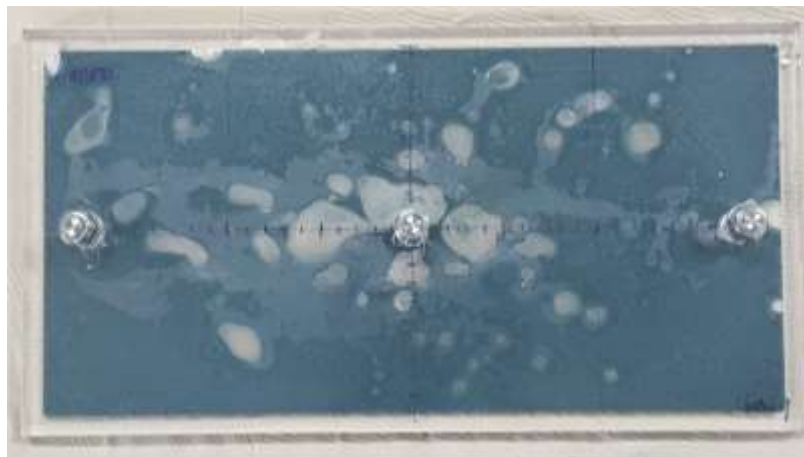
When the grout is injected into the fracture, the air bubble can be formed due to the mixing and injection processes. In this study, many air bubbles were observed and separately located in the fracture inside as shown in Fig. 8.

Fig. 8 An example of air bubble occurrence in the grouted fracture.

To evaluate the effect of the air bubbles on leakage or water permeability after grouting, the high pressure water over 100 bars was injected into the grouted fracture.

Consequently, the separated air bubbles as the closed pores do not affect the short-term permeability of fractures sealed by grouting. However, in case of the grout injection with high pressure at deep depth, more air bubbles may occur due to the formation of turbulent flow. This can induce water leakage of the grouted fractures by creating continuous pores. Moreover, the air bubbles may become large water pathway if the grouting is corroded or deformed in the long-term, which can greatly reduce the grouting efficiency.
