Health Monitoring and Analysis on Deep Consequent High Rock Slope

*Yan-Peng Zhu¹⁾ and Jing-Bang Li²⁾

^{1), 2)} *College of Civil Engineering, Lanzhou University of Technology, Lanzhou 730050, China*

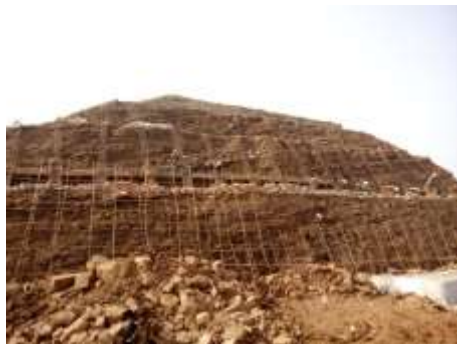
Fig.1 before the supporting

LanYong first class highway is east from new town of Lanzhou city, and west to Yongjing County Gucheng village, which total length is about 48.25km. High fill and deep excavation cutting slope distribute along the road. Most of deep excavation cutting slope is high slope, and the maximum height of slope reach to 63.0m. This slope is located in K23+890~K23+975 period of LanYong highway, belonging to deep excavation cutting slope. The roof location of the slope lies between K23+940~K23+950, the height is 36.4m. Because of the effect of topography, rock mass distribution and properties, the slope is a deep consequent high rock slope. Slope field is shown in Fig.1, Fig.2.

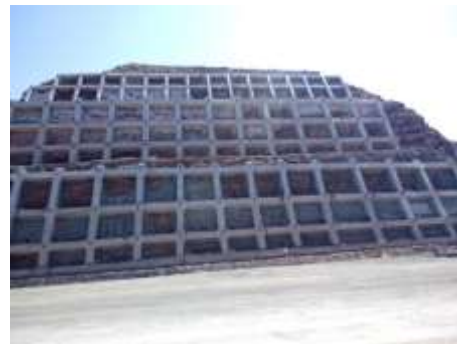
Fig.2 after the supporting

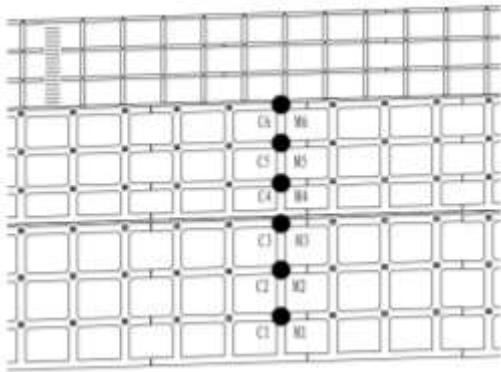
Fig.3 elevation of slope supporting

This slope is reinforced by prestressed anchor-cable lattice beams and anchor lattice beams. First grand ratio of Slope is 1:0.5, and slope height is 10m. The second grade and the third grade ratio of Slope both are 1: 0.75, and slope height both are 8m. The fourth grand ratio of slope is 1:1, and the support height is 8m. Among them, the first grade and the second grade slope are supported by prestressed anchor-cable lattice beam, and the design value of anchor cable prestress is 410KN. The third grade and the fourth grade slope reinforced by anchor lattice beam, and the anchor is full-length grouting. After the design change, the slope of the fourth grade is shaved, and the supporting structure is canceled. Slope supporting design is shown in Fig.3 and Fig.4.

The installation position of sensor is shown in Fig.3 and Fig.4: A21-A32 for stress meter, M1-M6 for anchor dynamometer, and C1-C6 for single point displacement meter. Sensors and monitoring system are shown in Fig. 5 and Fig. 6.

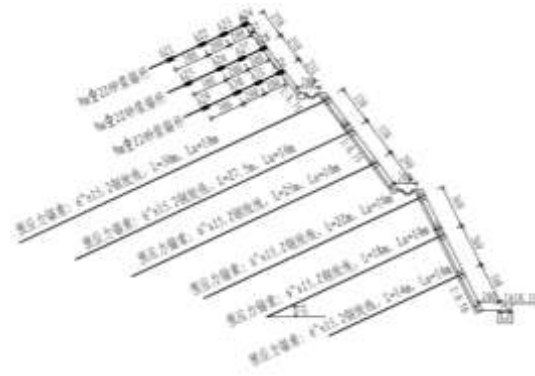
Fig.4 profile of slope supporting

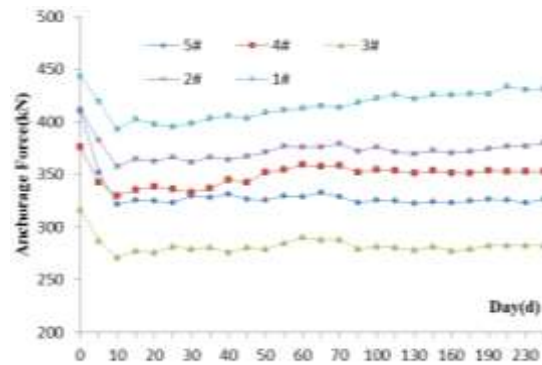
Fig. 7 anchorage force variation curve.

With the monitoring the anchorage force change of the anchor cable locked, there is found that the change of the anchor cable anchorage force is divided into three stages(Meng Xiang-ming 2012).As shown in Fig.7 for anchor cable dynamometer anchor hold variation curve.

The first stage is the accelerated loss of anchoring force. 10 days after locking anchor cable, anchor anchoring has a most loss. There are a few reasons as followed. The slope has much larger rock mass fractures, which lead to the shrinkage deformation increase in the tension process. Steel strand stress relaxation is a influencing factor of the accelerated loss for anchoring force. In addition, there is a anchor clip obviously loose phenomenon in the process of drawing, which may be lead to the accelerated loss of the anchoring force.

The second is anchoring force fluctuation stage. Slight fluctuations of the cable anchorage force and slowly lifting phenomenon appeared in this stage, and it continuous about 30 days. The slope stress is adjusted constantly by the anchor cable and slope rock impacted with each other.

The third is anchoring force sustained stable stage. It shows that the anchoring force and the slope internal force tend to equilibrium after. At this stage, the adjustment of slope internal force has already come to an end. The anchor is already into the loading stage. It also shows that the anchor cable has a the better reinforcement effect to this slope.

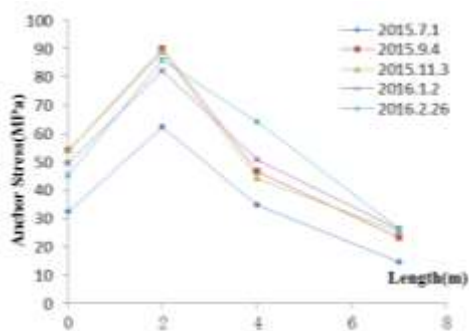
Fig. 8 the curve of anchor stress along the rod length

After the anchor cable locked, three root of anchor stress change trend is basically the same along the rod length. This paper only takes the second anchor monitoring data and its variation curve to analyze the stress change trend. Fig.8 shows the anchor stress along the rod length variation curve after supporting by five sets of data. Fig.9 for anchor stress change curve with time after supporting

The data curve showed that the anchor stress value has always existed in 2M site for the peak stress after supporting, and all the data are showing an overall "bow" change. The stress of each position showed varying degrees of increase at the first 30 days. After then, the stress tends to be stable. The stress which site 4m has a special downward trend. About in December 2015 28th, it appeared significantly increased trend, and then became stable.

The author believes that there is may be exist a dangerous fissures at 2m site because of the slope internal joint development. After the slope supporting and anchor cable locked, slope unloading is started, and the phenomenon of prestressed loss accelerated is appeared. At the moment, there is a larger adjustment of internal force, which leads to the fissures increase and slide rupture. The slope internal force is adjusted constantly results in the anchor stress increase slowly at the first 30 days. The anchor stress change stable with the adjustment of slope internal force is over. At the slope stress adjustment stage, the increase and reduce of slope internal force may be lead the internal fissures growth slowly. It results in the anchor cable be into the loading stage, and the corresponding position anchor stress increase also begin to increase. Thus ,there may be a fissures at 4m site along the rod length. Because of the anchor played a supporting role, the anchor stress of 4m site tended to the flat Steady state. Therefore, prestressed anchor cable lattice beam and anchor lattice beam of the slope have the obvious strengthening effects and anchor and prestressed anchor cable play the better ability to work together.
