Health Monitoring and Analysis on Deep Consequent High Rock Slope

*Yan-Peng Zhu¹⁾ and Jing-Bang Li²⁾

^{1), 2)} *College of Civil Engineering, Lanzhou University of Technology, Lanzhou 730050, China*

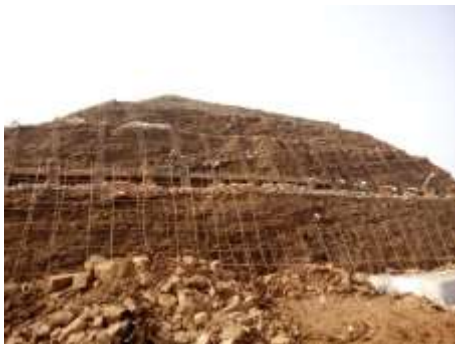
Fig.1 before the supporting

LanYong first class highway is east from new town of Lanzhou city, and west to Yongjing County Gucheng village, which total length is about 48.25km. High fill and deep excavation cutting slope distribute along the road. Most of deep excavation cutting slope is high slope, and the maximum height of slope reach to 63.0m. This slope is located in K23+890~K23+975 period of LanYong highway, belonging to deep excavation cutting slope. The roof location of the slope lies between K23+940~K23+950, the height is 36.4m. Because of the effect of topography, rock mass distribution and properties, the slope is a deep consequent high rock slope. Slope field is shown in Fig.1, Fig.2.

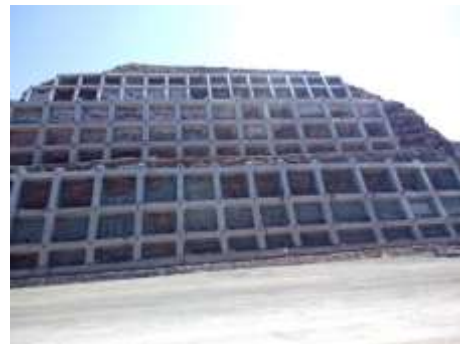
Fig.2 after the supporting

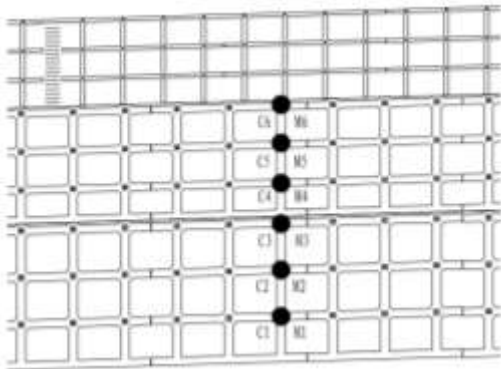
Fig.3 elevation of slope supporting

This slope is reinforced by prestressed anchor-cable lattice beams and anchor lattice beams. First grand ratio of Slope is 1:0.5, and slope height is 10m. The second grade and the third grade ratio of Slope both are 1: 0.75, and slope height both are 8m. The fourth grand ratio of slope is 1:1, and the support height is 8m. Among them, the first grade and the second grade slope are supported by prestressed anchor-cable lattice beam, and the design value of anchor cable prestress is 410KN. The third grade and the fourth grade slope reinforced by anchor lattice beam, and the anchor is full-length grouting. After the design change, the slope of the fourth grade is shaved, and the supporting structure is canceled. Slope supporting design is shown in Fig.3 and Fig.4.

The installation position of sensor is shown in Fig.3 and Fig.4: A21-A32 for stress meter, M1-M6 for anchor dynamometer, and C1-C6 for single point displacement meter. Sensors and monitoring system are shown in Fig. 5 and Fig. 6.

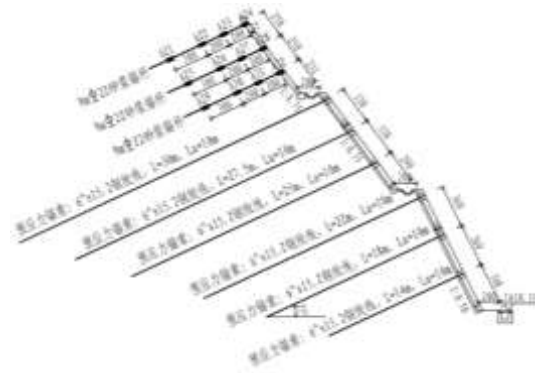
Fig.4 profile of slope supporting

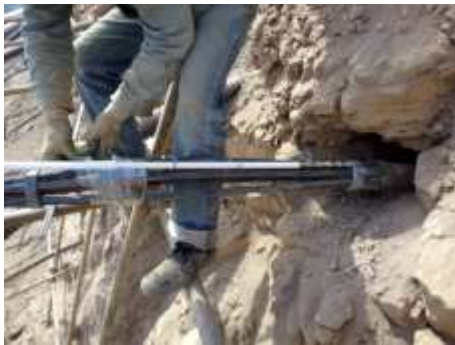
Fig.5 sensor installation

(1) There are 4 stress meters arranged each one anchor bolt, which used to monitor the anchor stress. The first one is located in the anchor head, and then arranged others along the anchor in turn interval 2m, 2m, 3m. The stress meter is

arranged on the anchor by welding;

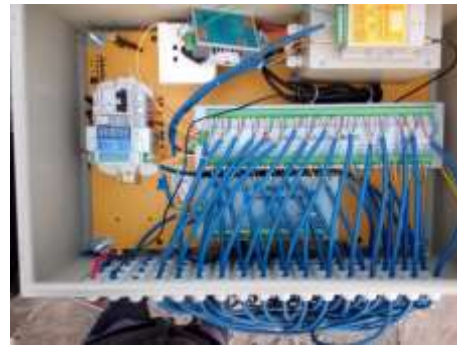
Fig. 6 data collection box

Combined with the supporting design, a health monitoring scheme is designed for this deep consequent high rock Slope, which is used to monitor the slope itself and the its supporting structure. All instruments are connected to the data acquisition system through the cable conductor. The data acquisition system sent monitor data to the computer by wireless communication module in order to realize the remote automatic monitoring of the slope and its supporting structure.

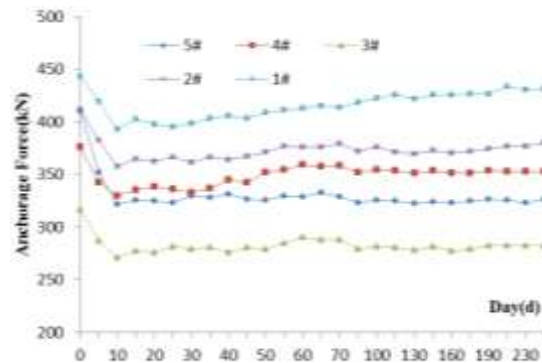
Fig. 7 anchorage force variation curve.

With the monitoring the anchorage force change of the anchor cable locked, there is found that the change of the anchor cable anchorage force is divided into three stages(Meng Xiang-ming 2012).As shown in Fig.7 for anchor cable dynamometer anchor hold variation curve.

The first stage is the accelerated loss of anchoring force. 10 days after locking anchor cable, anchor anchoring has a most loss. There are a few reasons as followed. The slope has much larger rock mass fractures, which lead to the shrinkage deformation increase in the tension process. Steel strand stress relaxation is a influencing factor of the accelerated loss for anchoring force. In addition, there is a anchor clip obviously loose phenomenon in the process of drawing, which may be lead to the accelerated loss of the anchoring force.

The second is anchoring force fluctuation stage. Slight fluctuations of the cable anchorage force and slowly lifting phenomenon appeared in this stage, and it continuous about 30 days. The slope stress is adjusted constantly by the anchor cable and slope rock impacted with each other.

The third is anchoring force sustained stable stage. It shows that the anchoring force and the slope internal force tend to equilibrium after. At this stage, the adjustment of slope internal force has already come to an end. The anchor is already into the loading stage. It also shows that the anchor cable has a the better reinforcement effect to this slope.

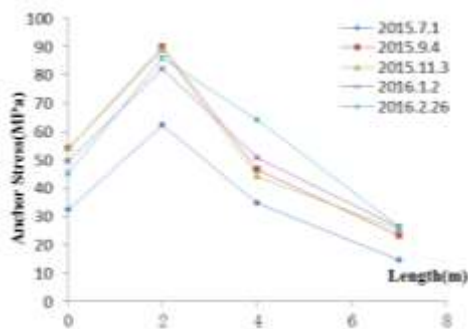
Fig. 8 the curve of anchor stress along the rod length

After the anchor cable locked, three root of anchor stress change trend is basically the same along the rod length. This paper only takes the second anchor monitoring data and its variation curve to analyze the stress change trend. Fig.8 shows the anchor stress along the rod length variation curve after supporting by five sets of data. Fig.9 for anchor stress change curve with time after supporting

The data curve showed that the anchor stress value has always existed in 2M site for the peak stress after supporting, and all the data are showing an overall "bow" change. The stress of each position showed varying degrees of increase at the first 30 days. After then, the stress tends to be stable. The stress which site 4m has a special downward trend. About in December 2015 28th, it appeared significantly increased trend, and then became stable.

The author believes that there is may be exist a dangerous fissures at 2m site because of the slope internal joint development. After the slope supporting and anchor cable locked, slope unloading is started, and the phenomenon of prestressed loss accelerated is appeared. At the moment, there is a larger adjustment of internal force, which leads to the fissures increase and slide rupture. The slope internal force is adjusted constantly results in the anchor stress increase slowly at the first 30 days. The anchor stress change stable with the adjustment of slope internal force is over. At the slope stress adjustment stage, the increase and reduce of slope internal force may be lead the internal fissures growth slowly. It results in the anchor cable be into the loading stage, and the corresponding position anchor stress increase also begin to increase. Thus ,there may be a fissures at 4m site along the rod length. Because of the anchor played a supporting role, the anchor stress of 4m site tended to the flat Steady state. Therefore, prestressed anchor cable lattice beam and anchor lattice beam of the slope have the obvious strengthening effects and anchor and prestressed anchor cable play the better ability to work together.

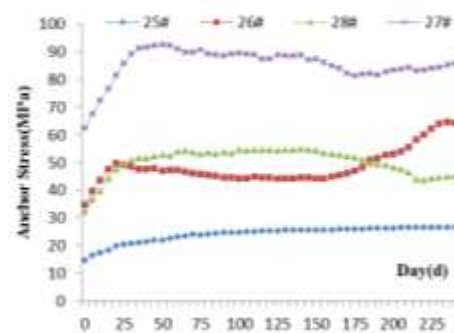
Fig.9 the anchor stress curve with time

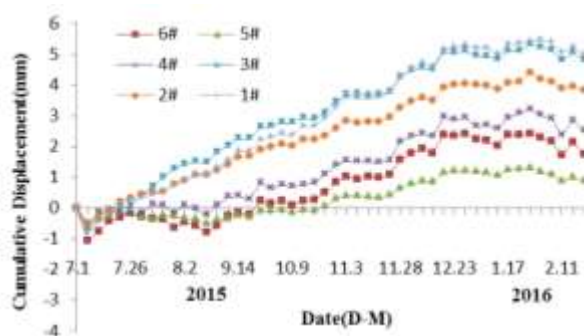
Fig.10 Cumulative displacement curve of slope

and anchor head. The anchor head is fixed in the bedrock, and the displacement sensor is fixed on the structure surface. The rod connects the anchor head and sensor. When the anchor head and the displacement sensor have tensile or compression change, the relative slip occurs between the coil in the sensor and the rod. At the time, the sensor obtains the displacement. In the setting of sensor, there is 50mm relative displacement between rod and coil as the initial displacement value. Monitoring results shown in Fig.10 and Fig.11.

Each displacement meter change is basically consistent. In July, the displacement is more obvious. Specially, it has a sharp fluctuation in the first few days, and the change speed is between $-0.83\sim 0.57\text{mm/d}$. This time is in the anchor cable tension stage, the displacement sensor has the deformation in the slope direction during the anchor cable tension process, and the displacement decreases sharply. In a few days after the tension, the displacement increase rapidly because of anchorage force loss larger. About 30 days later, the slope is in the unloading stage, and the displacement is volatility change due to the internal stress adjustment of the slope. In this stage, the change speed is between $-0.20\sim 0.57\text{mm/d}$. After then, the displacement of each monitoring point is basically stable.

Deadline of the end of February, the displacement of 1~6# sensor cumulative change is 5.00mm, 3.85mm, 4.79mm, 2.5mm, 0.87mm and 1.76mm. The maximum displacement change speed after the supporting is 0.17mm/d less than 0.5mm/d, and the maximum cumulative displacement amount of all monitoring points is less than 10mm (Ruan Fei-peng 2007). At the present, the slope is in stable state.

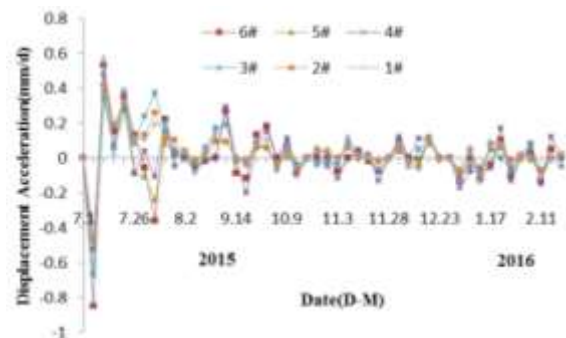
Fig.11 Displacement acceleration curve of slope
