Comparative performance of RC shear walls designed by different standards

*Farhad Dashti¹⁾ and Rajesh P Dhaka²⁾

^{1), 2)} *Department of Civil and Natural Resources Engineering, University of Canterbury, Private Bag 4800, Christchurch 8140, New Zealand,*

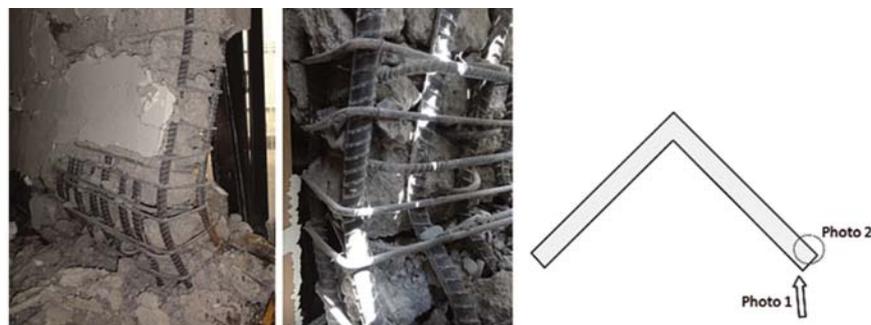
Figure 1. Web buckling of well-confined wall (Elwood 2013)

On the other hand, modern (Post-1970s) RC wall buildings were observed to have experienced failure patterns like wall web buckling, boundary zone bar fracture and buckling failure of ducted splice. In a number of cases, compression failure occurred in the outstanding legs of T and L walls in addition to significant out-of-plane displacements, thereby resulting in overall buckling of the wall. In some cases, the transverse reinforcement did not meet the spacing requirement to prevent buckling of the longitudinal reinforcement, and bar buckling resulted in high localized strains and decreased the tensile strain capacity. Figure 1 and Figure 2 show some examples of different failure modes, observed in RC walls in 2011 Christchurch earthquake.

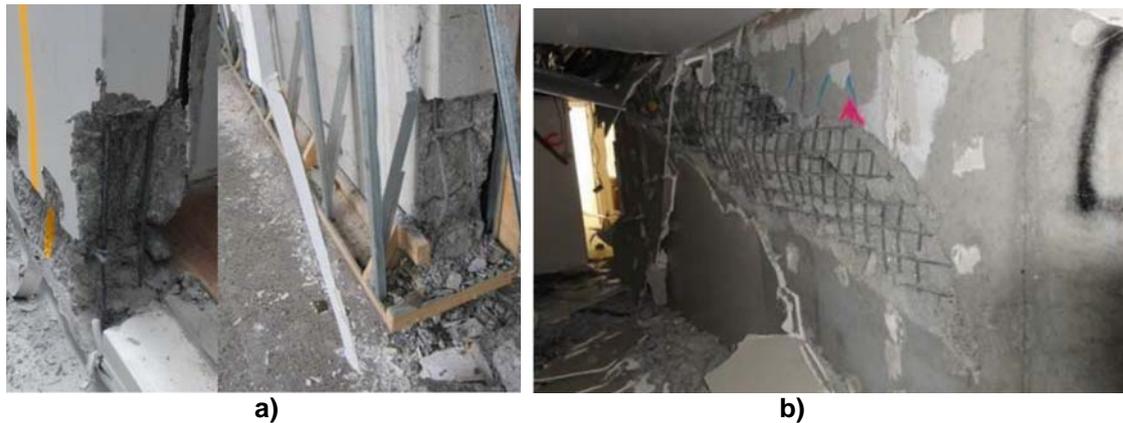
**Figure 2: a) Bar buckling and fracture in lightly reinforced slender RC shear wall
b) Slender wall shear-axial failure (Kam et al. 2011)**

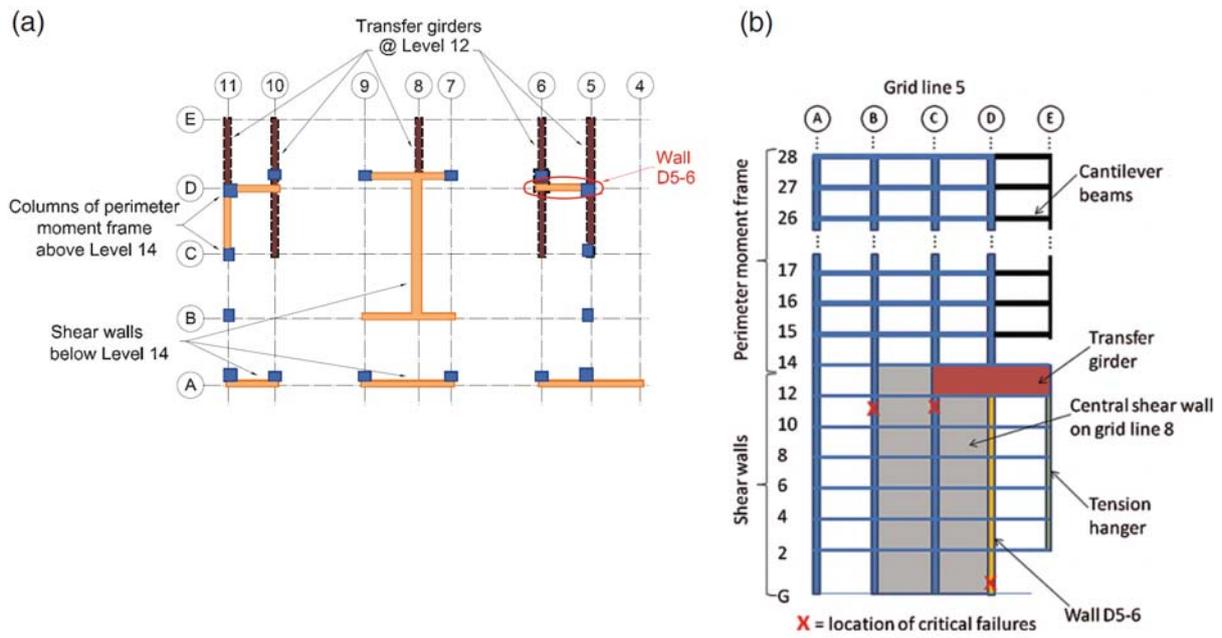
Figure 3. Hotel Grand Chancellor structural layout sketch (a) plan; (b) elevation along grid line 5 (Elwood 2013)

The Hotel Grand Chancellor was one of the severely damaged buildings during the 22 February 2011 Christchurch earthquake. The tower was constructed between 1985 and 1988 according to the NZS4203:1984 loading standard and NZS3101:1982 concrete design standard, and was the tallest building in Christchurch at the time of construction. As shown in Figure 3, the lateral load resisting system comprised of RC shear walls in the lower tower and moment-resisting RC frames in the upper tower resulting in the vertical irregularity of the structure (DunningThorntonReport 2011). The building has horizontal irregularity as well, arising from the cantilever bay between grids D and E. The east side of the building (bay D-E) was cantilevered over an adjacent service lane (

Figure 3). Several deep transfer girders were used between levels 12 and 14 to transfer the cantilever load to the adjacent lane leading to a considerably great amount of axial load applied to a critical shear wall denoted as D5-6 in

Figure 3. Wall D10-11 was almost under the same loading condition but was completely different from Wall D5-6 in terms of reinforcement arrangement and maximum story height (3.6 m, compared to 5.1 m for wall D5-6) and had a return wall at one end to help support the high axial loads. As shown in

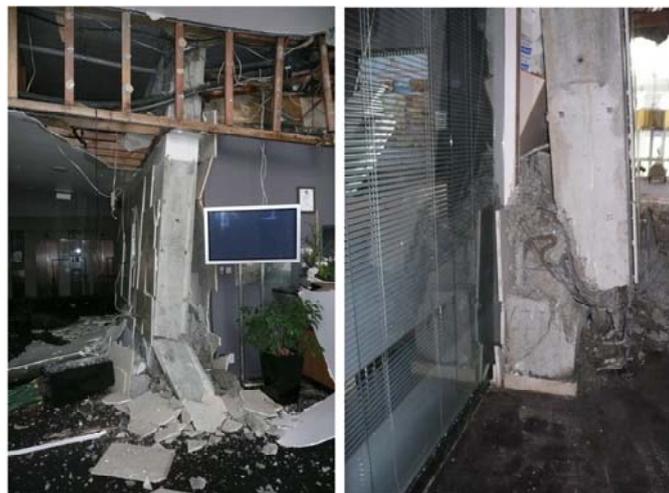
Figure 4. Failure of Shear wall D5-6

Figure 4, wall D5-6 suffered a brittle failure at the base with out-of-plane instability. The failure plane initiated at the top of the lap splice in the web vertical reinforcement. The confinement hoops opened allowing the longitudinal bars to deform with the shortening of the wall. This wall was subjected to excessive amount of axial load from the cantilever structure, the corner column of the upper tower perimeter moment frame and the vertical excitation of the cantilever structures both above and below level 14. The combined axial load and bending exceeded the concrete compression strain capacity given the limited tie reinforcement provided at the base of the wall. Some out-of-plane drift of the wall during the earthquake excitation and the plane of weakness created at the end of the splice of the web vertical reinforcement further contributed to the failure at its base. Figure 5 displays the reinforcement configuration of the wall along the length and height of the wall. Scrutinizing these details indicates a deficient confinement length and inadequate reinforcement ratio in the boundary element.

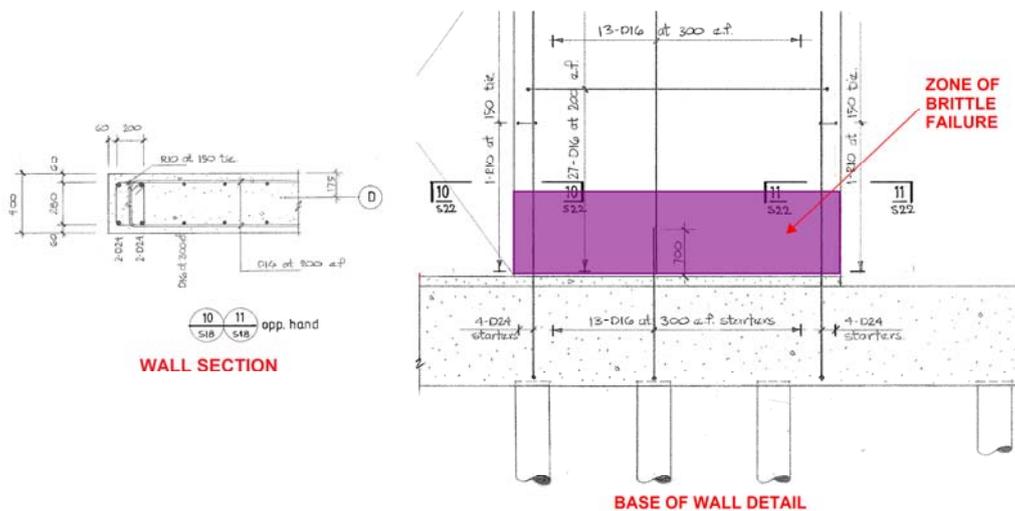
Figure 5. Reinforcement details of wall D5-6 (DunningThorntonReport 2011)

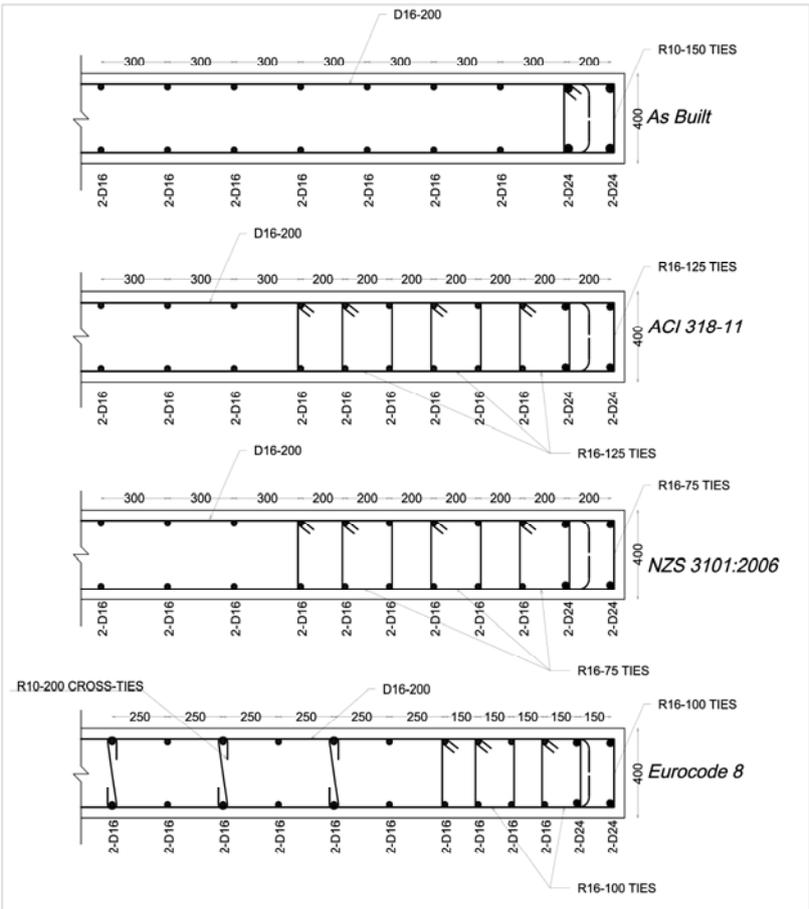
Figure 6. Wall sections

The wall is redesigned in this study to comply with the detailing requirements of three standards: ACI-318-11 (2011), NZS3101:2006 (2006) and Eurocode 8 (CEN 2004) in such a way that the demand used for design of the as-built wall (Wall D5-6) could be met. Figure 6 displays the wall sections designed based on the three codes in comparison with the as-built section. The as-built wall section was modified to meet the design requirements of each code with the least possible changes.

Since ACI318-11 does not limit the web and boundary thickness of walls, the wall thickness was not changed. It should be noted that this issue is currently a matter of concern following the wall instabilities observed in Chile (2010) earthquake as the building code adopted in Chile in 1996 was based on ACI 318-95, except that the boundary element confinement was not required. According to ACI318-11 Equation (21-8), special boundary elements are required for the wall with the minimum horizontal dimension calculated based on the neutral axis depth. The minimum length of confinement was calculated as 1365 mm which is considerably bigger than the 260 mm confinement length of the as-built wall. The confinement reinforcement of the as-built wall did not meet the minimum requirements of ACI318-11§ 21.9.6, and bigger size hoops with smaller spacing were used to satisfy the minimum allowable cross-section area of transverse reinforcement.

According to Eurocode 8, the minimum web thickness is governed by the story height and the minimum boundary thickness is calculated based on the confined length as well as the story height. The existing web thickness of the as-built wall was satisfactory and the confinement length was calculated based on the neutral axis position as well as the required value of the curvature ductility. Since the flexural

capacity of the wall was much greater than the flexural demand, the required curvature ductility was reduced resulting in a much smaller value for the confinement length than the ACI318-11 wall section. It should be noted that a bigger value for confinement length required a considerable increase in the minimum boundary element thickness (from 340 mm to 510 mm) and would cause a significant change in the wall section when compared to the sections designed by other codes as well as the as-built wall. Therefore, the minimum confinement length was adopted. The minimum volumetric ratio of confining reinforcement was satisfied using bigger hoop size with smaller spacing. Also, the maximum spacing of the longitudinal reinforcement was limited to 250 mm with cross-ties at every 500 mm connecting two curtains of reinforcement.

Different failure patterns including wall buckling under high axial load, flexural torsional buckling and out-of-plane buckling of the compression zone are addressed in the provisions of NZS3101:2006 for the minimum web and boundary thickness and the effective height to thickness ratio. The as-built wall satisfied the dimensional limitations but did not meet the confinement requirements in plastic hinge region and the modifications were made according to Section 11.4.6.5 of NZS3101:2006.

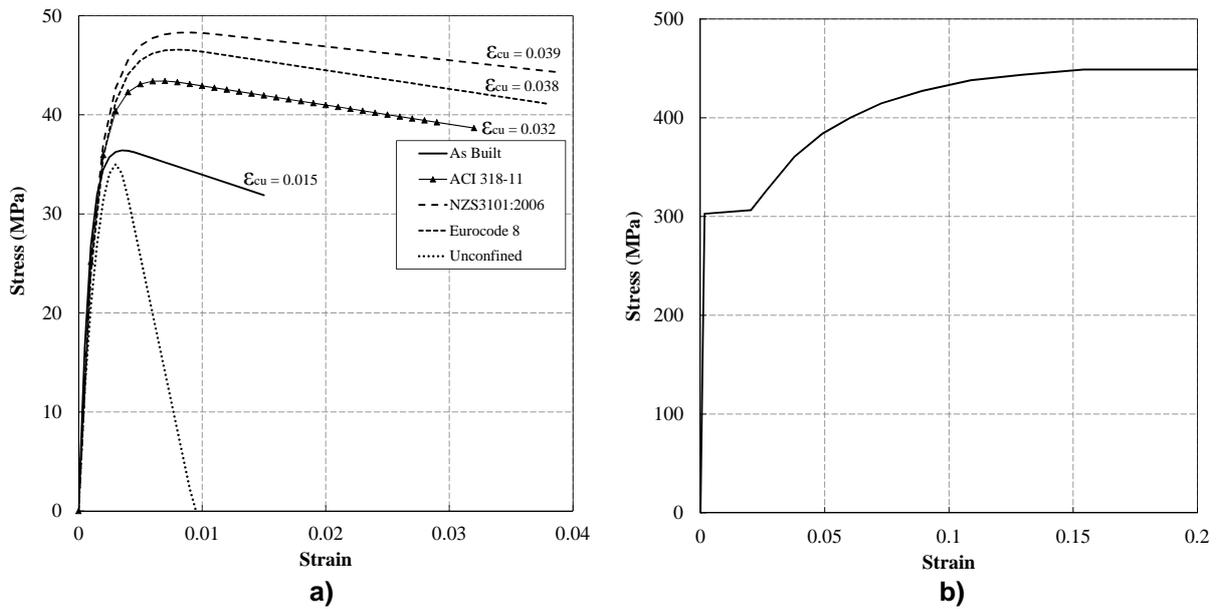
Figure 7: a) Confined concrete models of the wall sections
b) Stree-strain curve of the reinforcing steel

The major difference between the four wall sections is in the amount and arrangement of transverse hoops because of the different confinement requirements of the design standards. The axial stress-strain curves of the confined concrete obtained using Popovics/Mander's constitutive model (Mander et al. 1988) for the wall sections are compared in b)

Figure 7 (a). The ultimate strain of confined concrete is defined using the equation proposed by Priestley (1996). The stress-strain curve of the as-built configuration is considerably different from the curves of the other sections in terms of both strength and ductility and its ultimate strain is less than half of the strain capacity of the other sections. Figure 7 (b) shows the nonlinear stress-strain curve used for the reinforcing steel.

Figure 7(a), the axial stress-strain curve of the confined concrete of the Eurocode8 section (originating from the size and spacing of hoops) indicates a confinement level that is as good as the ACI318 and NZS3101 sections, despite this, the moment-curvature curves of the three wall sections (Figure 8) are considerably different in terms of curvature ductility; this is mainly due to the difference in the confinement length which has a telling effect on the section behavior.

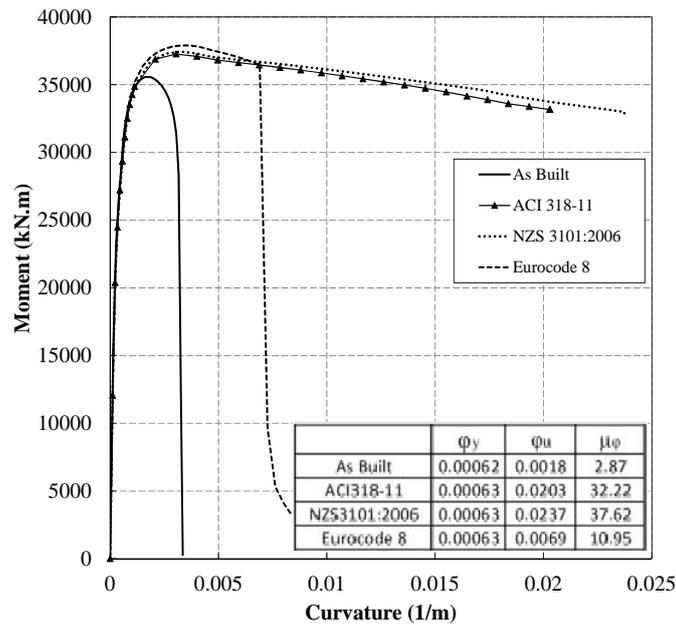
Figure 8. Moment-curvature curves of the wall sections

The moment-curvature curves of the wall sections generated using Xtract (TRC 2011) are shown in Figure 8 which clearly display the substantial deficiency of the as-built wall in terms of curvature ductility. As expected, the NZS3101 and ACI318 sections with better confinement (the larger amount of hoops and smaller spacing) sustained larger curvature before failure. The curvature ductility of the Eurocode8 section is higher than the as-built section but substantially less than the NZS3101 and ACI318 sections which is mainly due to its smaller confinement length when compared to the ACI318 and NZS3101 sections. It should be noted that, as shown in b)

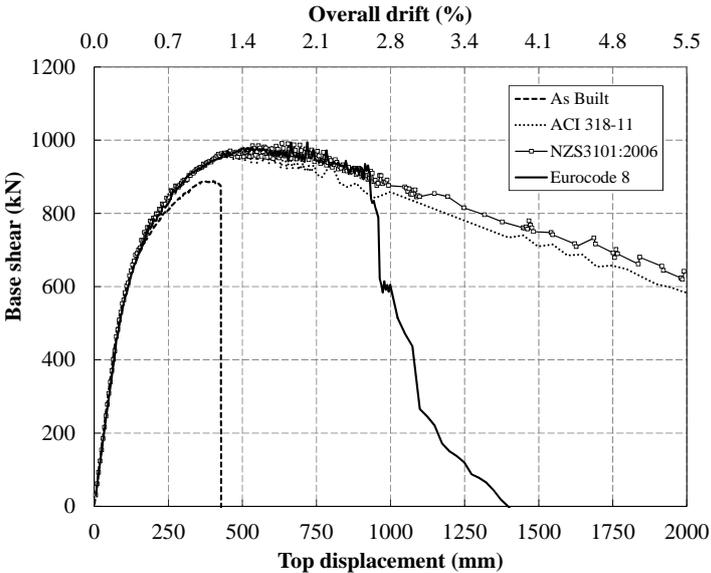
Figure 9. Base shear-top displacement response of the models

Figure 9 displays the base shear versus top displacement response of the four walls. As shown in this figure, the as-built wall undergoes a brittle failure when the top displacement is only about 430 mm (i.e. 1.2% average drift). Failure of the Eurocode8 model was also accompanied by sudden degradation of the push-over curve, but the failure displacement was greater than twice of the as-built model. The models designed based on ACI318-11 and NZS3101:2006 were both ductile enough not to fail within the range of the analyzed displacement (i.e. 2000 mm top displacement or 5.5% average drift). It should be mentioned that reinforcement buckling and bond-slip failure were not considered in these models, although geometric nonlinearity was activated in the analysis to take the P-delta effect into account.

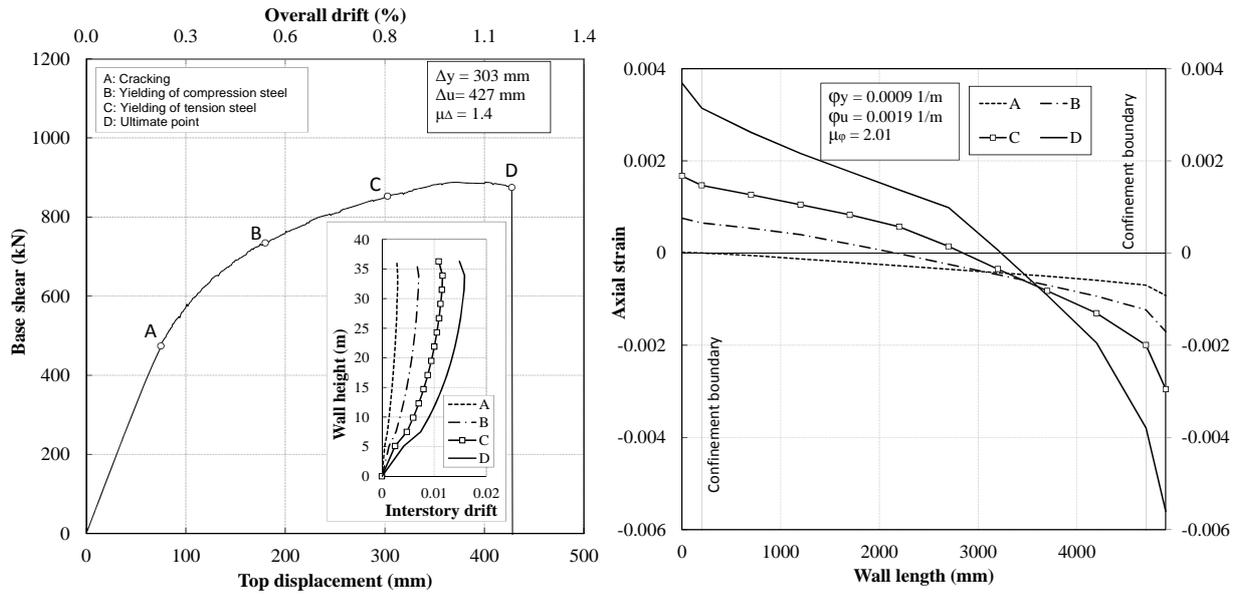
Figure 10. Push-over response of the as-built model

Figure 10, at Point A, which corresponds to considerable cracking in the tension side of the wall, the neutral axis position is quite far from the extreme compression fiber which is obviously due to the substantially large axial load ($0.25 f_c A_g$). Yielding of the reinforcement at extreme compression and tension fibers start at Points B and C, respectively, resulting in considerable change of the neutral axis position. The axial load applied to the wall was so great that compression reinforcement yielded before the tension reinforcement. As the axial strain of the unconfined concrete exceeds the strain at the peak stress, strength degrades considerably in sufficient number of concrete elements, which results in overall collapse of the wall. In DIANA, the response of the embedded reinforcement is completely dependent on the mother element which is concrete in this case, and as the mother element becomes unstable, the whole element collapses. Figure 14 shows the plastic strain of the 1st story reinforcement of the as-built model. At Point D, where the ultimate capacity of the wall is reached, the number of yielded reinforcement is relatively small since the section was not ductile enough to allow much more uniform yielding along the wall length. The maximum plastic compressive strain of the reinforcement was 0.00365 at Point D which abruptly increased to 0.329 as the overall failure was observed (Figure 14). As shown in Figure 10, the as-built model could reach the displacement ductility of 1.4 and curvature ductility of 2.01, which is in agreement with the moment-curvature curve plotted in Figure 8. The inter-story drift profile of the wall also shows the incapability of the wall to reach an acceptable value of drift.

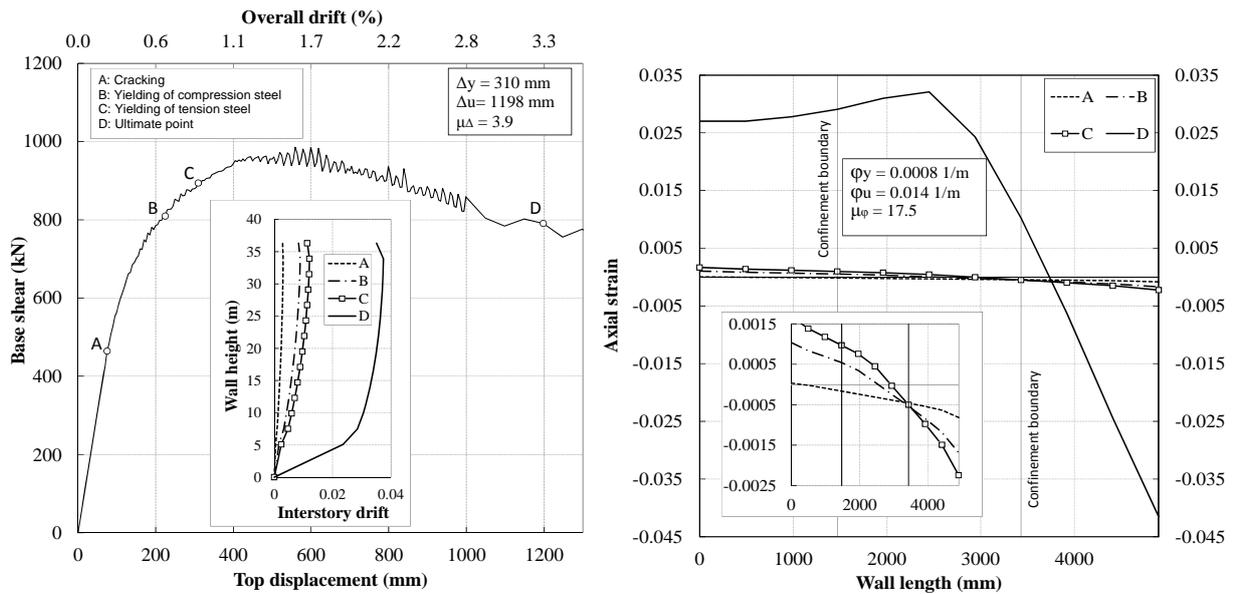
Figure 11. Push-over response of the ACI318-11 model

Figure 11 indicates the response of the wall designed based on ACI318-11. As previously mentioned, the wall did not fail even at a displacement equivalent to a drift value of 5.5% as the effect of reinforcement buckling and bond-slip was not taken into account. As a consequence, the point corresponding to 80% of the maximum strength of the wall was defined as the ultimate point (Point D). The axial strain versus wall length curve at different points, shown in

Figure 11, displays significant migration of the neutral axis position. Strain profiles corresponding to Points A to C are magnified in the figure to show the neutral axis position at these points. As shown in

Figure 11, the strain values of the ultimate point (Point D) are considerably bigger than the yield point (Point C). In this model the confinement was long enough to protect the unconfined concrete from reaching the peak strength. As shown in

Figure 11, the neutral axis was positioned within the confined concrete zone at the ultimate stage (Point D), where the confinement provided by the transverse reinforcement is enough to ensure a curvature ductility of 17.5 which corresponds to a

displacement ductility of 3.9. It should be noted that the ultimate strain of this model at the extreme compression element (0.04152) exceeds the ultimate strain value calculated for the confined concrete (0.032). However, the average strain of the mesh element equals 0.03298 which is consistent with the calculated value. Also, the ultimate curvature value (0.014 1/m) was calculated based on the sum of the extreme tension and compression strains divided by the whole length of the wall assuming a linear strain profile and is less than the value captured by the section analysis (Figure 8), whereas the curvature angle shown in

Figure 11 displays the effect of nonlinear strain profile on the value of curvature ductility. The distribution of reinforcement yielding in Figure 15 indicates capability of the wall to provide enough ductility and allow formation of a desirable plastic hinge at Point D. The reinforcement plastic strain at the top displacement of 1950 mm (5% drift) shows the fact that the increase rate in compression and tension strain was approximately identical and there was not a considerable change in neutral axis position. The inter-story drift profile of this model also shows its capability to reach a reasonable value of drift at the ultimate point.

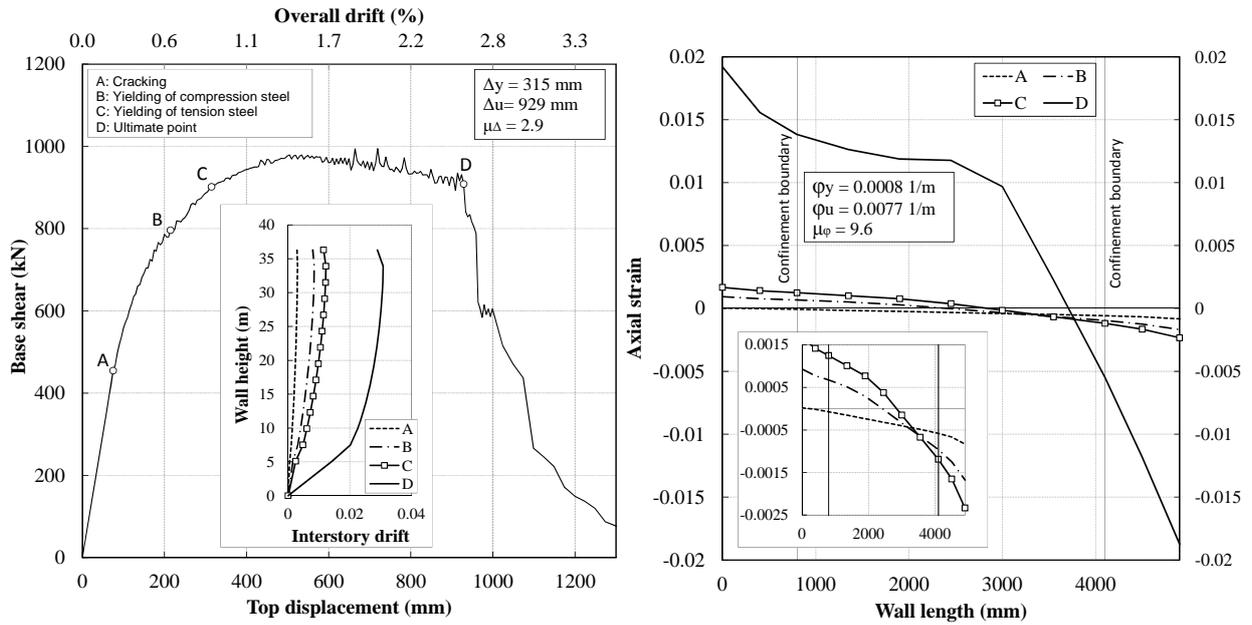
Figure 12. Push-over response of the Eurocode8 model

The base shear versus top displacement response of the wall designed based on Eurocode8 shows considerable strength degradation at an average drift of 2.6% (Figure 12). According to the axial strain profile along the wall length, the confinement was not long enough to prevent the unconfined concrete from reaching the peak stress at the ultimate state. The calculated ductility values are 2.9 and 9.6 in terms of displacement and curvature, respectively. Also the value of ultimate curvature (0.0077 1/m) is in good agreement with the value obtained from the moment-curvature curve (Figure 8). The plastic strain distribution of the reinforcement within the 1st story (Figure 16) shows a considerable increase in compression strain with only 5mm increase of the wall top displacement which indicates a considerable shift of the neutral axis position resulting from failure of the compression concrete elements. According to Figure 13, response of the wall designed based on NZS3101:2006 showed a similar trend to the ACI318-11 model. The curvature and displacement ductility values were about 19 and 4.5, respectively, and the wall top displacement at failure (defined as 20% drop in strength) was about 1400 mm, which corresponded to an average drift of about 3.9%. As the strain profile of the NZS3101 wall along the length and across the height are quantitatively similar to the ACI318-11 model, the strain profiles are not separately illustrated for the NZS3101 wall.

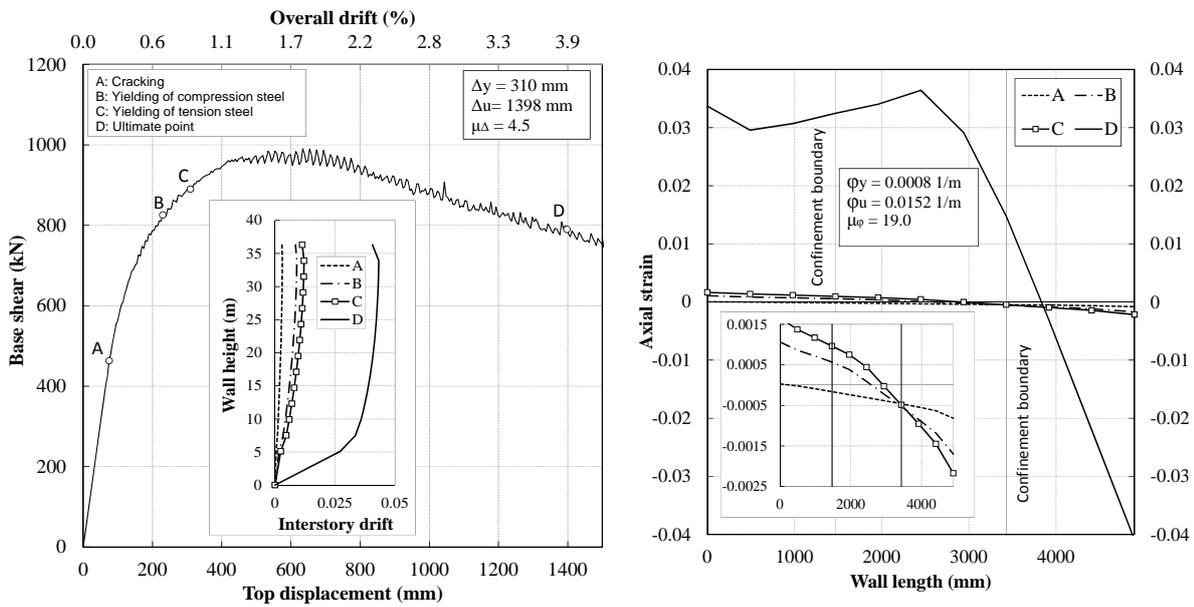
Figure 13. Push-over response of the NZS3101:2006 model

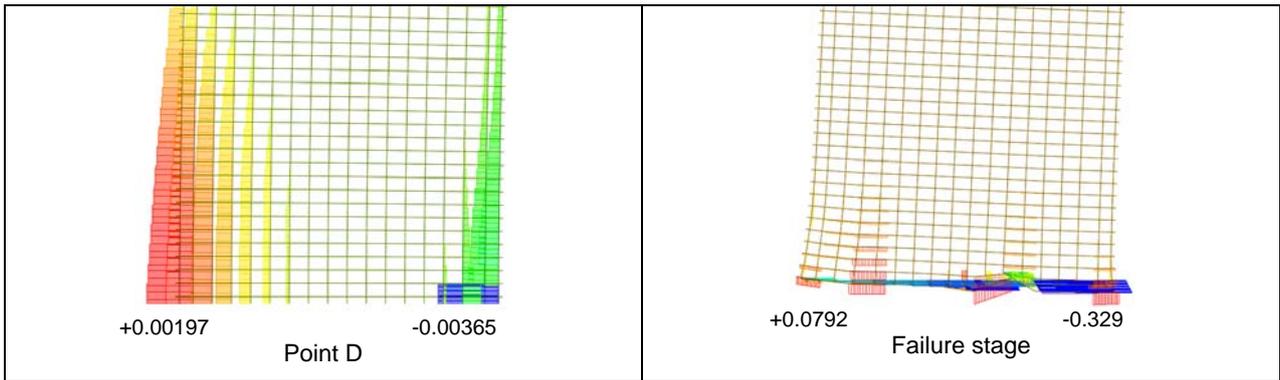
Figure 14. Plastic strain of the reinforcement, As-built

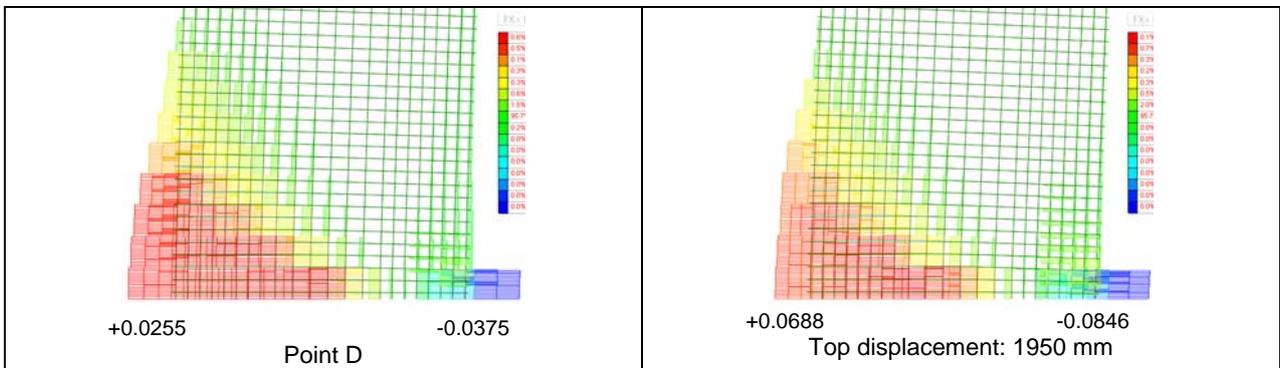
Figure 15. Plastic strain of the reinforcement, ACI318-11

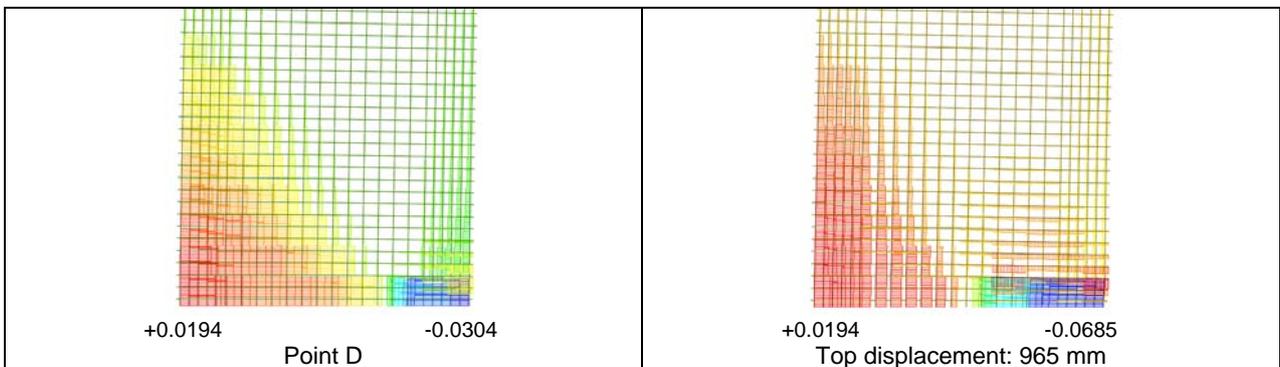
Figure 16. Plastic strain of the reinforcement, Eurocode 8

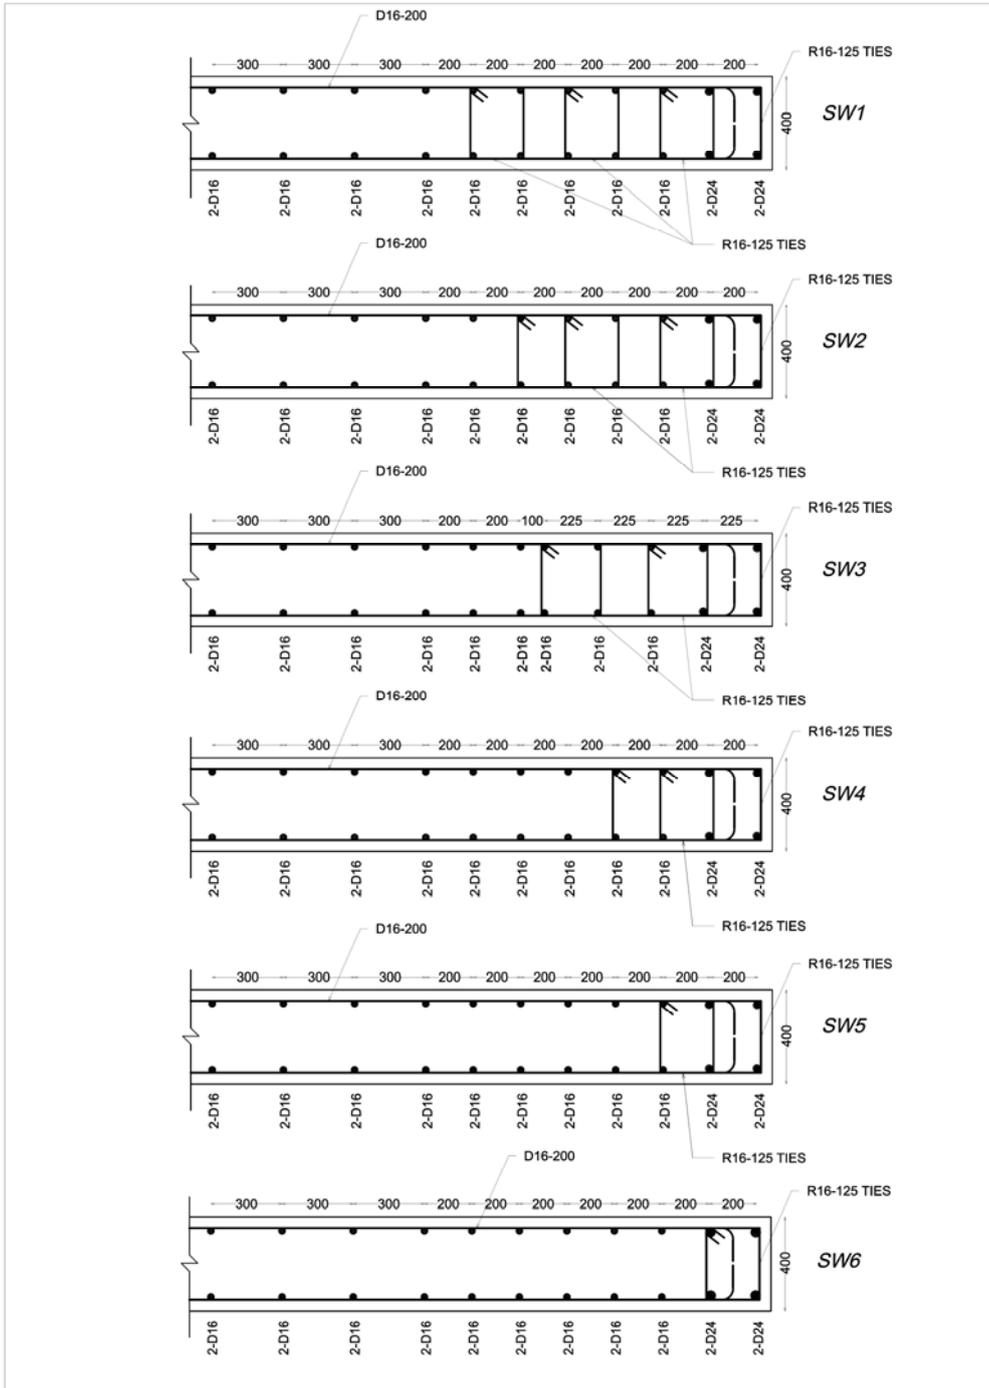
Figure 17. Wall sections with different confinement lengths

In order to investigate the effect of the confinement length on the wall response, the push-over curves of wall models with different confinement lengths were compared. For this purpose, the confinement length of the wall section designed based on ACI318-11 was gradually decreased to reach the confinement length of the As-Built wall (SW1-SW6,

Figure 17). It should be noted that only the confinement length was changed and the boundary and panel reinforcement configuration was kept the same as the ACI318-11 section. Figure 18 compares the response of the wall models SW1 to SW6 as well as the Eurocode8 and as-built models. The confinement length variation is 200mm for all models except between SW2 and SW3 where the variation is only 100mm. Confinement length of the Eurocode8 model is 200mm smaller than SW2 but its ultimate displacement was much smaller. SW3 shows the sensitivity of the degradation point to the confinement length within the region between SW2 and Eurocode8. Based on the detailed investigation of strain profiles and push-over curves of the different models, the critical confinement length appears to be between SW2 and SW3.

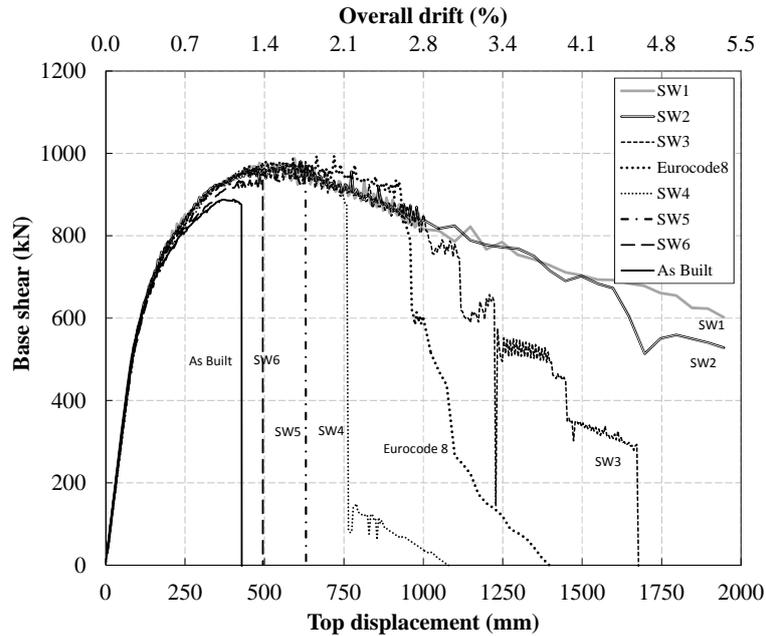
Figure 18. Push-over curves of the wall sections with different confinement lengths

Walls with a confinement length greater than the critical value would have a neutral axis positioned within the confined concrete region when the extreme compression strain exceeds the ultimate strain capacity of confined concrete. The effect of confinement length becomes even more significant at larger axial load ratios. As the axial stress increases, the critical compression strain of unconfined concrete is more likely to reach at smaller values of top displacement. This phenomenon was observed in recent earthquakes. According to Wallace (2012), limit should be placed on the axial stress applied to walls. Higher axial stresses in addition to irregular wall cross section shape (eg. T) in Chile earthquake caused concrete compressive strain to reach 0.003 prior to yield of tension steel.

The wall models of ACI318-11 and NZS3101 had such a good confinement that the neutral axis position was within the range of the confinement length at high compression strains and resulted in relatively high level of ductility for these models even after reaching 5.5% average drift. However, as the confinement length decreases, the neutral axis position is more likely to be placed outside the confinement length at critical stages of loading. As for SW4, the failure of the wall occurred at 1.8% average drift. SW6 had the same confinement length as the as-built wall but the transverse reinforcement ratio was the one calculated based on ACI318-11. Thus, the confined concrete model was the same as ACI318-11 (b)
