Structural characteristics of ancient dome in Jerash

*Takashi Hara¹⁾, Kenichiro Hidaka²⁾ and Reiko Seta³⁾

ABSTRACT

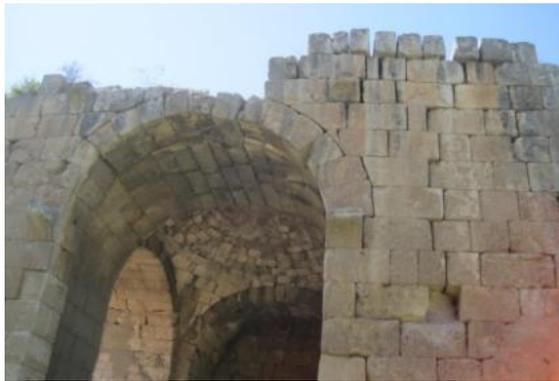
Fig. 4 Northern view of the dome

Fig. 4 shows the northern view of the vault. The right side shows the west that is the street side. From Fig. 4, the vault shows gaps between bricks because the left side of a vault settles down and the shear crack occurs on the main piers. Especially, the deformation of each brick appears at the bottom of the pier on the eastern view (Fig. 5).

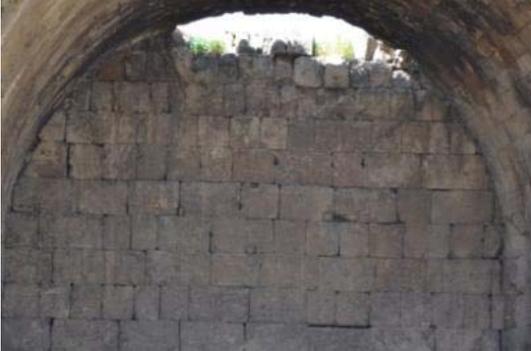
Fig. 7 Brick wall on southern end

Fig. 7 shows the southern wall from the northern view. The right side of the figure also shows the street side. As the same as Fig.4, the vault incline to the eastern side.

Therefore, the large gaps arise between the vault and the wall and the opening due to a shear deformation exists.
