## **Seismic performance of hollow reinforced concrete columns under cyclic pure torsional loading**

### **ABSTRACT**

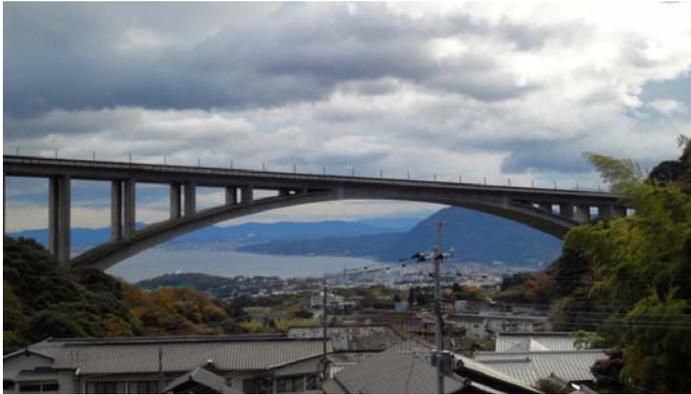
Photo 1 RC arch bridge

The structural members subjected to large torsional loading, i.e. arch ribs in arch bridges and L-shape pier, are increasing with the construction of long span bridges and the shortage of available area as shown in Photo 1. The strengths and rigidities of the members subjected to bending loadings, shear loadings and torsional loadings at the same time decline compared to those of the members under pure bending, pure shear and pure torsion loading condition. However, in general earthquake response analyses, the equivalent linear analyses are only conducted. In these analyses, the torsional rigidities are assumed to be nearly 0.1 times of the initial rigidities. The interaction curves between bending and torsion and the torsional nonlinearity aren't considered severely. Therefore, it isn't confirmed that these affect the response of bridges subjected to the motion of earthquake. It is because the torsional performance isn't clarified sufficiently.

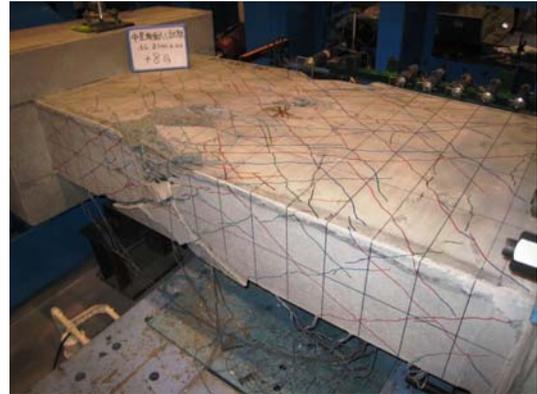
Photo 2 The 3-hollow specimen under pure torsion

From the above, the experiences of 1-hollow columns were conducted under pure torsional loading. The experiments of the hollow members had been conducted under pure torsion in our lab previously as shown in Photo. 2. 3-hollow girders considered as RC arch ribs under pure torsional loading and combined loadings had been conducted and the pure torsional skeletons, the interaction curves between torsional and bending loading, the stiffening effect for torsional loading and the converting the amount of CFS (carbon fiber sheet) to that of hoop ties had been clarified. However, the experiences of hollow members are very few compared to that of solid members and seismic torsional performance of the hollow members isn't clarified currently. Therefore, the experiments of 4 one-hollow RC columns were conducted under axial forces and pure torsion. In these tests, the hysteresis curves, the torsional skeletons, the distribution of cracks and the failure mechanism were clarified before the applicability of the proposal skeletons and interaction curves based on the previous experiments for members with other sections is confirmed. Two types of wall thickness (60mm and 100mm) and pitch of hoop ties (30mm and 60mm) were prepared.

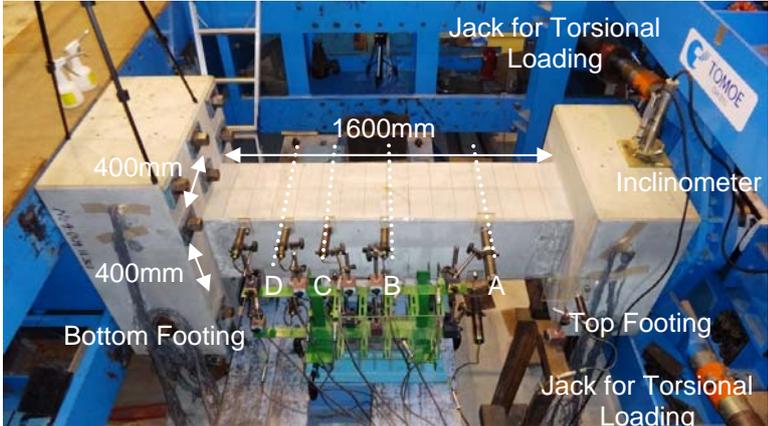
Photo 3 Test specimen and test setup

Photo 3 shows the photo of test specimen and Fig. 1 shows the position of the strain gauge in cross section of test specimen. The hollow RC columns had 400×400mm cross-section, 1600mm length, and footings at top and bottom. The target compressive strength of concrete was 40N/mm<sup>2</sup>. The main rebars and the hoop ties were deformed bars. Main rebars were used D13 and hoop ties were used D6. The yielding stress of the main rebars and the hoop ties was 295N/mm<sup>2</sup>.

In the torsional hysteresis curves, torsional loading was calculated based on loadings measured by load cells on two jacks for torsion as shown in Photo 3. The angle of twist was measured by the inclinometer on the top footing. Fig. 2 shows the comparisons of the torsional hysteresis curves. Fig. 3 shows the comparisons of the torsional skeletons in the test cases with same pitches of hoop ties. Here, the torsional skeletons show the line connecting the crack point, the torsional yielding point and the maximum strength point. In all specimens with hollow sections, the existences of the torsional yielding point were confirmed as well as the specimens with solid sections.

When these tests were conducted, in every section (from A to D) shown in Photo 3, the strain gauges were pasted to 10 points on the main rebars and 8 points on the hoop ties. The yielding strain of main rebars (Diameter: 13mm) was  $2095\mu$  and that of hoop ties was  $1950\mu$ .

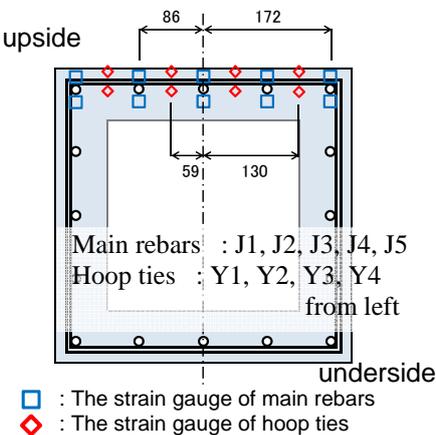
Fig. 1 The position of strain gauges

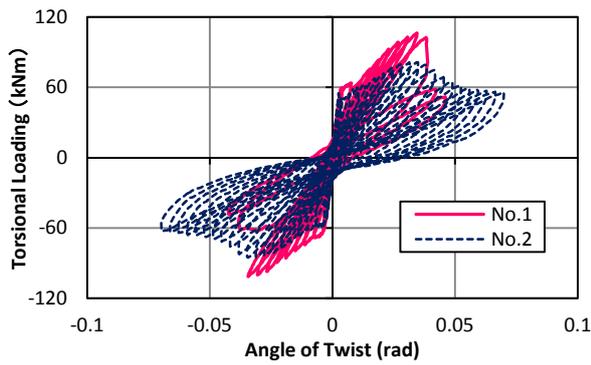
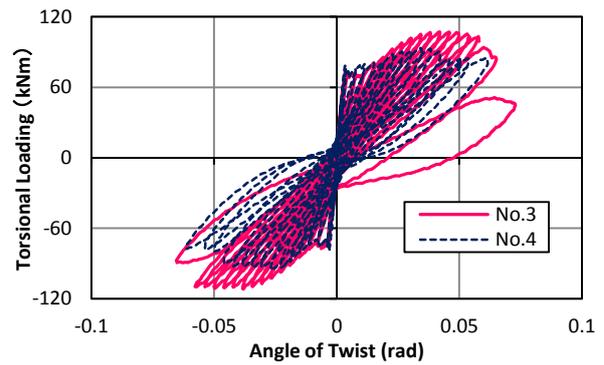
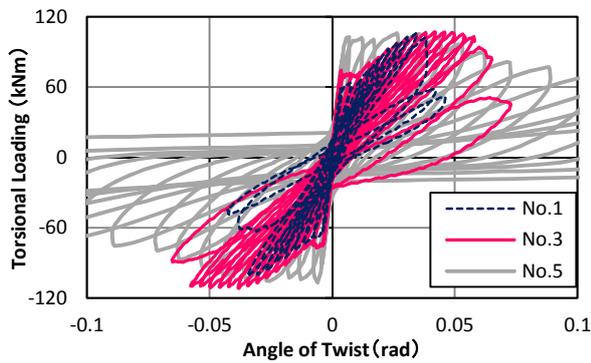
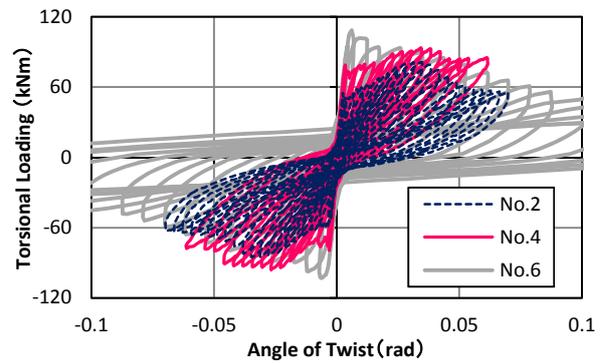
(a) Thickness 60mm

(b) Thickness 100mm

(c) 30mm pitch of hoop ties

(d) 60mm pitch of hoop ties

Fig. 2 Torsional hysteresis curves

In Fig. 2(a) and (b), compared to the torsional hysteresis curves of the hollow RC columns with same thickness, the initial rigidities were almost same and the rigidities after the torsional yield were higher in the cases of 30mm pitch of hoop ties than those of 60mm pitch of hoop ties. However, the rigidities after maximum strength of 30mm pitch of hoop ties were lower compared to that of 60mm pitch of hoop ties. This tendency of hollow RC columns was different from that of solid RC columns.

Compared to the torsional hysteresis curves of the hollow RC columns with same pitch of hoop ties, the initial rigidities were almost same. Also, in Fig. 2(c) and (d), the

thicker the thicknesses were, the lower the rigidities after the torsional yielding were, and the larger the rigidities after the maximum strength were.

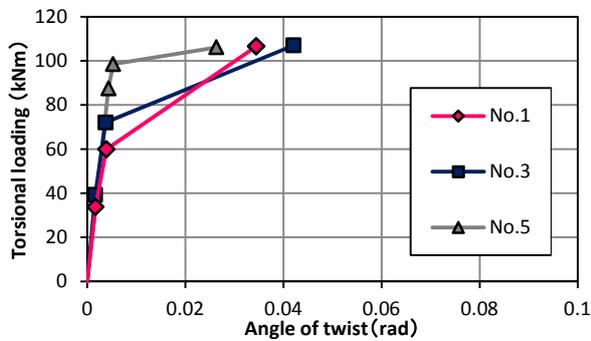
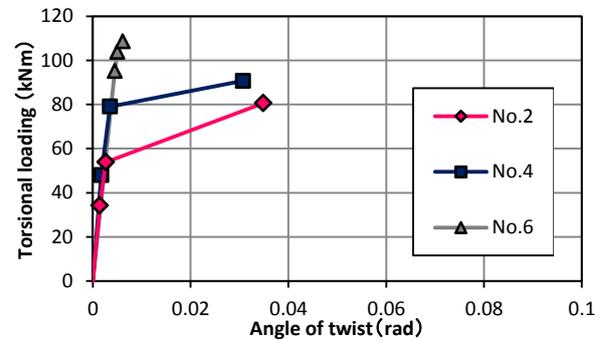
(a) 30mm pitch of hoop ties

(b) 60mm pitch of hoop ties

Fig. 3 Torsional skeletons

Compared the torsional skeletons of hollow and solid columns with same pitch of hoop ties, the thicker the thicknesses were, the larger the crack strength and the torsional yield strength as shown in Fig. 3. In the cases of test specimens with solid sections, the torsional yield strength were nearly 1.15 times of the crack strength, but the torsional yielding strength of all specimens with hollow sections were larger than 1.50 times of the crack strength. In particular, the torsional yielding strength of No.3 specimens was 1.84 times of the crack strength. The maximum strengths in the all cases of 30mm pitch of hoop ties were almost same. In the cases of 60mm pitch of hoop ties, the maximum strength of the test specimen with solid section was largest. On the other hand, in Fig. 3, the pitch of hoop ties didn't affect the crack strength and the torsional yield strength, but the maximum strengths of the test specimens of 30mm pitch of hoop ties were larger than those of 60mm pitch of hoop ties.

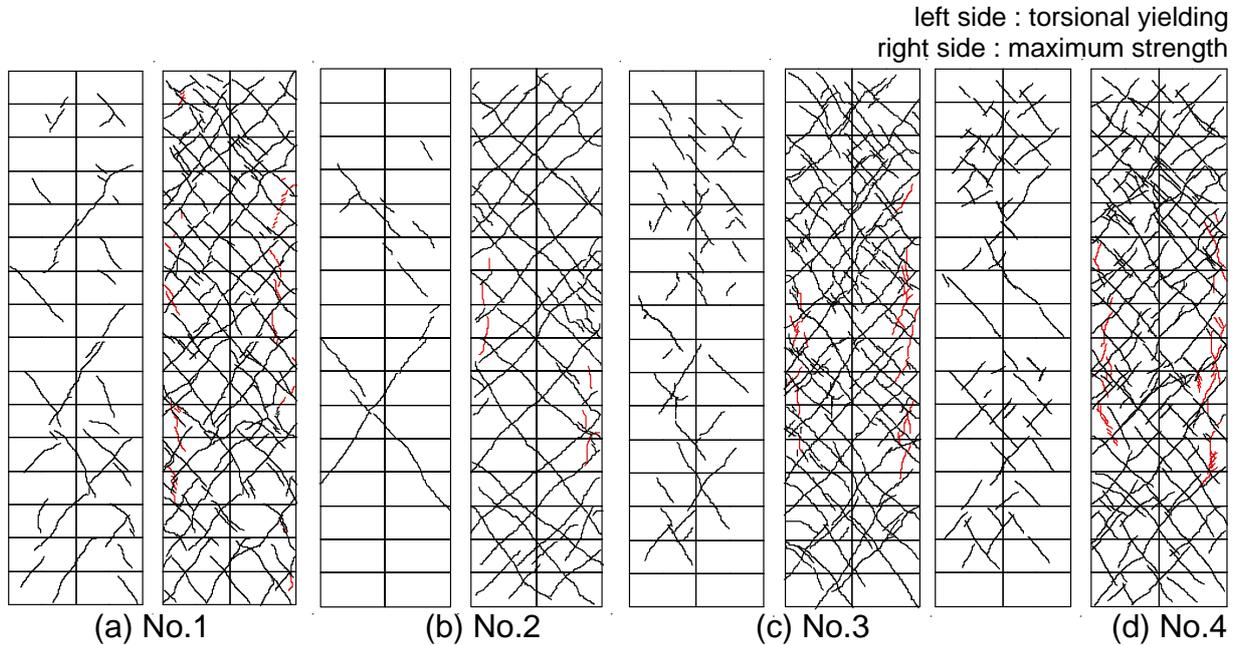
Fig. 4 Distribution of cracks

Fig. 4 shows the distribution of cracks in the loop of torsional yielding and the maximum strength. In all test cases, the diagonal cracks occurred from the center of columns surface at first. Because of effect of axial forces, the crack angles to the axis of the members were smaller than 45 degree. In the distribution at torsional yielding, the cracks of the test cases of 100mm thickness were more dominant in the center of column surface than that of 60mm thickness as shown in Fig. 4. Also, the number of the cracks increased and the cracks were distributed when the hoop ties were increased.

The cracks in maximum strength developed to the corners of section and the number of cracks and the width was extended compared to the distribution of the cracks in torsional yielding. Also, the axial cracks described by red lines in Fig. 4 occurred just before maximum strength and they were confirmed along the main rebars arranged at the corner of the section.

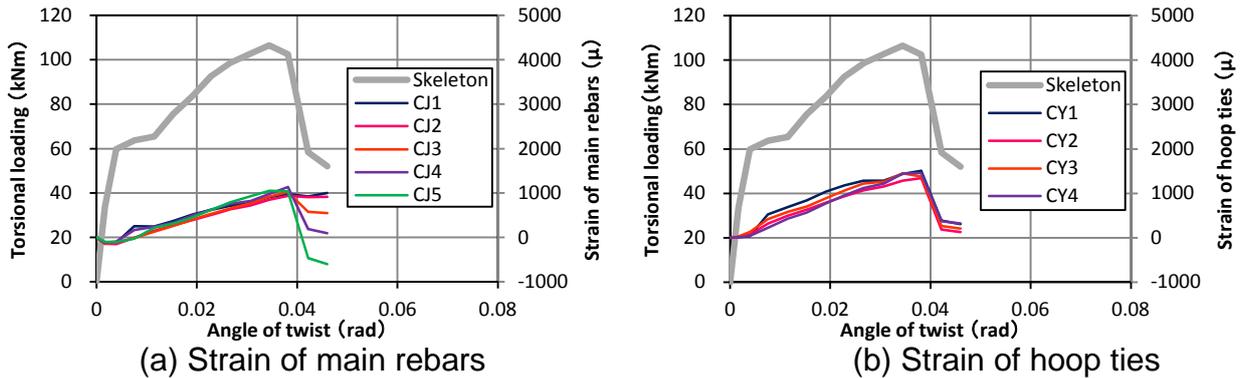
Fig. 5 Strain of main rebars and hoop ties (No.1)

Fig. 5 and Fig. 6 show the strain of main rebars and hoop ties of the maximum angle of twist in the every loading loop. In Fig. 5 and 6, the torsional skeletons were also described. Fig. 5 shows the strain in No.1 specimen and Fig.6 shows the strain in No.2 specimen. The strains at the C section in Photo 3 were used because the axial cracks developed and the cover concrete peeled at the C section as shown in Fig. 4. The strain of main rebars decreased because of axial forces and didn't change before torsional yielding. After the torsional yielding, the strain increased equally in all main rebars. The strain distributed in the section after the maximum strength. In particular,

the compressive strain occurred intentionally on the main rebar arranged at the corner of section (CJ5). The steel yielding weren't confirmed in any main rebars.

The strains of hoop ties were almost 0 before the torsional yielding, but they increased equally in any hoop ties after the torsional yielding as well as main rebars. However, the strains decreased after the maximum strength. In Fig. 6 (b), the strains of CY2 and CY3 were different from those of CY1 and CY4 because the hoop ties arranged No.2 specimen were few and the strain of hoop ties directly under every crack was easy to increase. In the specimens prepared 60mm pitch of hoop ties, the yielding of hoop ties were confirmed at the C section in No.2 and the D section in No.4. On the other hand, in the specimens prepared 30mm pitch of hoop ties, the yielding of hoop ties wasn't confirmed.

Before the maximum strength, the axial cracks along the main rebars arranged at the corner occurred and developed as shown in Fig. 5 and Fig. 6. The axial cracks were confirmed in all test specimens. The axial cracks were similar to the cracks due to bond splitting, which were confirmed under shear loading generally. The cracks due to bond splitting were known the strength decreased rapidly because of disappearance of

In Fig. 5(a) and Fig. 6(a), the strains of main rebars in the C section confirmed the peeling of cover concrete showed the linear distribution considered the center of column surface as the origin after the maximum strength. For this reason, it is considered that the load bearing mechanism transitioned from the form of space truss to that of skew bending.

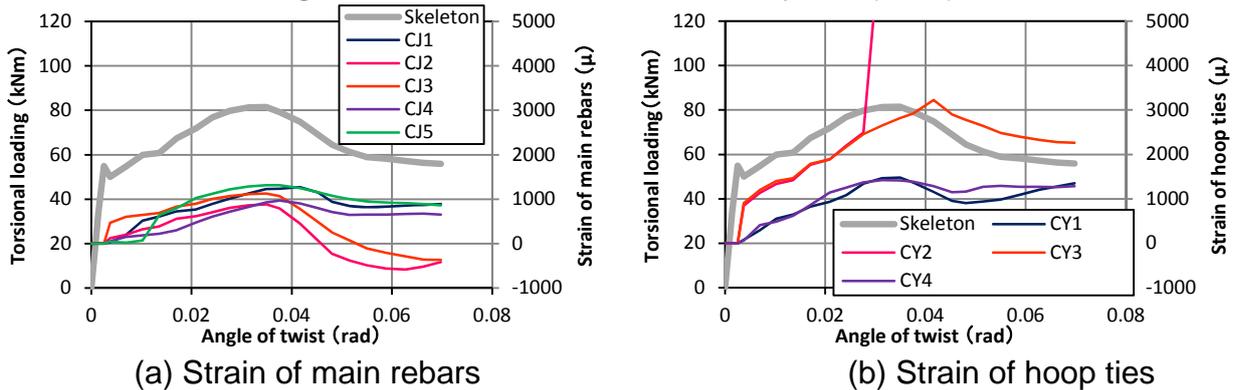
Fig. 6 Strain of main rebars and hoop ties (No.2)

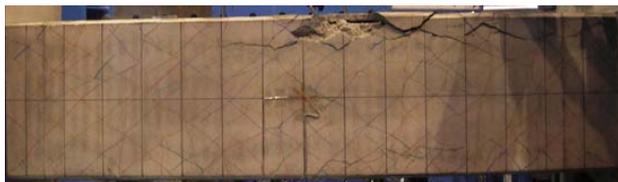
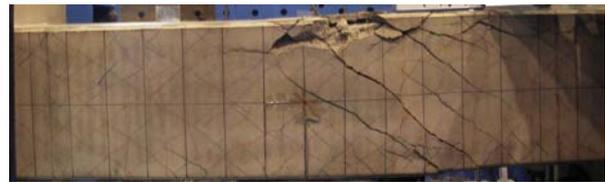
(c) the peeling of cover concrete

(d) the converting to skew bending

Photo 4 The failure mechanism in No.1 specimen
