Lateral Load Testing of Two Existing Masonry Buildings

ABSTRACT

Keywords: In-situ, Pushover Test, Brick Masonry

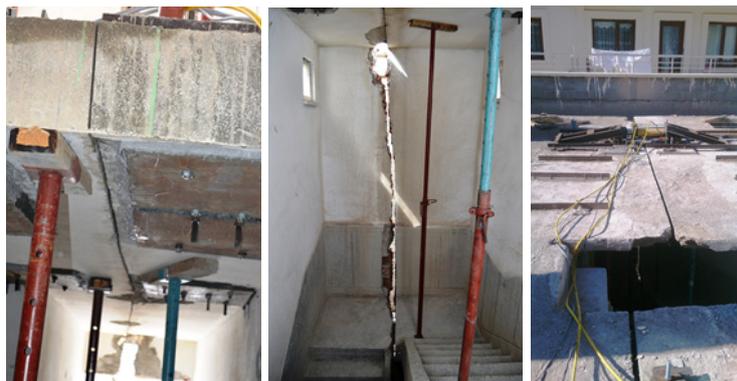
The stiff reaction wall is required to apply lateral loads on the test structure. Therefore, the test building was sliced into two parts by using saw-cutters (Figure 3). In this way, the lateral loads could be applied by leaning on the west side of the building after strengthening four walls lying in that part of the building shown as hatched areas in Figure 1 with external mesh reinforced mortar.

Figure 3. Photos of Interface between Retrofitted and Tested Structures

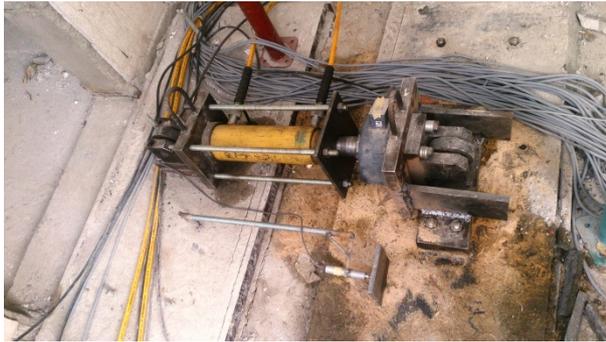
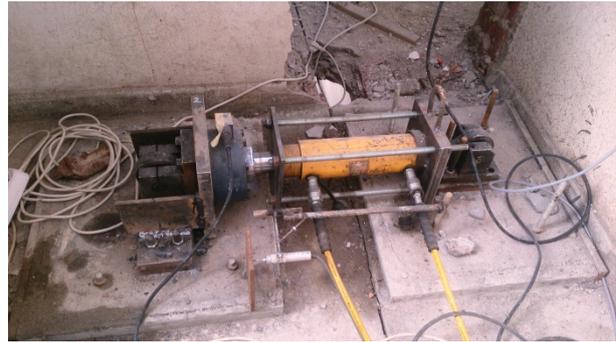
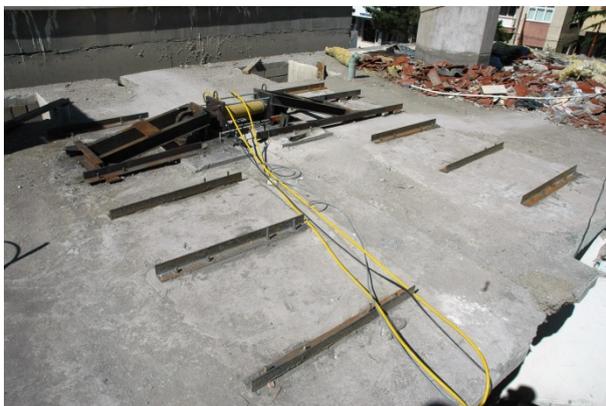
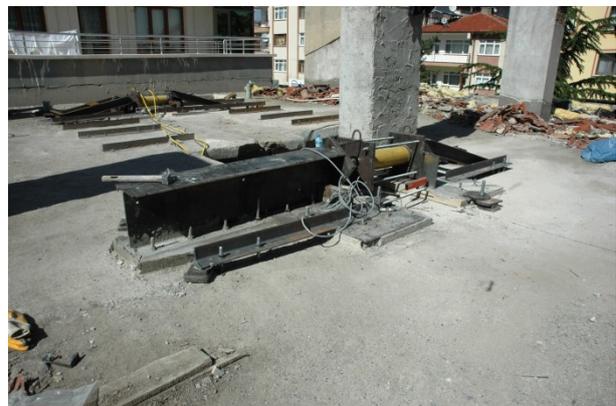
Figure 5. Photos of Hydraulic Actuators at Each Story

(a) Hydraulic Actuators at First Story

(b) Hydraulic Actuators at the Roof

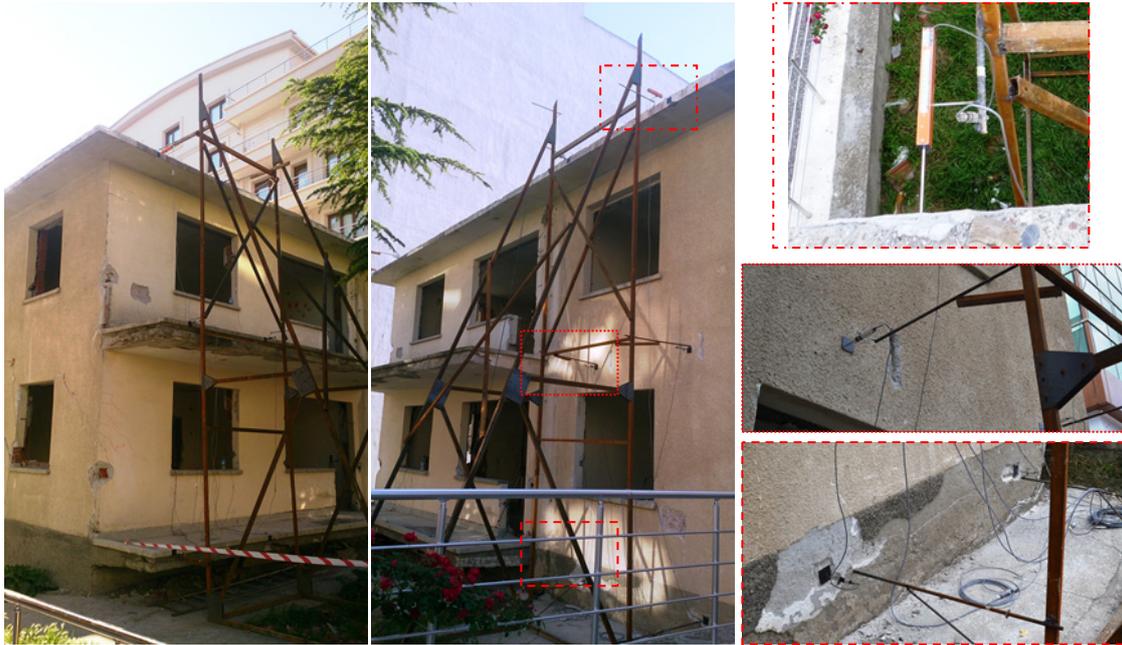
Figure 6. Photos of LVDT's installed at Each Story Level

The lateral displacements of every stories were recorded with Linear Variable Differential Transformers (LVDTs) installed at four different points. The locations of these LVDT's are also shown in Figures 4-6. In addition, the deformations of the walls were measured by using four LVDTs, two measuring vertical deformations, two

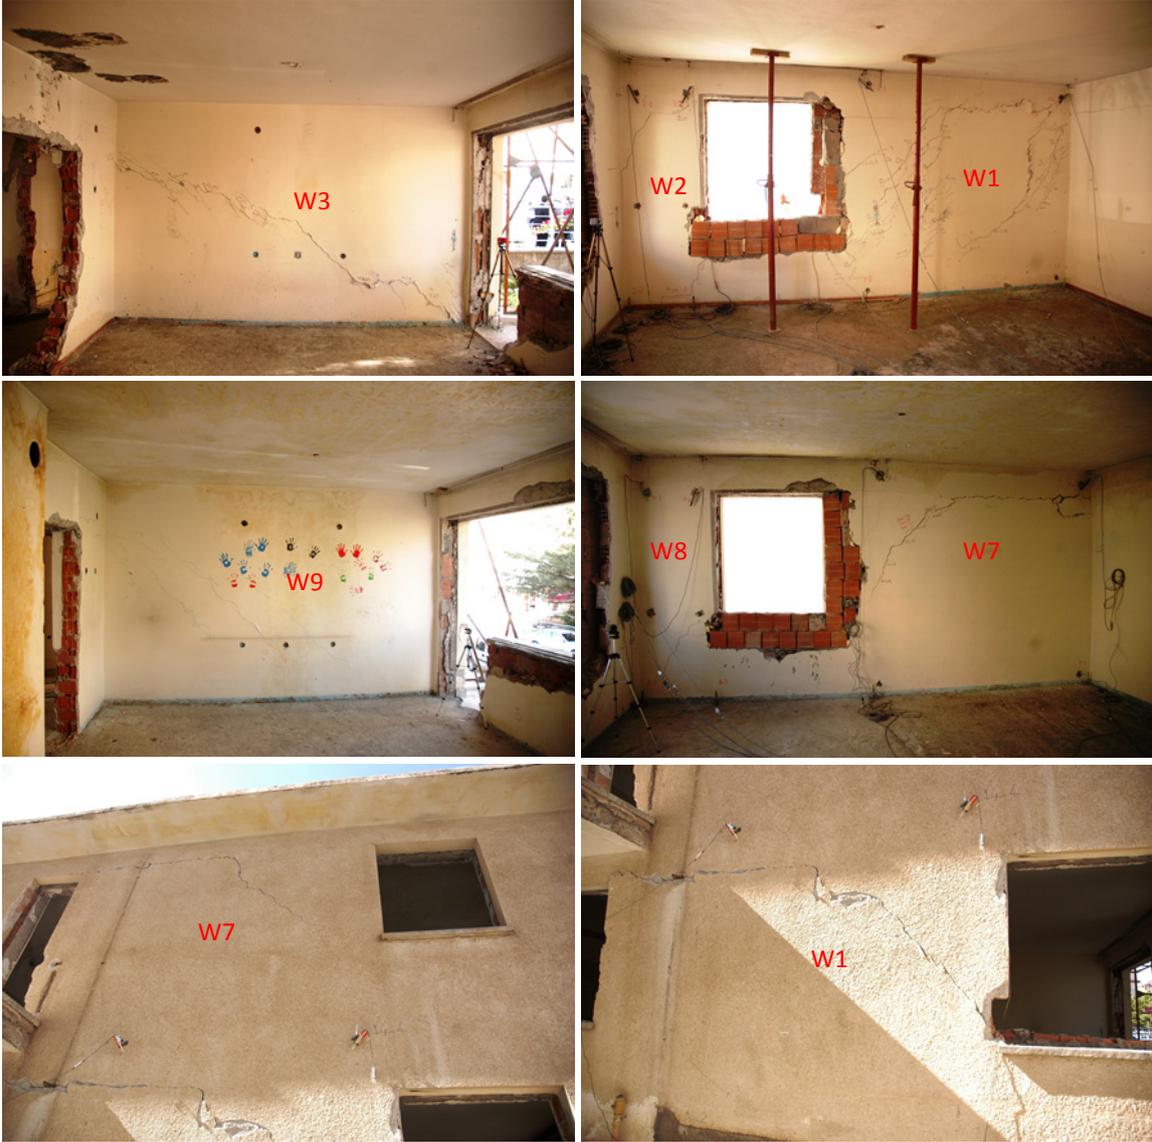
Cracking patterns observed in walls 1, 3, 7 and 9 are shown in Figure 11. Horizontal cracks occurred between the horizontal bond beams and walls. Afterwards, diagonal cracks started to initiate. Even for walls with relatively large aspect ratio (H/L), diagonal cracking was the dominant failure mode as opposed to expected rocking failures. This observations support the recent findings of Russell et al. (2014) who point out the importance of flange effects for accurate failure mode and strength estimation of masonry walls.

Figure 15. Observed Wall Damages

Measured load deformation response of the building is presented in Figure 12.a-12.c. In these figures, the deformation measurements at the mass centre are exhibited determined by dividing the story displacement with the story height in those graphs. The profile of story displacements and the plan deflections for the different roof displacement demands are shown in Figures 12.d and 13, respectively. The damage pictures of the selected walls are also presented in Figure 15.
