Structural condition of Peruvian heritage architecture to resist earthquake actions

ABSTRACT

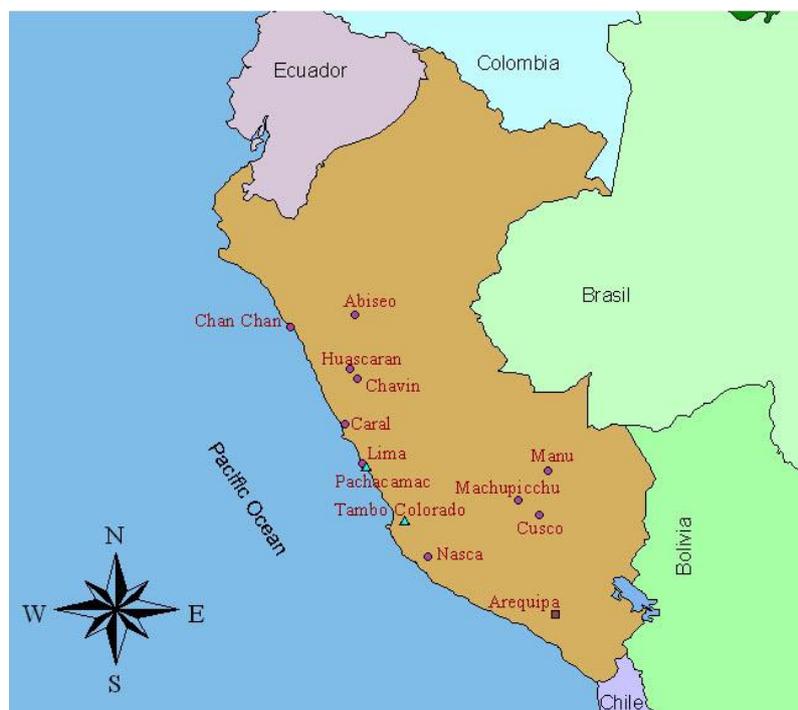
Fig. 4 Peruvian world heritages distribution

Peru has many sites of cultural and natural heritage reflecting the pre-Inca era, Inca era as well as the subsequent era following Spanish conquistadors in the 17th century. The distribution of these heritages can be observed in Fig. 4 and includes the world heritages declared by UNESCO which are marked by circles. Of the eleven Peruvian heritage sites in the UNESCO world heritage list, seven are considered cultural and two are considered natural. The remaining two are considered mixed category, meaning that the sites reflect the cultural as well as the natural heritage. Additionally to this UNESCO list, other architectural heritages located in the coast of Peru are included in Figure 4 and are marked by triangles. Most of these selected architectural heritages correspond to structures made of adobe. Descriptions of some important sites are presented in the following sections.

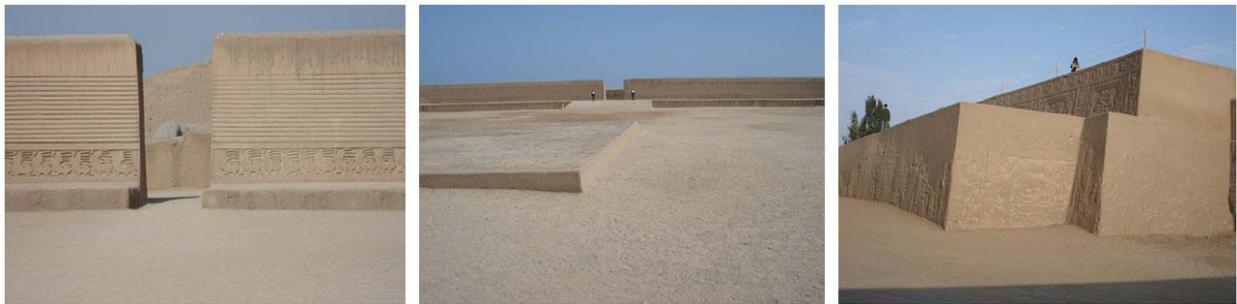
Chan Chan is considered the largest old city of South America that was made of adobe. Chan Chan was the capital of a pre-Inca kingdom of Chimu. The remains of the city can be found in nine parts that are considered separated units or palaces because only around these places can be appreciated remarkable constructions. In Fig. 5 some views of adobe constructions can be observed.

Fig. 5 Some views of Chan Chan adobe city

The adobe constructions are quickly damaged by natural erosion due to the air, salt, humidity and rain and they require continuous conservation efforts. This zone is also subjected to the impact of El Nino current which affects climate world-wide. Some years like 1983 and 1998 this phenomenon was unusually strong, leading to torrential rain and flooding. As was shown previously the seismic activity in this north part of Peru are smaller in comparison to the southern and central parts. However, historical earthquakes distribution and hazard analysis shown that this area is not free of earthquakes and on the contrary occurrence of rarely earthquakes could strike and damage earthen structures like Chan Chan.

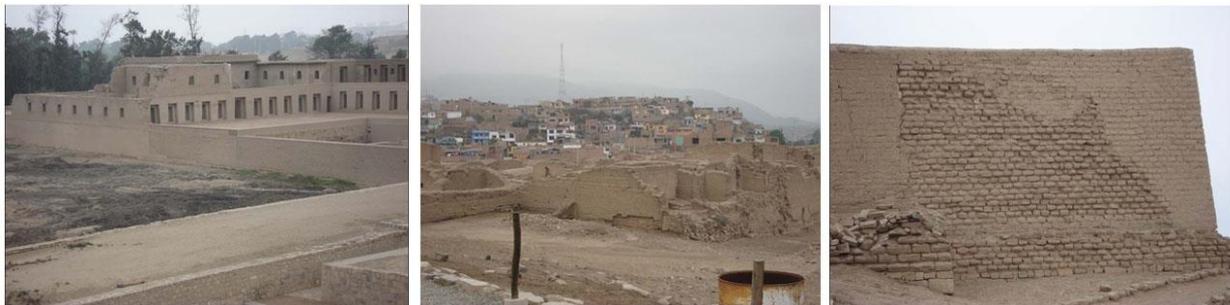
This complex was one of the main centers of religious cult, an oracle center of ancient civilization in the central coast of Peru. It is a pre-Inca heritage which origins date from 200 a. c. It is believed that one of the deities of this temple was the god of earthquakes. Their constructions are made of adobe which present condition shows the fragility of this kind of material to the action of natural hazards. Fig. 7 shows some view of the Pachacamac complex. The buildings in general are affected by the erosion due to the sand and also by the movement of the sand dunes that in some cases has destroyed and cover completely the buildings. It is difficult to infer the action of past earthquakes because the damage condition of the building could be the result of the action of earthquakes and the lack of appropriate maintenance. Another hazard to this complex becomes the rapidly development of the urban area near the complex that affect not only the landscape of the zone but the architecture heritage itself since construction materials are obtained from the historical place.

Fig. 7 Some views of Pachacamac archaeological complex

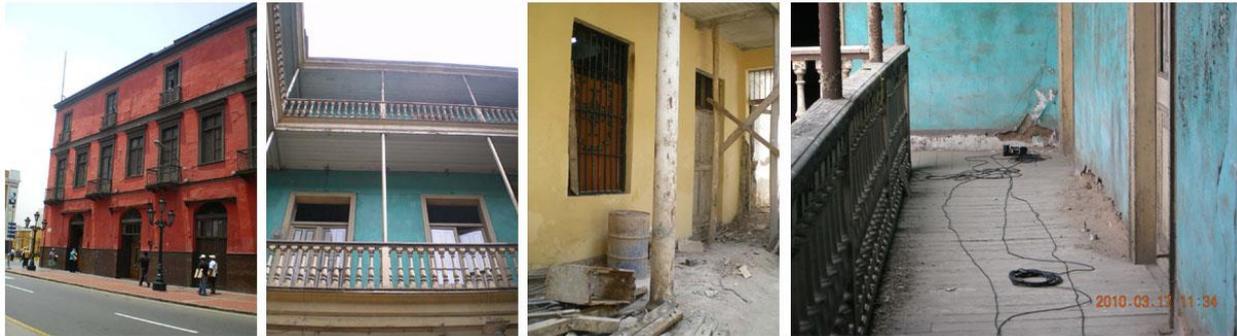
The city of Lima, the capital of Peru, was founded by Spanish conquistador Francisco Pizarro on January 18, 1535 and given the name City of the Kings. Lima played a leading role in the history of the New World from 1542, when Carlos V establish the vice royalty of Peru, until the middle of the 18th century. In 1988, UNESCO declared the historic center of Lima a World Heritage Site for its originality and high concentration of historic monuments constructed in the time of Spanish presence and at the beginning of the Republican era. The architecture of the buildings corresponds in general to typical Hispano-American baroque of the 17th and 18th centuries. Since its foundation the city has suffered the action of many earthquakes that have severely affected historical buildings and reconstruction works have been done keeping the originality of the buildings. However due to the age of buildings studies for retrofitting or strengthening are necessary. In this study a preliminary evaluation of structural condition of buildings is presented. As example a building that correspond to an old hotel is presented where ambient vibration measurements were performed to estimate the period of vibration. This building can be observed in Fig. 9. Walls are made of quincha that consists of a wooden frame with a mesh of cane that receives a mud plaster. The first story is made of adobe walls and the upper two stories are made of quincha. The building presents some partial collapse of interior walls and serious deterioration of the quincha walls.

Fig. 9 Views of a historical building at historic centre of Lima

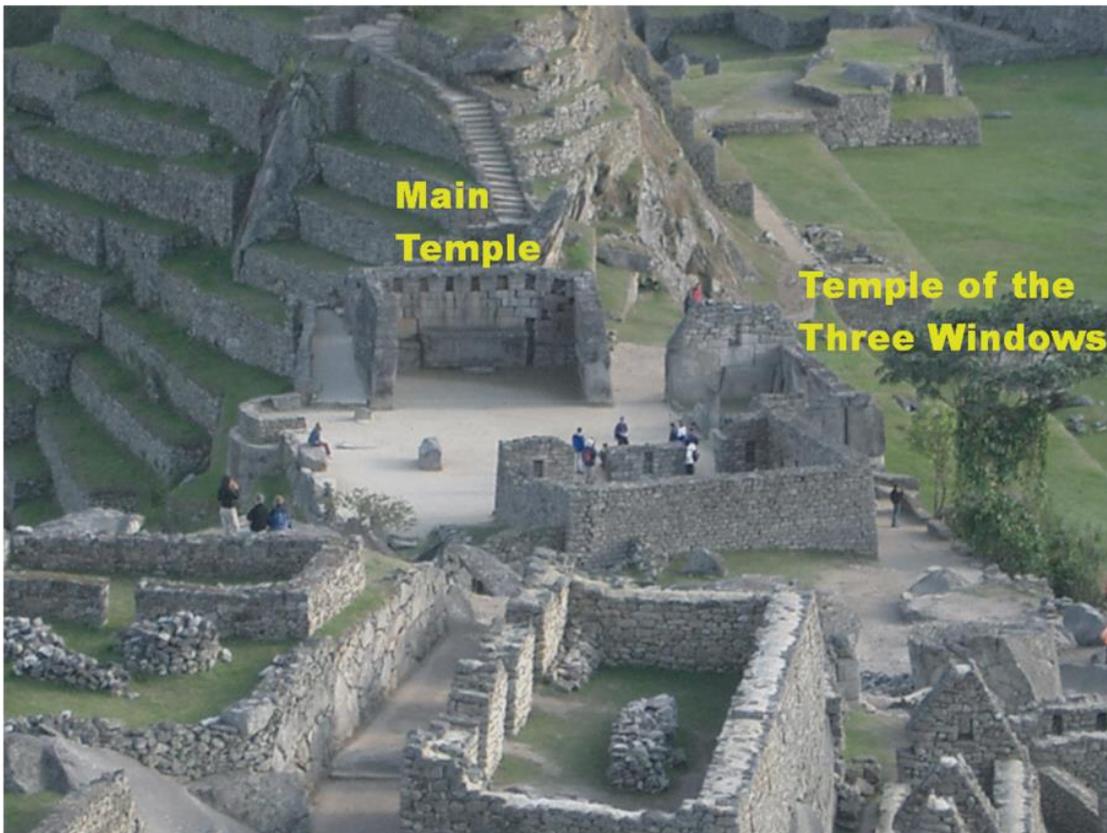
Field survey has been performed on selected part of Machupicchu citadel (Fig. 11) to evaluate the structural condition of historical constructions. Damages were detected in many buildings and, an evaluation to establish the causes of these damages was done. Slips of stone blocks are observed as gaps between adjacent blocks in stone masonry walls. In some cases the movement of blocks could be due the settlement of the underlying ground. However, in some cases there is not ground settlement and therefore it is supposed that the movement of blocks could be the result of the action of past earthquakes. The particular horizontal sliding between stone blocks at one wall corner of the Temple of the Three Windows could be consequence of strong seismic forces of past earthquakes.

Fig. 11 Stone masonry structures at Machupichu

Probable action of past earthquakes on the failure of these buildings or portion of these historic buildings can be inferred from the observation of the structural condition of gables walls. Most of them have collapsed and from detailed observation of apparently undamaged walls it can be observed that most of them have been reconstructed. The evaluation of the settlement observed in the Main Temple conduces to think that it is probably due to the fracture of the subjacent bedrock in which the building is founded. Apparently, the bedrock is shallow and the fracture of this rock can be explained only by the action of large geodynamic forces.
