Field test research on failure of photoelectric composite submarine cable under impaction by dropped anchors

ABSTRACT

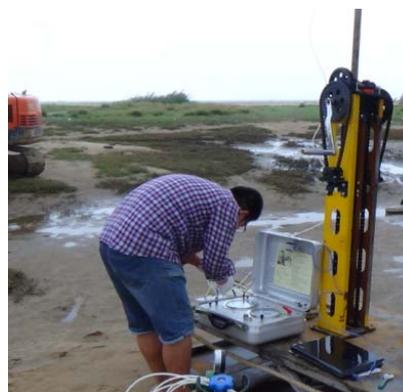
Fig. 1 Soil properties test with DMT

The field test site, the seabed of Fenghe bay in Qingdao, China, is an intertidal zone. When tide rises, it's submerged, and when tide ebbs, the seabed emerges. The seabed is mainly fine sand. Before impacting on the cable, the geotechnical parameters of seafloor are measured with a flat dilatometer test (DMT), including internal friction angel (φ). DMT now is a very popular method for in-situ measurement of soil properties, with advantages of efficiency and economy. The operating principles of DMT are elaborated in detail in the reference (Marchetti et al. 2001). Along the cable path, the internal friction angels of sand at five different points with the same horizontal interval of 1.4 m are measured, as shown in Fig. 1. The average internal friction angel of the test region is 40° .

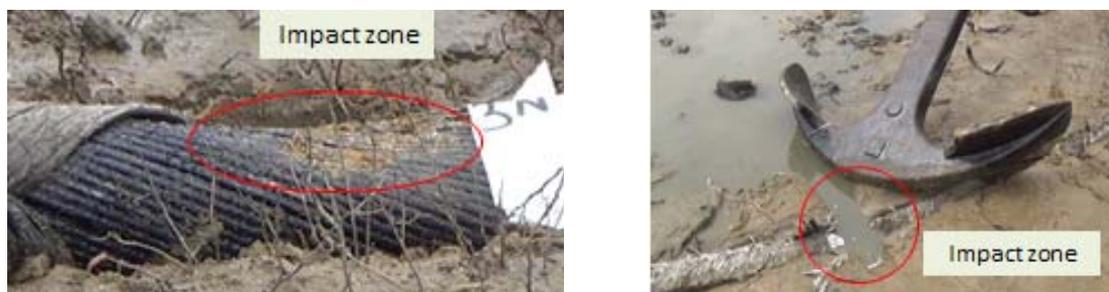
Fig. 5 Armoring layer damage under impact

As shown in Fig. 5, after being impacted, the cable armoring layer produces indentation. The whole cable produces a deflection. In one word, global and local deformations of the cable occur under impact. The heavier is the anchor, the more obvious is the deflection of the cable. Fig. 6 shows the schematic diagram of global and local deformation.

(a) Anchor (100kg) falling 3m

(b) Anchor (500kg) falling 3m
