Seismic performance of Japanese traditional old wooden house against a strong earthquake ground motion

The 2019 World Congress on
Advances in Structural Engineering and Mechanics (ASEM19)
Jeju Island, Korea, September 17 - 21, 2019

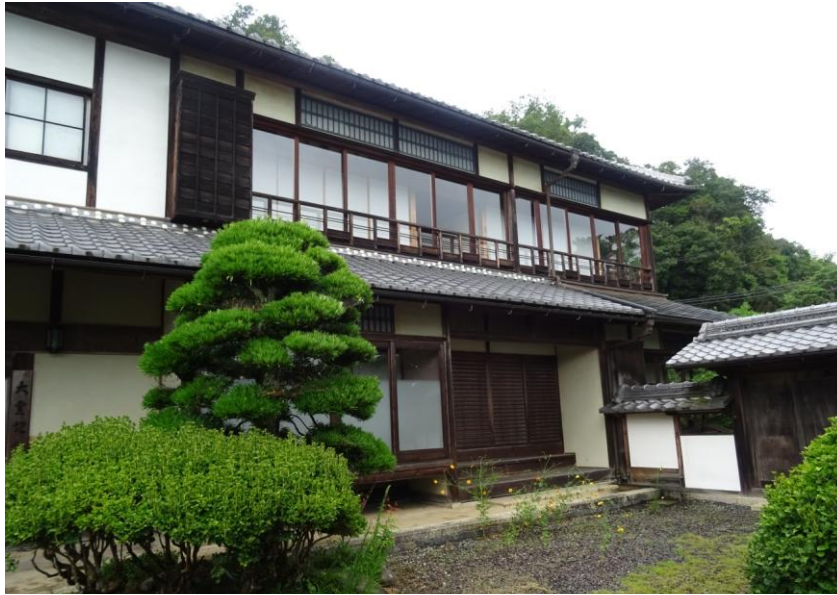
Photo 1. The Ohkumo memorial house (Former Hirano house)

Photo 1 shows the Ohkumo memorial house (former the Hirano house) built by the technique of Sukiya-zukuri in 1909, which is a modern Japanese-style two-story wooden house and has a king-post truss in the roof frame over a kitchen as shown in Photo 2. There are many reception rooms with tatami floor, a tea-ceremony room, and a beautiful garden in this wooden house as shown in Photo 3.

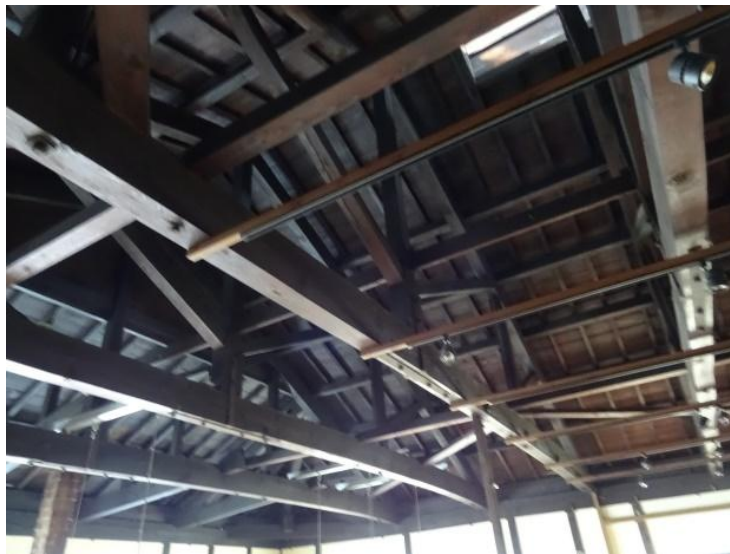
(a) King-post truss

Photo 2. Roof frame and reception rooms in the Ohkumo memorial house

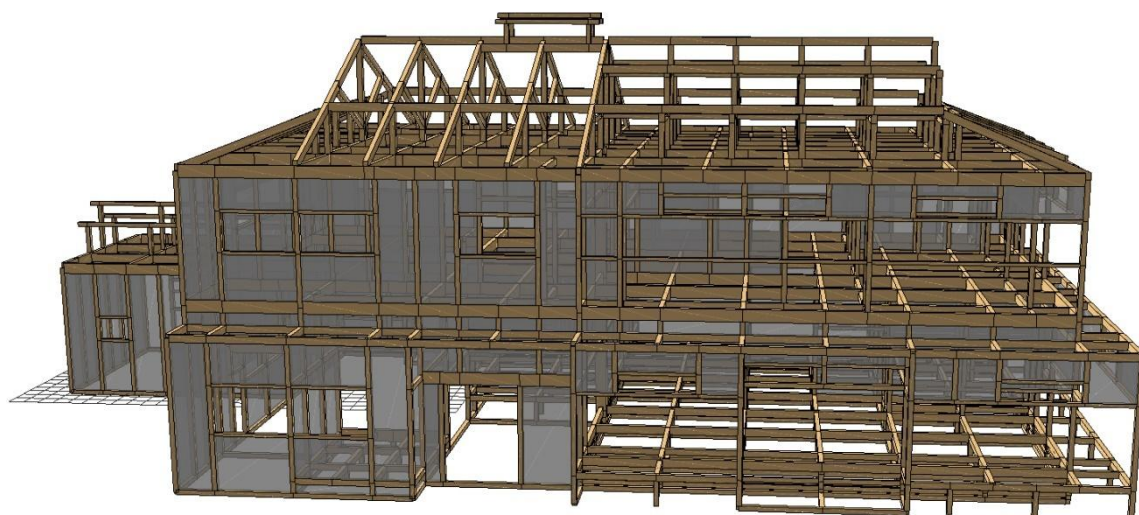
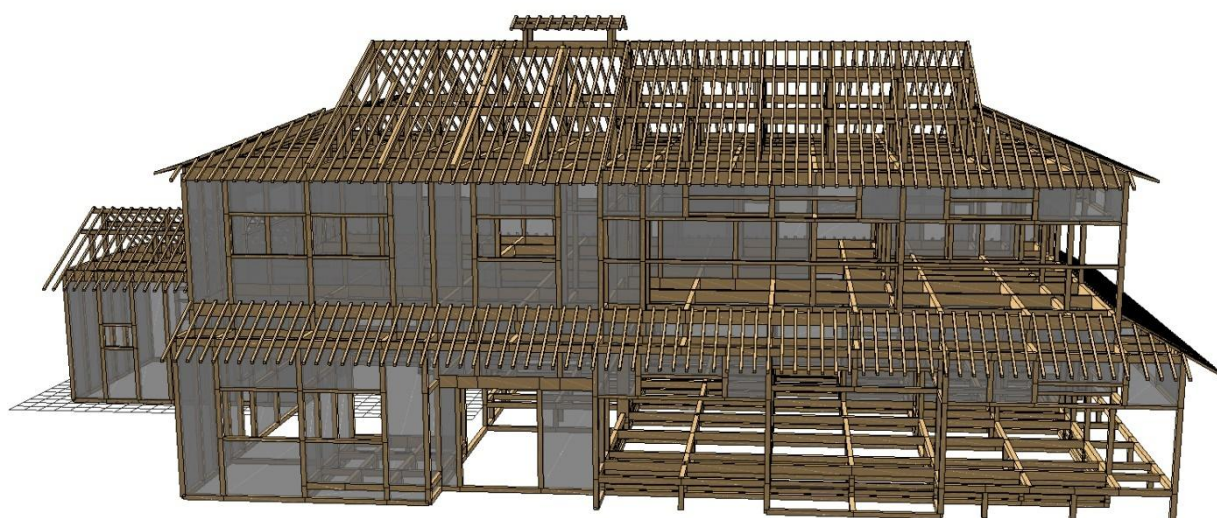
Fig. 3 Wooden frame model for 3-D collapsing process analysis

(a) Frame model

(b) Frame model with roof joist

Fig.3 shows a wooden frame model of the Ohkumo memorial house, which consists of wooden beams and posts. Fig.3(a) indicates a frame model with walls and Fig.3(b) illustrates a frame model with roof joists. In this paper, a frame model shown in Fig.3(a) is employed in 3-D seismic collapsing analysis.
