# A Study on the Numerical Analysis of Curtain Wall with 3-Axis Displacement Absorption

Structures20

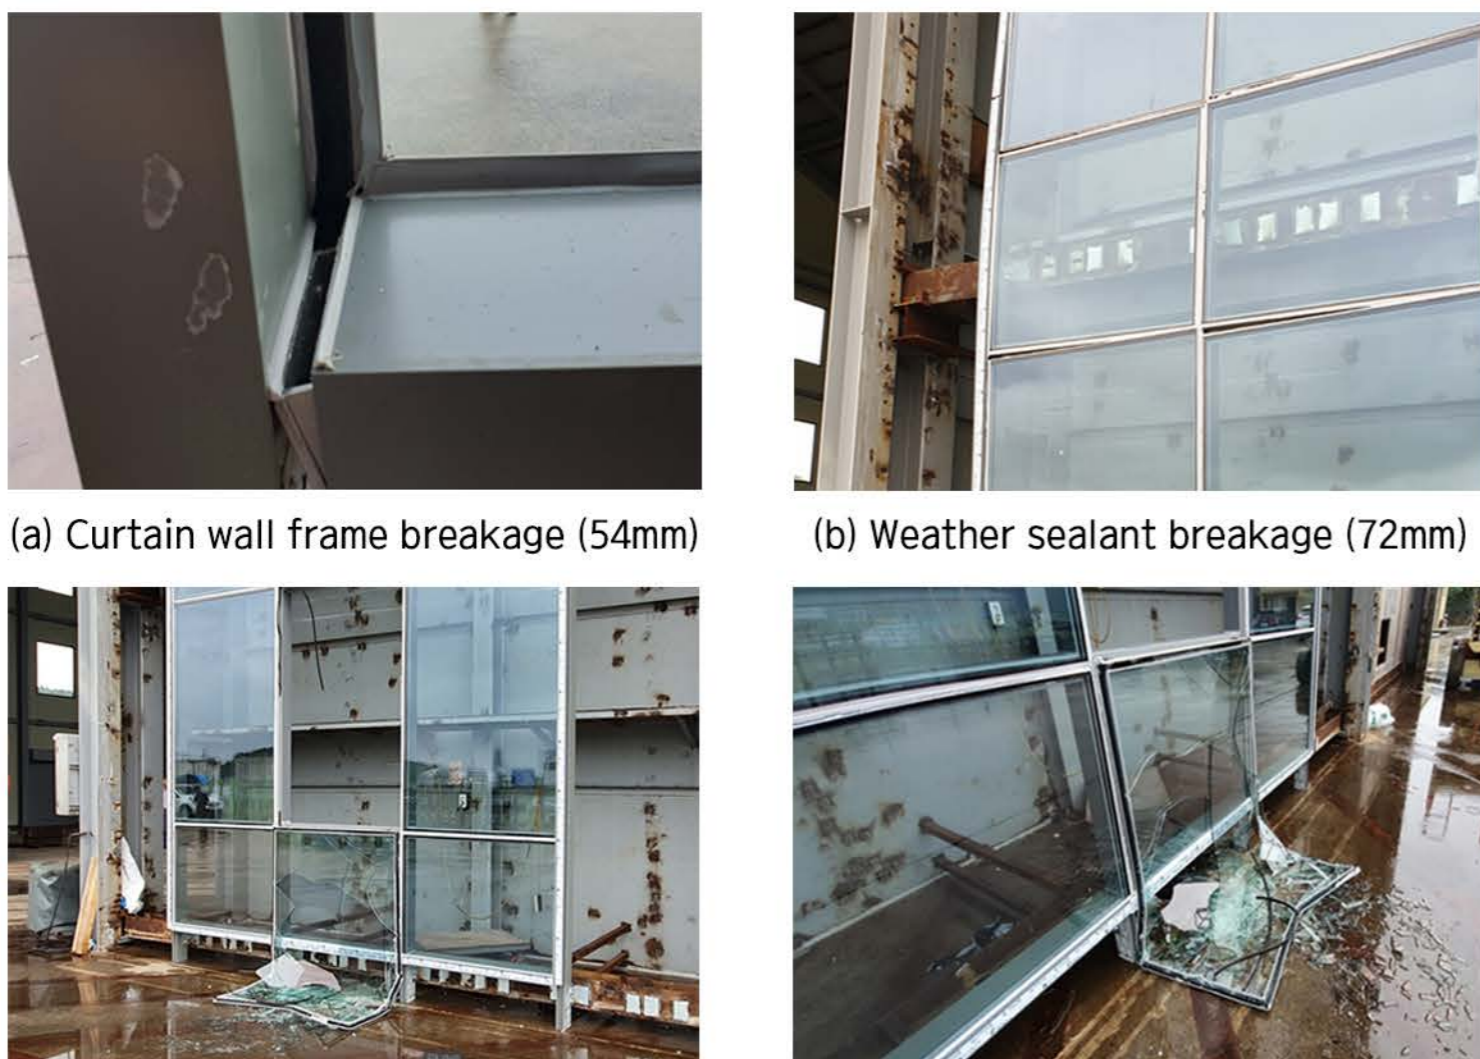
Fig 2. The main vulnerabilities of curtain wall

1. In the case of the experimental seismic performance evaluation of the existing curtain wall, weaknesses such as large deformation and concentration of stress at the joints of fasteners and expansion joints were confirmed. It was confirmed that experimental result was similar to the result of the review of the vulnerabilities by finite element analysis.
2. As a result of finite element analysis, by applying the 3-axis displacement absorption curtain wall fastener, the structural problems of the existing curtain wall were completely compensated and the effectiveness of improving the seismic performance of the curtain wall was verified.

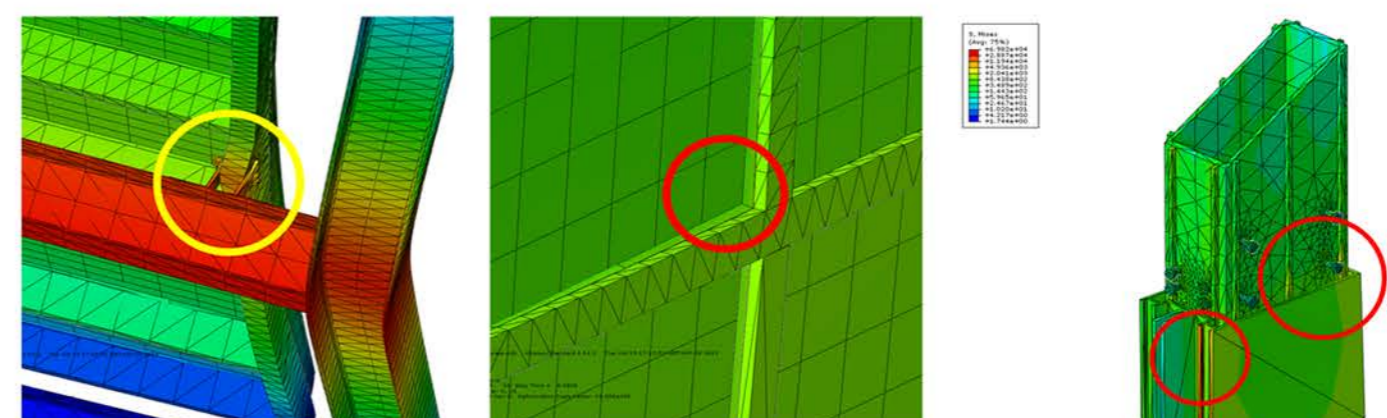
(a) Fastener distortion (b) Aluminium frame fallout (c) Expansion joint distortion

Fig 3. Vulnerabilities of existing curtain walls According to numerical analysis

- It was modeled on the same 1:1 scale as the experimental specimen.
- It is assumed that the behavior of all materials is limited to the elastic range.
- Nonlinear static pushover analysis was performed by displacement control.
