Scaffolding Support System Monitoring of Cantilever Structure Based on FBG

*Sun Li¹⁾, Li Chuang²⁾, Hui Xiangshuo³⁾ and Li Ke⁴⁾

^{1), 2), 3), 4)} Department of Civil Engineering, Shenyang Jianzhu University, China

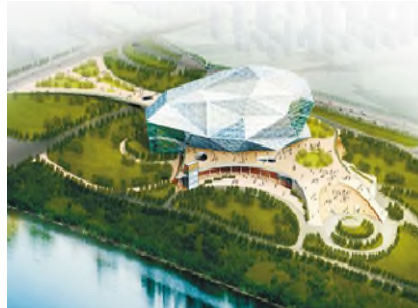
Shengjing Culture Art Center is located in commercial core area of Shenyang Hunnan New District. The architecture of the center is made up of three auditoriums, including the comprehensive hall (1800 seats), the concert hall (1200 seats) and the multi-function hall (500 seats), as shown in Figure 1. The concert hall is a typical long-span cantilever structure. Due to complicated structure form, the bearing capacity and stability of the scaffolding in the construction process is worth more attention.

Fig. 1 Architectural effect figures of Shengjing Culture Art Center

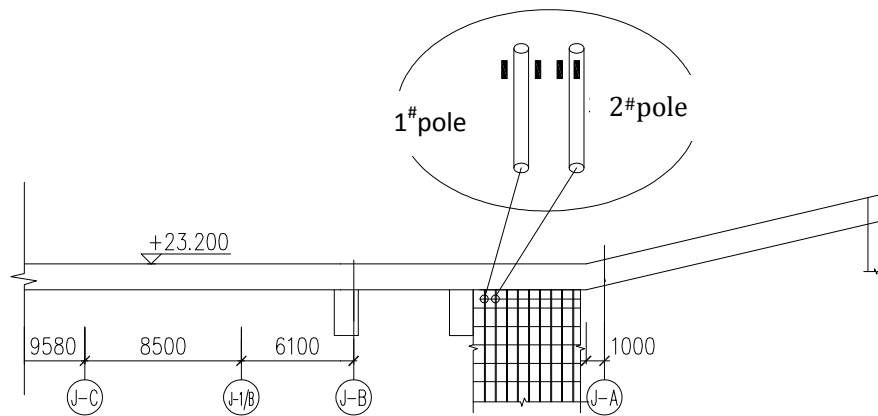
Shengjing Culture Art Center engineering monitoring object: 1[#], 2[#] scaffolding [1]-[4] poles position of prestressed cantilever beam in +23.200m level are as shown in Figure 2.

Fig. 2 FBG sensors of scaffolding in+23.200m level

Shengjing Culture Art Center engineering monitoring point : FBG^{[5]-[8]} strain and temperature sensors are routed to monitor the strain variation of the pole cross section. 4[#] and 5[#] FBG sensors are set on 1[#] pole, and 1[#]、2[#]、3[#] FBG sensors set on 2[#] pole. Furthermore, 1[#] sensor is FBG temperature sensor, while others are FBG strain sensors. FBG sensors are pasted on the pole which has been polished and cleaned. In order to protect FBG sensor, 8 core armored cable is set, as shown in Figure 3,4.

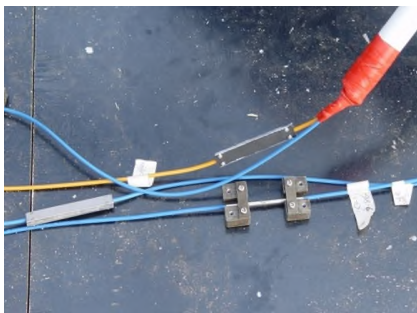
Fig. 3 FBG strain and temperature sensors

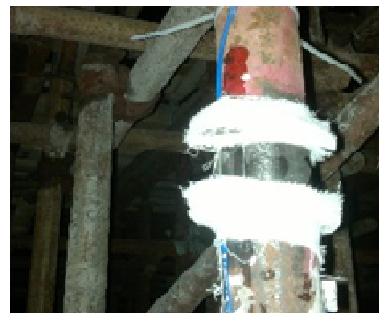
Fig. 4 Protection of FBG sensor in the scaffolding pole

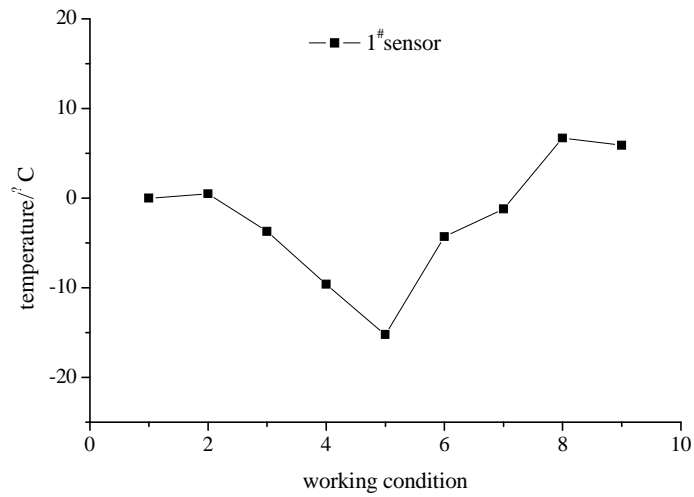
Fig. 5 FBG temperature sensor measurement data

Fig. 5 is temperature change curve of FBG temperature sensor (1[#] sensor). Temperature monitoring results show: the curve first decreases and then increases in the construction process of condition 1- 9. The minimum temperature is -15.2°C, in January 19th, the monitoring temperature consistent with ambient temperature. Meanwhile, it plays the role of temperature compensation, eliminating the effect of

temperature change on wavelength shift of FBG strain sensor.

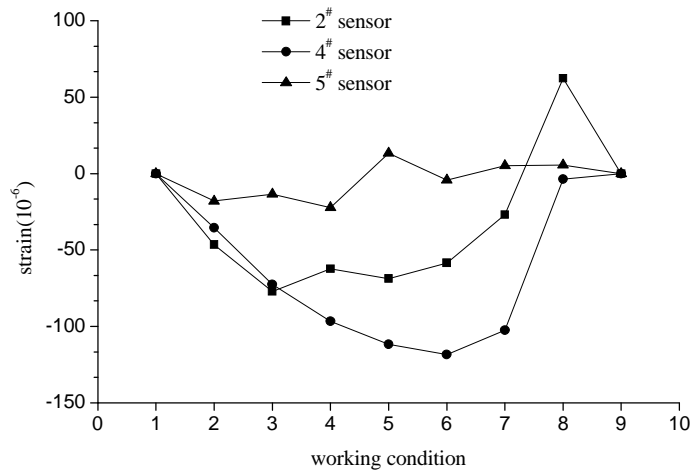
Fig. 6 FBG strain sensor measurement data

Fig. 6 is strain change curve of FBG temperature sensor (2[#], 4[#] and 5[#] sensor), 3[#] sensor is damaged in the construction process. In the condition of cantilever beam concrete casting, as the vertical load increased, the cross section of scaffolding is compressed. The maximum compressive strain from 2[#] sensor monitoring is 46 $\mu\epsilon$. In the condition of prestressed steel strand tension in the cantilever beam, the compressive strain from 2[#] and 4[#] sensor monitoring increases to 75 $\mu\epsilon$, and 5[#] sensor monitoring remained unchanged. The maximum compressive strain from 4[#] sensor monitoring is 118 $\mu\epsilon$ in the condition of formwork, concrete casting, prestressed steel strand tension in the column and roof. In the condition of stripping of cantilever beam, slab and column, the compressive strain from 2[#], 4[#] and 5[#] sensor monitoring gradually decreased due to redistribution of internal force in the cantilever beam. Especially in the condition of cantilever beam stripping in +23.200m level, the maximum tensile strain from 2[#] sensor monitoring is 62 $\mu\epsilon$.

In the whole process of Shengjing Culture Art Center engineering construction, the cross section strain of the scaffolding is changed as the load on the cantilever beam changes. The 1[#] and 2[#] pole of scaffolding in +23.200m level is basically in the state of compression. The compressive strain increased gradually until prestressed steel strand tension of column. The maximum compressive strain from 4[#] sensor monitoring is 118 $\mu\epsilon$. With the follow-up construction process, the compressive strain of the pole gradually decreases, even the pole being in tension, the maximum tensile strain from 2[#] sensor monitoring is 62 $\mu\epsilon$. It is concluded that: monitoring data is in a safe range.

(2) Due to prestressing, 4[#] monitoring point compressive strain reaches maximum, 118 $\mu\epsilon$. Monitoring data is in a safe range.
