Nondestructive Evaluation of Defects in Tendon Ducts of Post-tensioned Concrete Bridge Girders

ABSTRACT

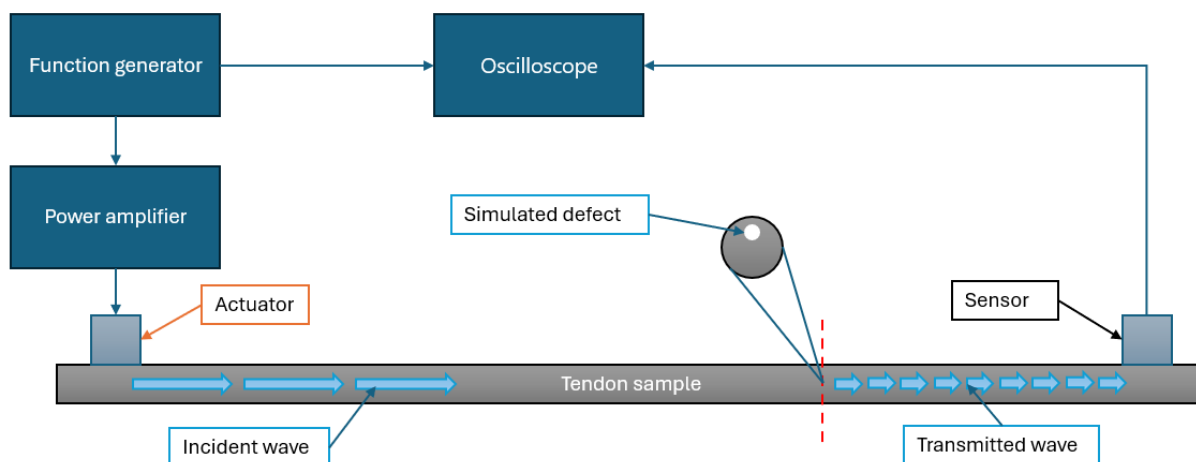
The proposed NDE approach is depicted in Fig. 1. A function generator is used to produce a short ultrasound burst that is amplified by a power amplifier that drives a piezoelectric transducer attached to the tendon. A guided wave propagates along the tendon and is altered by any defects along its propagation path to the sensor. A measurement from the sensor is recorded using an oscilloscope. It should be pointed out that this work focuses on assessing the guided wave-based NDE approach for the tendon only.

Fig. 1 Sketch of the guided wave-based NDE approach

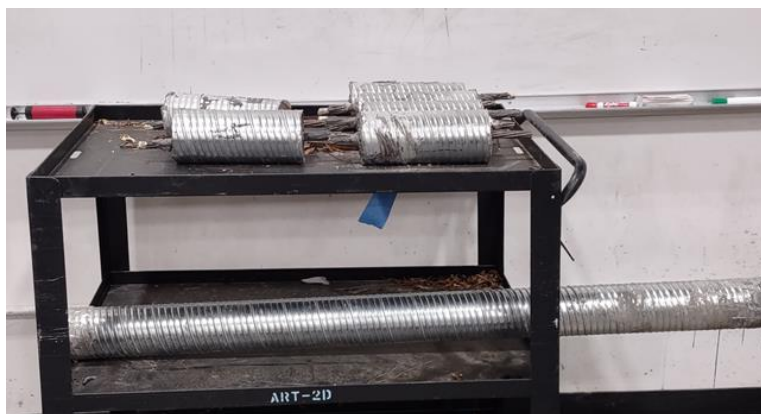
The authors prepared several tendons with corrugated steel ducts, grout, and steel strands, simulating real bridge applications using both short and long tendons, measuring 16 inches and 48 inches, respectively (**Fig. 2**). This paper focuses on the NDE of the short tendons grouted in 10-in. long ducts to identify pre-planned defects. To simulate broken wires, some steel wires or strands were intentionally cut, and portions of the strands were blocked to create voids. Fig. 3 shows the three grouted strands, i.e., Strand 1, Strand 3, and Strand 7, as discussed in this paper. Most strands, including Strand 1 and Strand 3, were grouted in a single duct. However, Strand 7 was grouted in a duct with three strands.

Fig. 2 Custom samples fabricated for this research

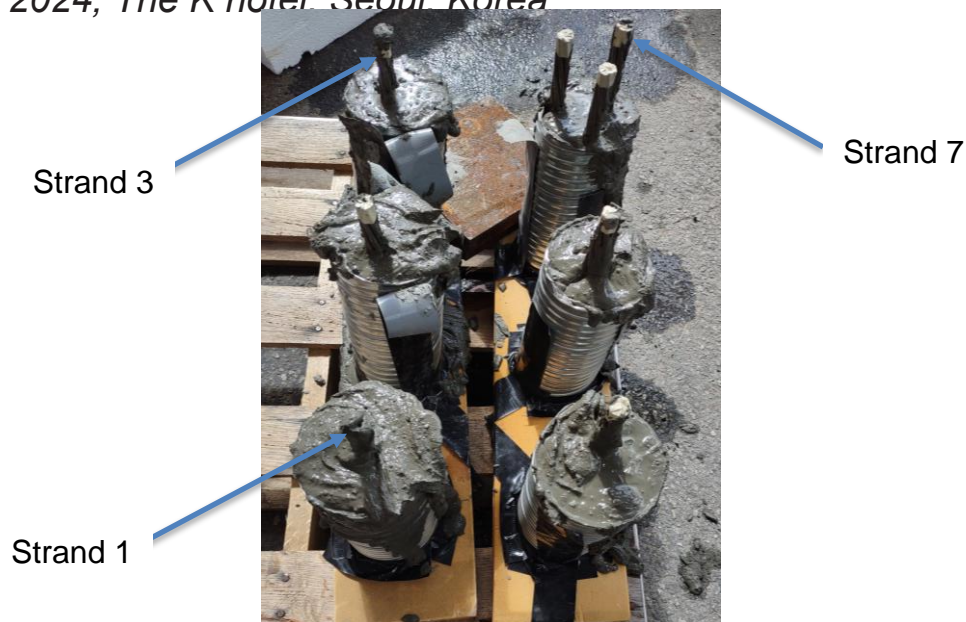
Fig. 3 Short tendons being grouted

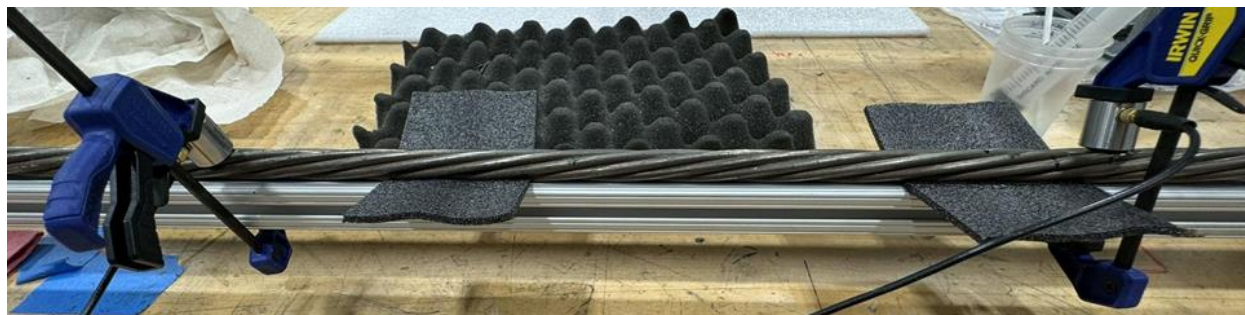
Several preliminary guided wave-based NDE experiments with the fabricated samples are conducted. A short sinusoidal tone burst of 8 cycles (Hann-windowed) is excited at 192kHz using an arbitrary waveform generator and then amplified to approximately 100Vpp using a power amplifier. The burst period is set to 40ms to ensure waves are fully attenuated prior to the next excitation. To improve signal to noise ratio (as no gain filter is used on the sensor side), an average over 2000 repeated measurements is taken with each measurement running for 400 μ s. First, baseline measurements are conducted on the isolated Strand 0 as shown in **Fig. 4**. Broadband transducers are clamped to an individual wire of the strand with an abundance of ultrasound gel couplant between the wire and the transducer. Actuator and sensor are placed 355mm apart from each other, roughly in the middle of the strand. The strand is isolated from the t-slotted profile it rests on using foam pads. Measurements are repeated several times, each time re-clamping the transducers to confirm repeatability of the test method.

Fig. 4 Reference ultrasound NDE experiment along Strand 0

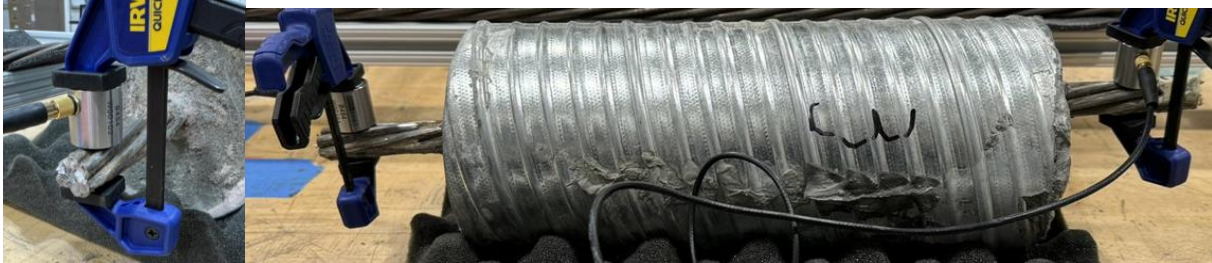
For all grouted samples, light prepping is performed: excess cement is removed from the exposed ends on the strand and light sanding is performed. Then, transducers are clamped to an individual wire as shown in Fig. 5. Experiments are repeated multiple times for each strand.

Fig. 5 Sample ultrasound NDE experiments across grouted Strand 3
