Field cyclic loading test of a 3-story non-seismically designed existing concrete frame structure in Korea

*Ji-Eun Roh¹⁾ Sang-Hyun Lee²⁾ Tae-Won Park³⁾
Seung-Ho Cho⁴⁾ Lan Chung⁵⁾

^{1), 2), 3), 4), 5)} Department of Civil Engineering, Dankook University, Yongin-si 126, Korea

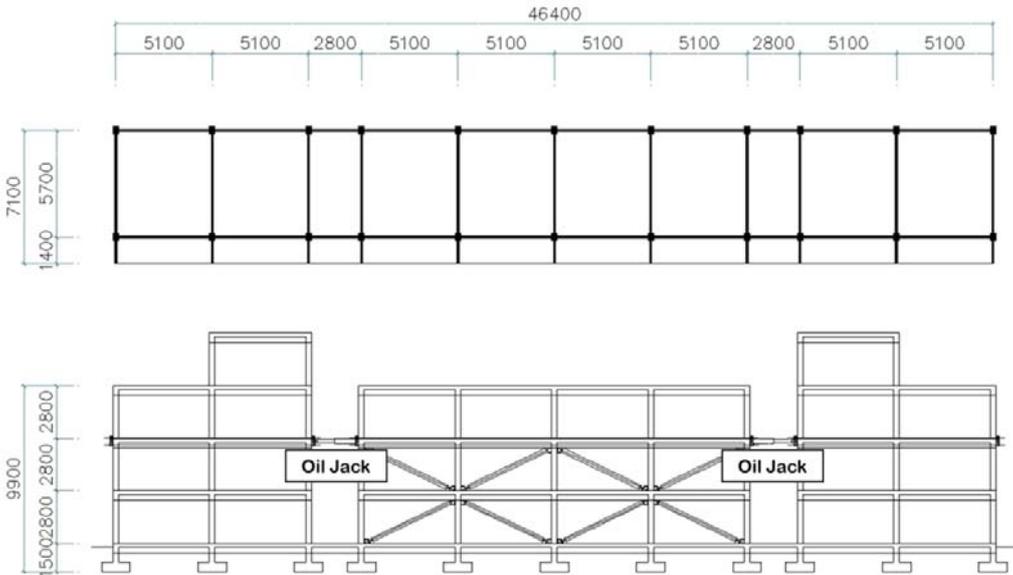
Fig.1 Plan of the test specimen and Test setup

The test specimen is an apartment building structure which was built in the late 1970's and located in Gwangju, Korea. Its structural system is 3-story reinforced concrete moment frame and it was designed only for gravity loads. Fig. 1 shows its plan and test setup. Housing unit has plan of 10.2m (two 5.1m bays) by 7.1m and two stairways of 2.8m by 7.1m are located between the housing units. The story height is 2.8m and slab thickness is 0.2m. In order to evaluate the seismic performance of concrete frame itself, partition walls, exterior walls and floor heating system were demolished. The average compressive strength of the concrete collected in field was 16MPa, and the tensile strength of the steel bar was 250MPa. Fig. 3 shows the section sizes and steel reinforcement details of beam and column. Outer two units are completely separated from inner two units by demolishing the staircases as shown in Fig. 1 and Fig. 2, and then the inner two units were reinforced using steel braces and were used as rigid supports for transferring actuator force to outer two units.

The left end unit in Fig.1 was used as a test specimen for existing bare concrete frame while the right end unit was used as one retrofitted by steel shear wall. The two hydraulic actuators with 0.5m stroke and 200tonf loading capacity were used for this cyclic loading test.

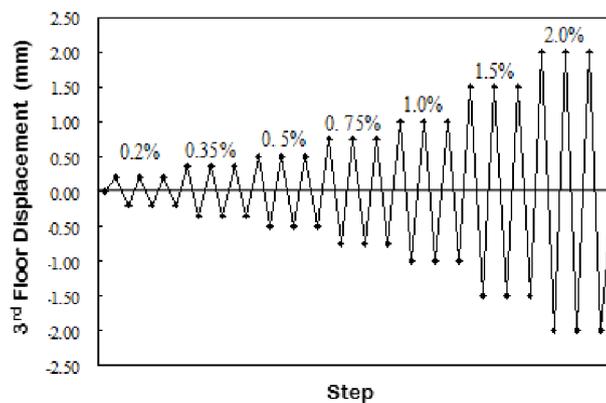
Fig.4 Loading plan

General seismic loading pattern on low-rise building is inverted triangular distribution. Since the resultant force of this distribution is applied to 2/3 point of the building height, the actuators were placed at beam-column connection on the 3rd floor. The actuators were operated based on displacement control. The target drift ratios were 0.2%, 0.35%, 0.5%, 0.75%, 1%, 1.5%, and 2%, and each drift ratio was repeated by 3 cycles.

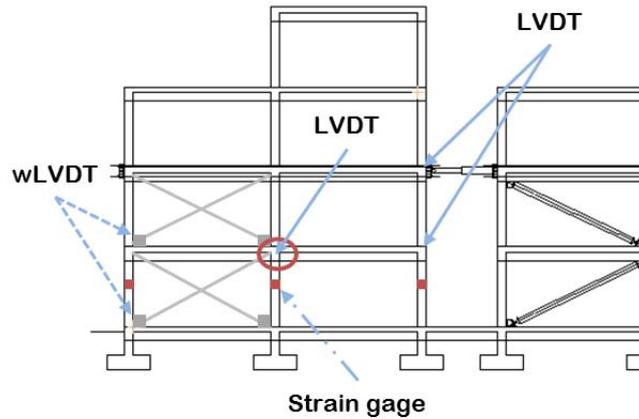
Fig.5 Measurement Sensor Location

After setting up a reference frame, LVDT sensors were installed between the reference frame and the 2nd/3rd floors to measure the story drift. And wire LVDT sensors were set in the 1st floor and the 2nd floor as shown to measure the inter story drift. Shear deformation and axial strains of the columns on the 1st floor were measured by attaching six strain gages to the central part of the column. Also, as shown in Fig. 5, three LVDT were set in beam-column joint to measure shear deformation of the joint.
