## **Corrosivity evaluation for each structural part of steel deck truss bridge before and after dam construction**

### **ABSTRACT**

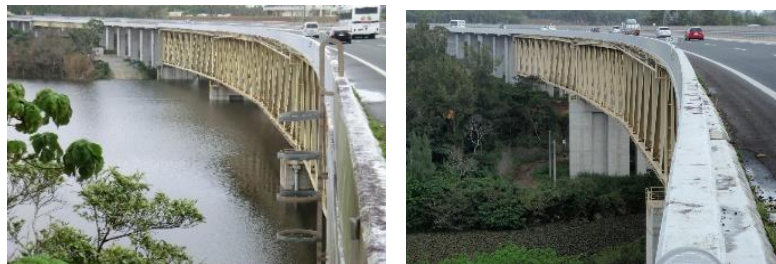
Fig. 1 Before and after dam construction

Distance from lower chord members to the ground was measured about 20m before dam construction, but the distance changed about 10m accordance with rising water level by dam construction. The monthly temperature and relative humidity were similar before and after dam construction, however, the precipitation before dam construction was a little larger than after dam construction.

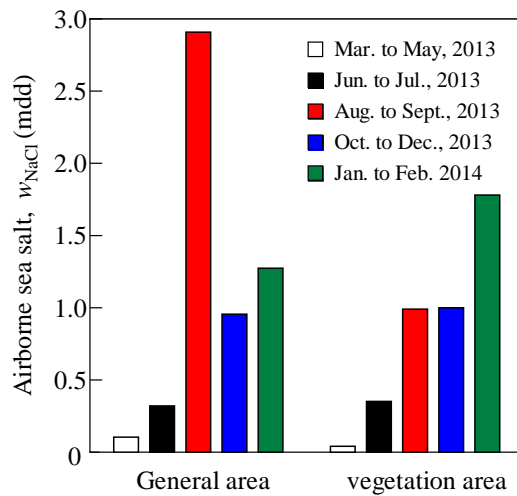
Fig. 4 Airborne sea salt after dam construction

Their airborne sea salt was analyzed using dry gauze method (JIS Z 2382) for 1 year. The mean corrosion depth on corroded surface was calculated by weight loss after removal of the rust for each corrosion specimen. The corrosion behavior in general area and vegetation area was characterized by the output of the ACM sensors.

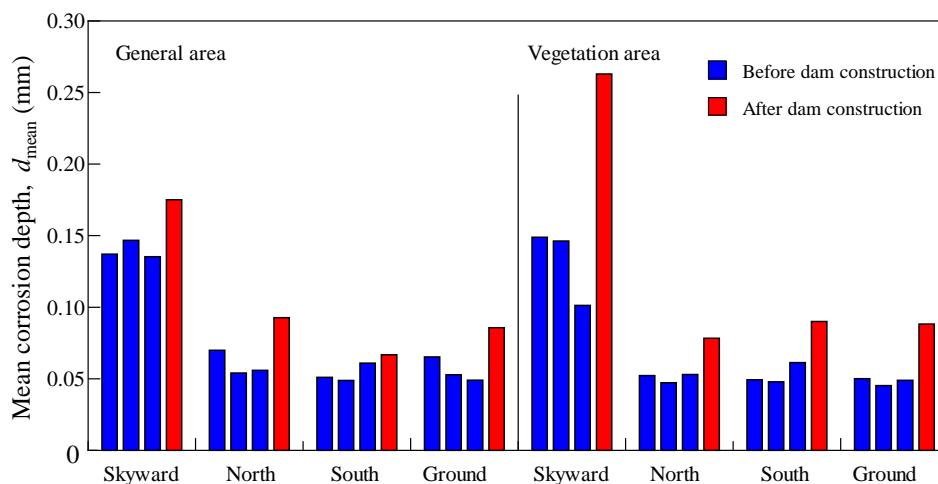
Fig 5. Mean corrosion depth

Fig. 5 shows that general area and vegetation area were compared with those of mean corrosion depth. From the results, the mean corrosion depth after dam construction was 1.3 to 2.0 times larger than those of before dam construction. It was shown to be similar tendency with airborne sea salt. The general area and vegetation area were compared with those of ACM sensor output for a month shown in Fig. 6. In case of rainfall, ACM sensor output was more than  $1\mu\text{A}$  (rainfall threshold) on the skyward and the northward of lower chord member of general and vegetation area. However, those of the groundward and the southward were less than  $1\mu\text{A}$ .

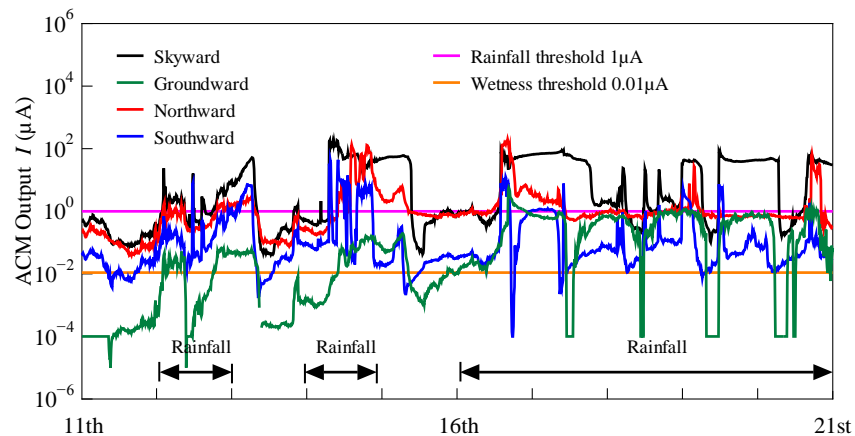
(a) General area

Fig. 6 ACM sensor output in April
