## **Fatigue damage monitoring of an airplane wing using active-sensors**

### **ABSTRACT**

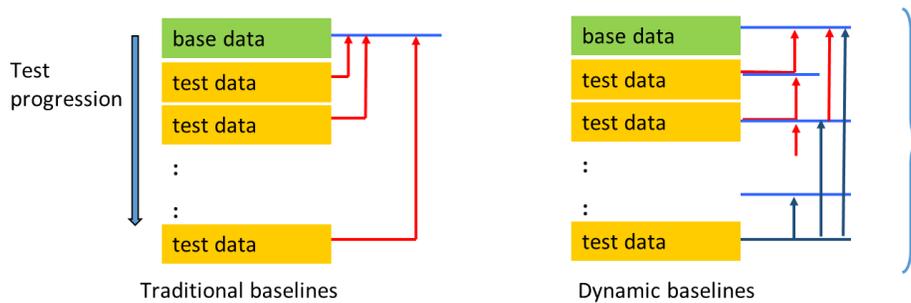
Fig. 1 Traditional & Dynamic baseline concept

Active sensing techniques based on guided waves in the frequency range of 20 to 80 kHz were used for fatigue damage monitoring. Baseline and test data were compared to extract residual signals which contains scattering and reflected waves caused by damage. These residual signals were used to monitor damage initiation and growth. In this study, two baseline concepts were applied. The traditional baseline concept uses difference between baseline and test data set for damage monitoring. The dynamics baseline concept uses difference between each test data set. The dynamic baseline concept allows to monitor damage growth of each measurement interval. These concepts were applied to phase arrayed piezoelectric transducers to detect fatigue damage and growth.

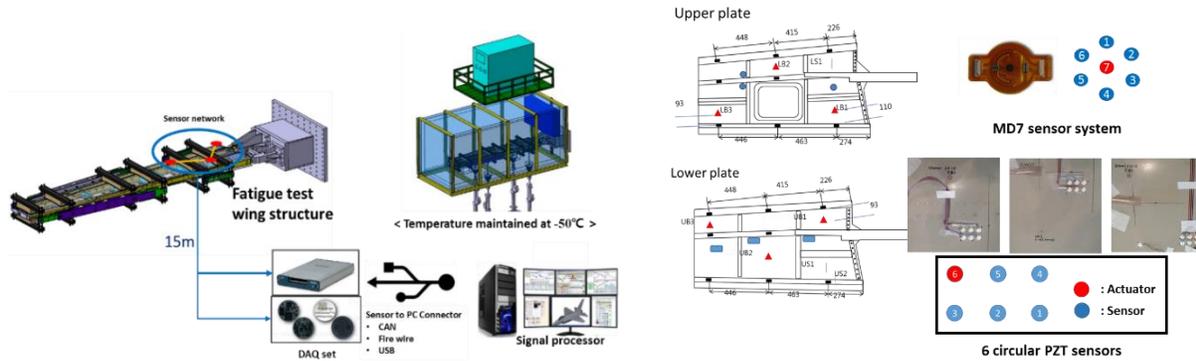
Fig. 2 (a) Test set up (b) Sensor installation

A cooling chamber was designed for extremely low temperature environments. The test structure is 4-m long with geometry similar to a wing, which consists of composite plates and inner spars. Before the fatigue monitoring test, initial delamination was introduced at three different locations on both upper and lower sides of the structure. Fatigue loadings were provided to this structure inside the chamber using a hydraulic actuator. Three different types of harmonic loadings were provided.

In order to measure the dynamic response of the structure, piezoelectric sensors are installed on the upper and lower side of the airplane wing. All the sensors are covered by Stycast epoxy to protect them against the low temperature.

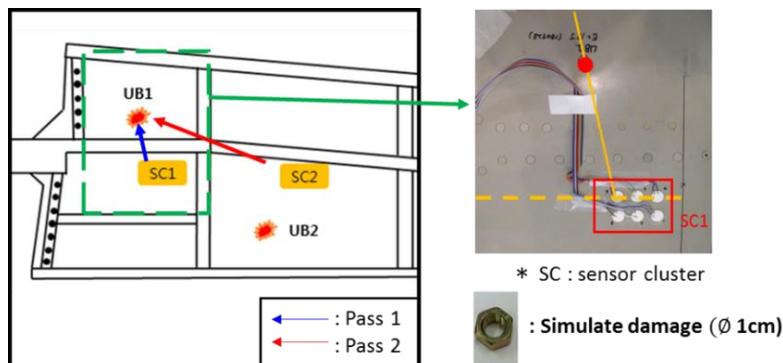
Fig. 3 Simulated damage

Before the fatigue test begins, simulated damages were introduced by attaching a piece of metal with 1cm of diameter. Results showed that it was possible to detect and localize damage accurately with the guided wave data. When additional metal pieces were attached, the responses show larger variations, which confirms that active sensors could be used to fatigue damage detection and monitoring for this structure.

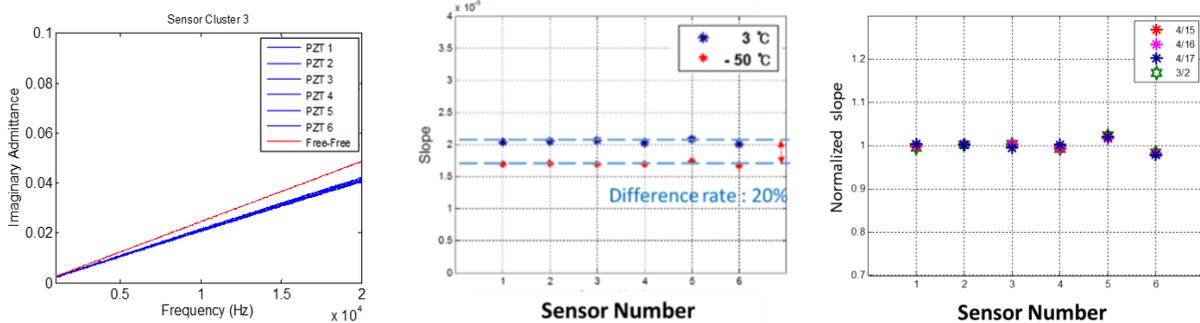
Fig. 5 (a) Admittance slope (b) (c) Admittance slope change of the same sensor array in temperature and time variant

Figure. 5 shows admittance slope of the installed sensors at initial state. The slopes of each sensor are almost the same with the maximum variation of the slopes within 2%. When sensors are in extremely low temperature, the slopes are decreased by 20%. However, the relative difference between the sensors remain the same in both room and extreme temperatures

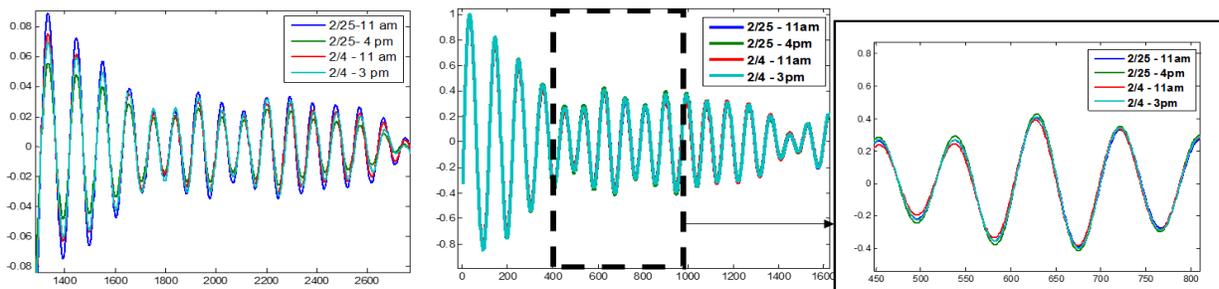
Fig 6. (a) Baseline signal under Extreme environment, (b) Normalized base signal

After 300, 000 cycle loadings, the piezoelectric sensors did not show any meaningful damage indication. An NDE inspection was performed to assess state of the structure, and found no fatigue damage initiation, which confirms the active-sensing results. As shown in the figure, there are very small variations of the measurements during the test.
