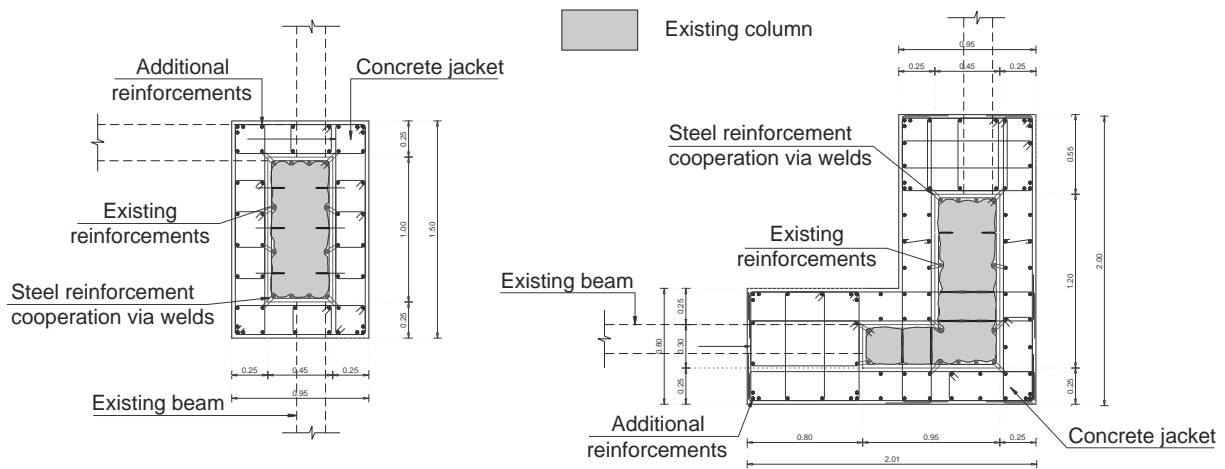
Fig. 6 Cross-sections of modified concrete columns
