Experimental Study on AE Stress Wave Propagation in Cables

Ji Qian^{1,2}, *Limin Sun², Guowen Yao¹

1. State Key Laboratory Breeding Base of Mountain Bridge and Tunnel Engineering, Chongqing Jiaotong University, Chongqing, 400074, China
2. State Key Laboratory on Disaster Reduction in Civil Engineering, Tongji University, Shanghai 200092, China. Email: lmsun@tongji.edu.cn

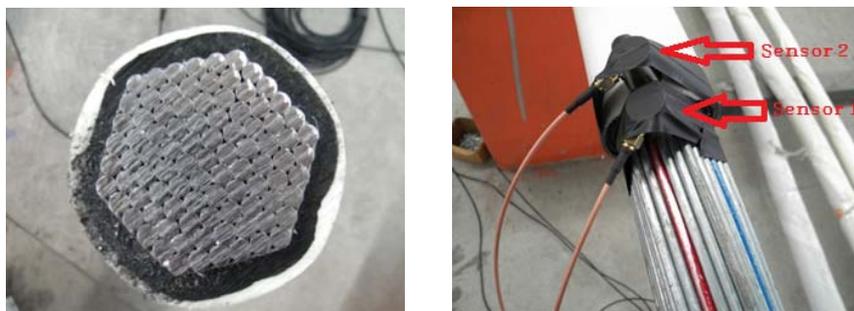
The experiments contains two conditions, one is carried out in a tension free cable shown in fig.4. The total length of this cable is 14.8 meters. Cable cross section contains 91 wires and 5 of which are prefabricated circular nick with 0.6 millimeter in depth (see fig.5). AE source is generated by high energy impaction, and the impact position is distributed at the center area of end section. Sensors layout are shown in fig.4.

Fig. 5 Cable cross section and sensors layout

In the first condition, sensor1 and sensor2 place at the same position in longitudinal direction, which difference is sensor1 at PE inside and sensor2 at PE surface (see fig.5). So, when the source generated from the center area of end section, the sensor1 and sensor2 pick up signals meanwhile. The acquisition data from sensor 1 and sensor 2 are shown in fig.7.

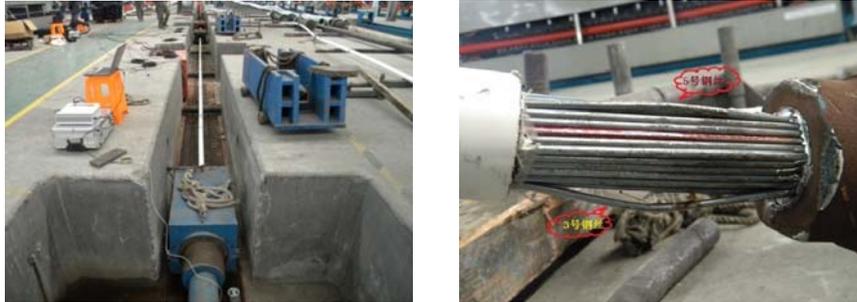
Another experiment is carried out in tensioned cable, which will snap several wires by step loading and the max tension force is 75 percents of the cable yield force (see fig.6). Five sensors, containing sensor2 to sensor6, are used to collected wire breakage signals in cables, and the sensor1, sensor7 and sensor8 are taken off after finish the first experiment condition.

Fig. 6 Cable stretch equipment and breakage wires
