Pinning Seismic Retrofit of Masonry Constructions with Application of Polymer-Cement Pastes as Bonding Agents

*Kshitij C. Shrestha¹⁾, Sanjay Pareek²⁾, Yusuke Suzuki³⁾ and
Yoshikazu Araki⁴⁾

^{1), 3), 4)} *Department of Architecture and Architectural Engineering, Graduate School of Engineering, Kyoto University, Kyoto 615-8540, Japan*

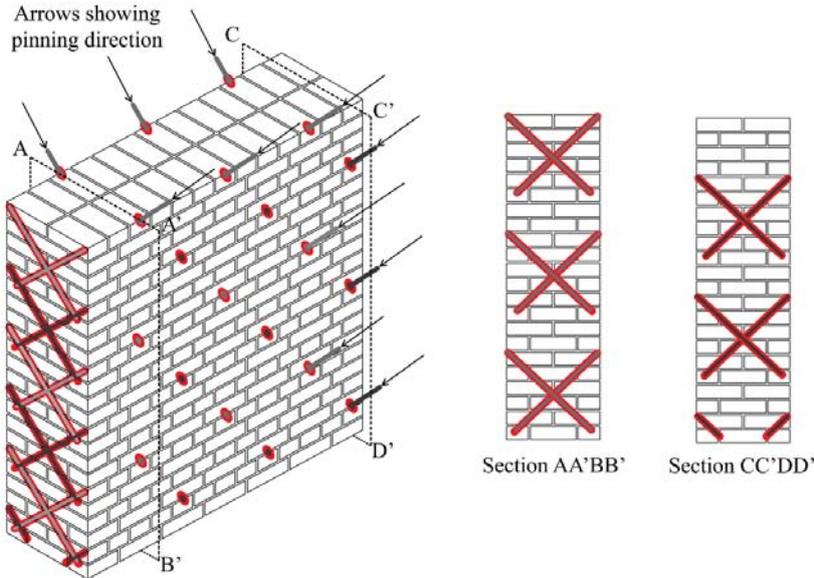
Fig. 1 Cross pinning retrofit technique

During pinning retrofit, a professional mason would require an open time limit up to 10 minutes between the injection of mortar paste and insertion of reinforcing bar. Here, open time represents the time interval between the injection of bonding agent and the insertion of reinforcing bars as shown schematically in Fig. 2. With an ordinary mortar paste as bonding agent, however, it is very difficult to insert reinforcing bars at larger open times due to its poor workability and small clearance available. Moreover, brick units absorb water from the mortar pastes in absence of any water barrier penetrants. As an alternative, use of polymer-cement paste (PCP) as bonding agent is proposed in this study with investigation on comparison of workability and bond strengths of various polymer based admixtures in brick masonry. Fig. 3 illustrates the above described scenario and main purpose of this proposed research.

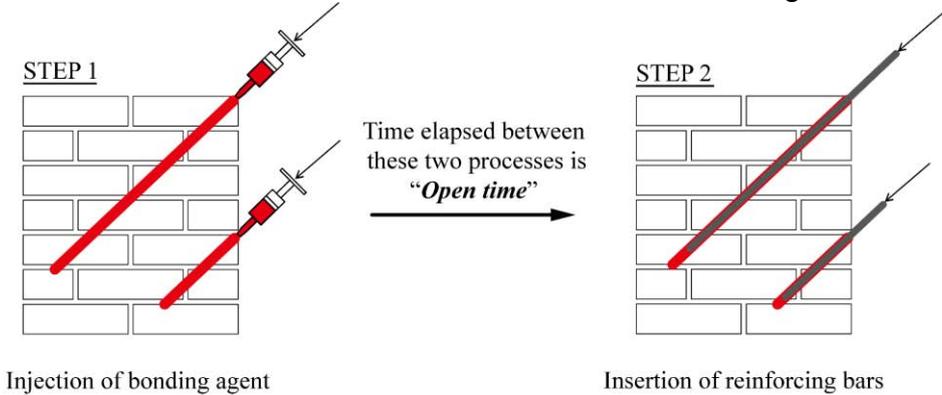
Fig. 2 Open time during pinning technique

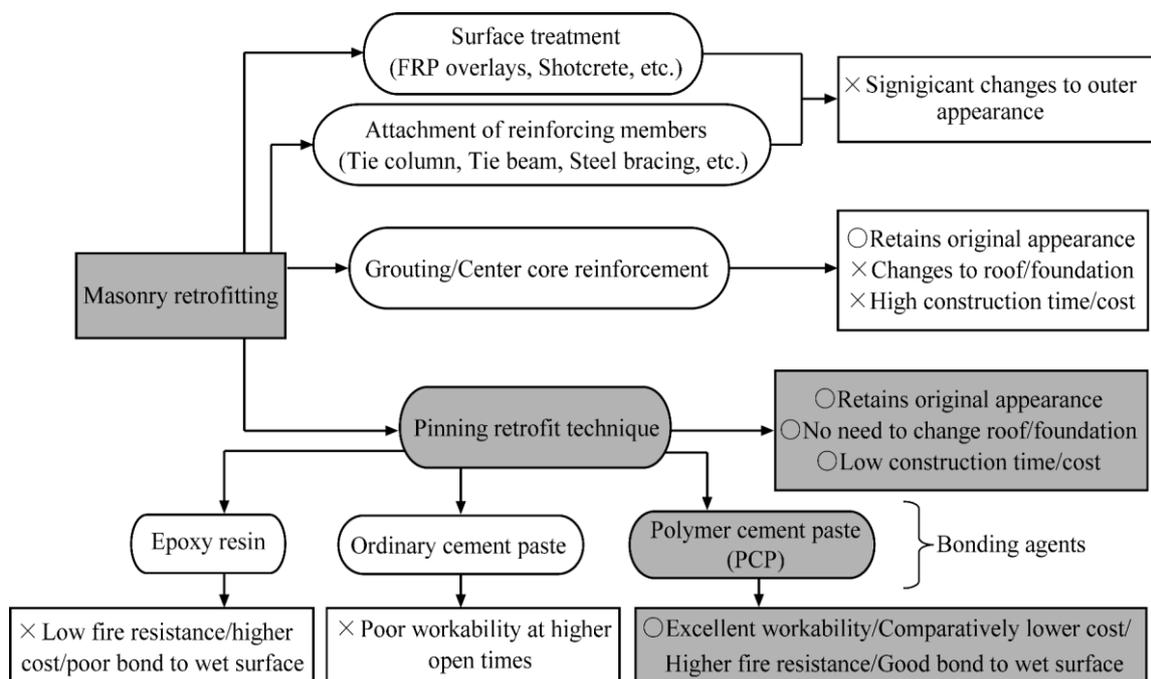
Fig. 3 Comparison on different masonry retrofitting techniques and purpose of the present work

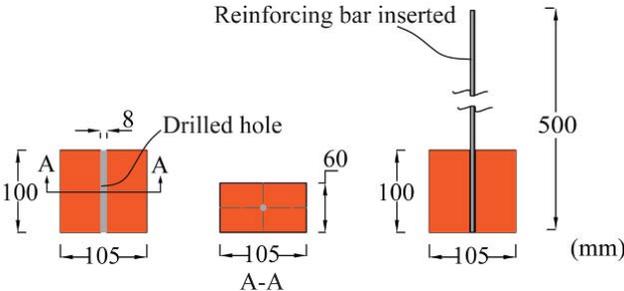
Fig. 4 Details of test specimen for workability and pull-out tests

Workability and pull-out test The first phase of the experiment involved workability tests for different PCPs with pre-application of the above mentioned impregnants. Ordinary Portland-cement with polymer-cement ratio (P/C) of 20% and water-cement ratio (W/C) at 40% was adopted for all the mixes. These proportions were determined after extensive sensitivity and trial and error studies on PCPs used. Each specimen, as shown in Fig. 4, first involved drilling of 8 mm diameter holes 100 mm deep on 100×105×60 mm³ well-cut brick samples. Dusts in the holes were blown out by applying air pressure. Afterwards 25 cm³ of impregnant was injected into the hole as shown in Fig. 5. After 60 minutes of impregnant injection, PCP was injected into the hole. A 6 mm diameter fully threaded steel bar was inserted into the hole at three different open times -- 0 minute, 5 minutes and 10 minutes for each type of impregnant and PCP. The specimen was placed over digital weighing balance and the amount of force required for the insertion of pin was recorded to measure the workability as shown in Fig. 6.

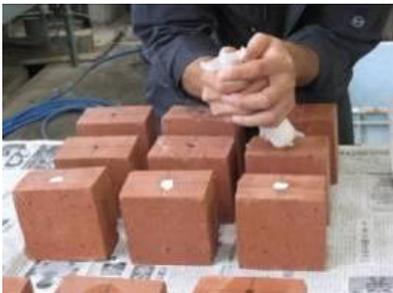
Fig. 5 Impregnant injection in drilled holes

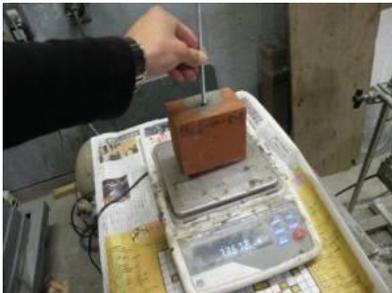
Fig. 6 Workability test procedure

The test arrangement is shown in Fig. 6 where the polymer injected brick is placed over the digital weighing balance. Workability is measured by the record of insertion load required for vertical insertion of reinforcing bar in to the hole at variable open times. Figs. 10(a)-(g) show the results for the workability tests of PCPs with different pretreatments performed. Here, better workability is reflected by lower values for insertion load which represents easier insertion of reinforcing bars. Plots are made with average value of insertion load of the 3 identical samples tested. The corresponding error bars shown in Fig. 10 represents the standard deviation of experimentally recorded data at particular open time for identical specimens. At open time of 0 minute, all combination of pretreatments with PCPs showed good workable response as shown in Fig. 10. In most cases, increase of open time led to increase of the load necessary for inserting reinforcing bars. The rates of increase however were significantly different depending on the type of PCPs used. With increment in open time up to 5 minutes with results given in Fig. 10(e), reinforcing bar could not be inserted in case of ACL PCP when pretreated with Polymer-II. Finally, for open time of 10 minutes, Polymer-II pretreated ACL and SBR2 PCPs were not workable enough for pin insertion and additionally untreated as well as water treated ACL sample was also not workable.

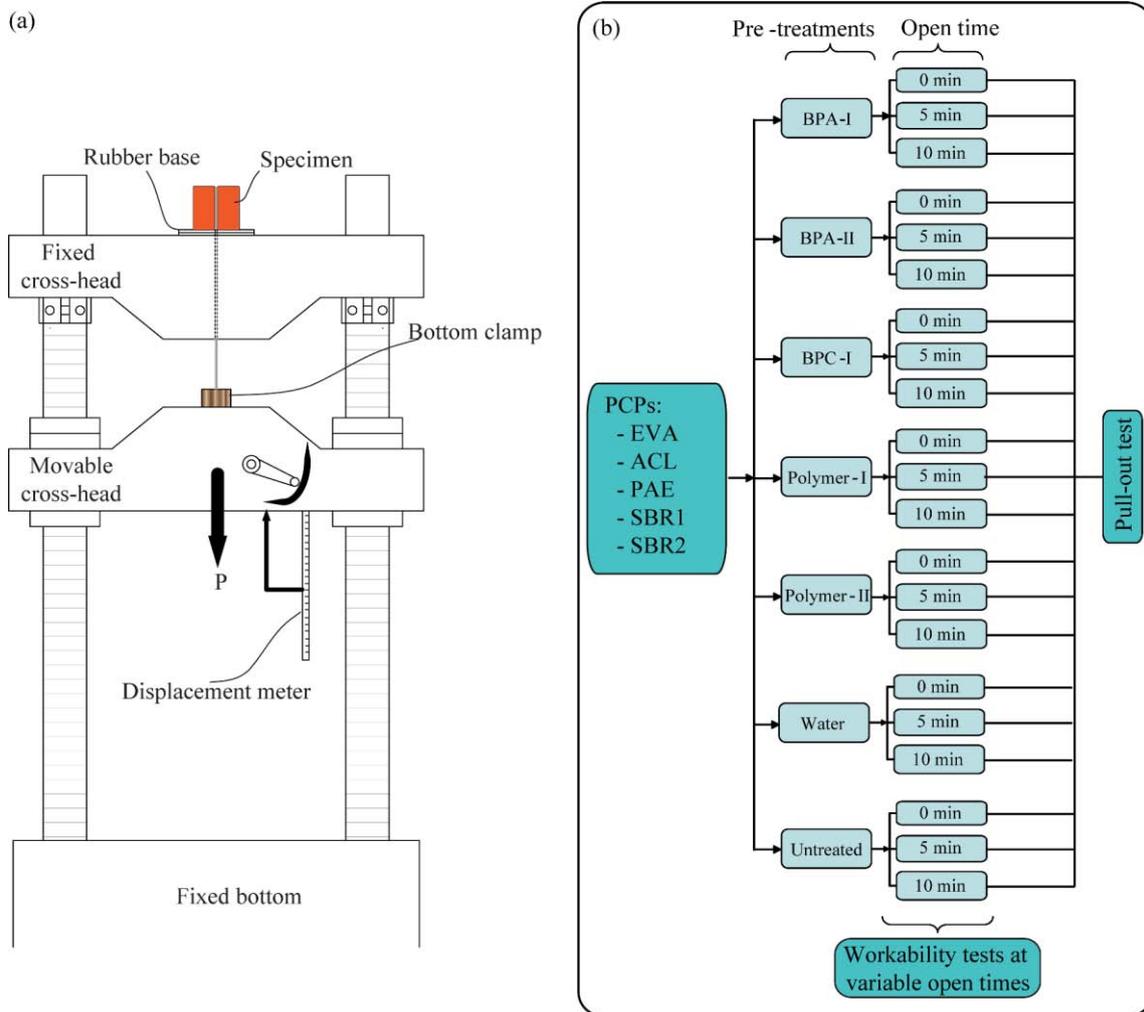
Fig. 7 Test program: (a) Pull-out test set-up, (b) Workability and pull-out test plan

pretreatment of the hole. For comparison, untreated specimens without application of any water penetration barrier agents, termed as untreated specimen here onwards, were also prepared. 3 samples of specimens were prepared for each test ID. For each PCP type, (7 pretreatments x 3 open times x 3 samples) 63 specimens were prepared with different pretreatments and tested at different open times. To summarize, a total of 315 specimens were prepared for all PCPs to test the workability. Direct pull-out tests of steel bars were performed on each of above prepared specimens to compare the bond strength of the PCP in brick masonry as shown in Fig. 7(a). Curing for test specimen was performed for 28 days at 90% relative humidity prior to pull-out tests. The above sequence of workability and pull-out test plan is illustrated in Fig. 7(b).

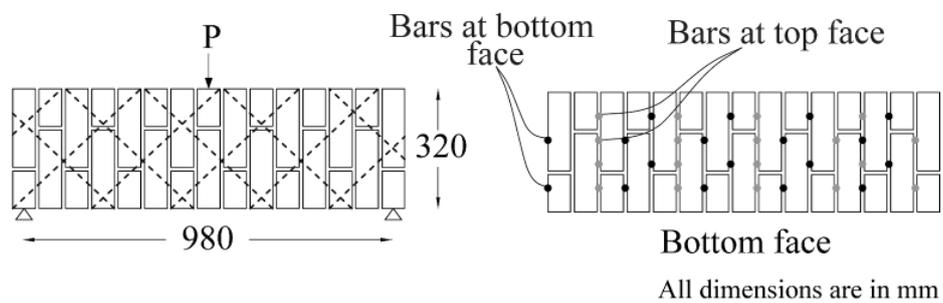
Fig. 8 Specimen and test set-up for three-point bending test

Out-of-plane bending test Fig. 8 shows the test set-up for masonry beam specimen with dimensions 1040×320×320 mm. Fig. 9 illustrates the procedures involved in the reinforced masonry beam specimen preparation. Two sets of each PCP bonded specimens were prepared. Three types of different polymer admixtures were used in this study – SBR2, ACL and PAE. PCPs for the above listed polymers were prepared using ordinary Portland-cement with polymer-cement ratio (P/C) of 20% and water-cement ratio (W/C) at 40% for all the mixes. One set of URM and epoxy resin bonded (ER) specimens were also prepared for comparison with PCP bonded specimens. For the reinforced specimens, fully threaded 6mm diameter reinforcing bars were used. Points of insertion of reinforcing bars on masonry beam specimen are clearly shown in Fig. 8 with all bars inserted from the top face as illustrated in Figs. 8-9. The present study involves use of BPA-II as impregnant for all the PCP bonded specimens. The choice of BPA-II as impregnant was decided on the basis of workability tests and bond strength tests performed previously with different types of impregnants available.

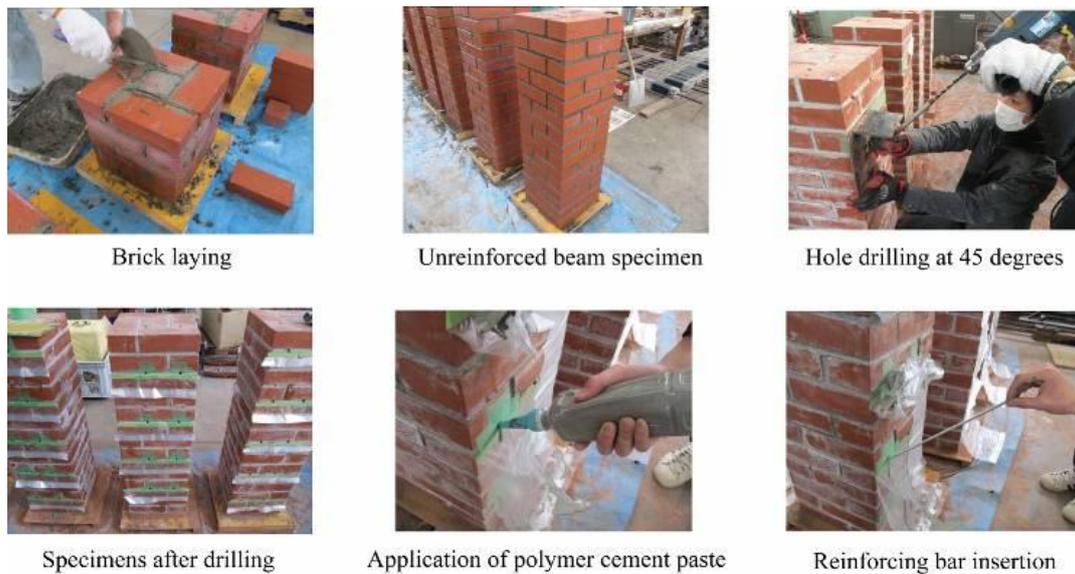
Fig. 9 Preparation of beam specimen for pinning retrofit

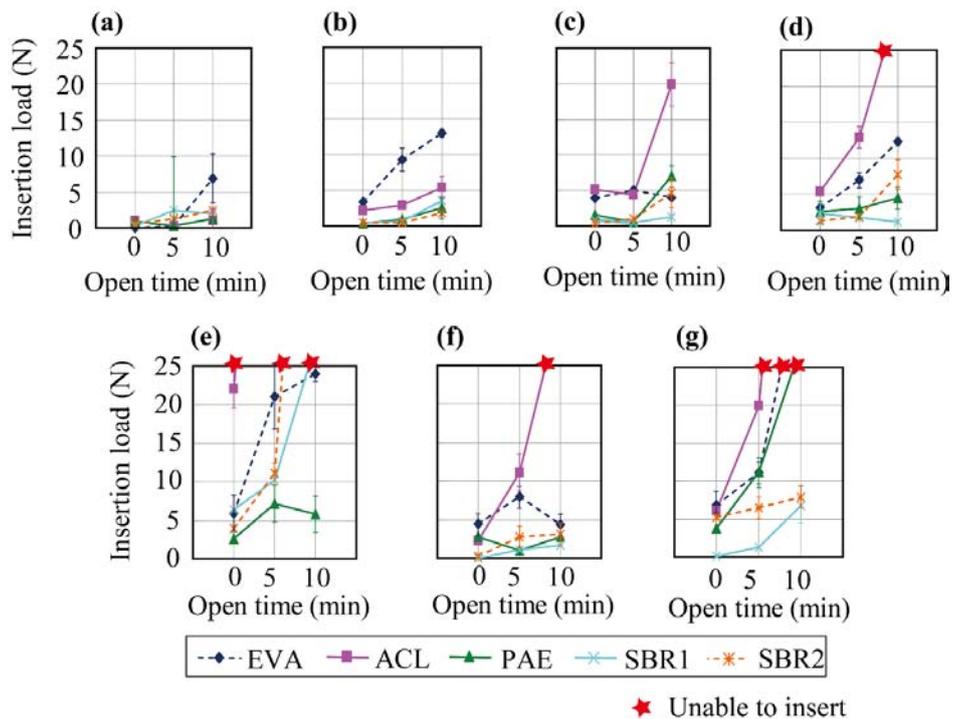
Fig. 10 Insertion load for combination of PCPs and impregnants at varying open times: (a) BPA-I, (b) BPA-II, (c) BPC-I, (d) Polymer-I, (e) Polymer-II, (f) Water treated, (g) Untreated

Workability tests showed that pretreatment plays an important role in keeping the PCP workable for longer duration of time. Use of impregnants -- BPA-I, BPA-II and BPC-I, as well as water all significantly increased the workability of all the PCPs used. Tests, on the use of polymer itself as a water penetration barrier system, did not show positive results. In fact, Polymer-II adversely affected the workability of the PCPs due to the formation of a thick layer of polymer film by drying, with its response inferior even compared to the untreated specimens. Untreated specimens also showed relatively inferior workability environment.

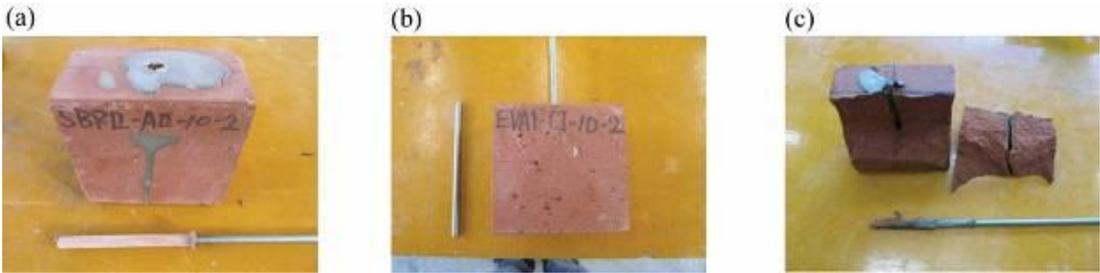
Fig. 11 Failure patterns observed during pull-out tests: (a) Bond slip along PCP, (b) Tensile failure of reinforcing bar, (c) Brick failure

Direct pull-out test results on steel bars of the specimens are shown in Figs. 11-12. Fig. 11 shows the failure patterns observed for pull-out test results. Three different types of failure patterns were observed during the pull-out tests: (a) bond slip along PCP joint interface, (b) tensile failure of reinforcing bar, and (c) brick failure as shown in Fig. 11. For impregnant pretreated specimens, majority of tests, around 75%, showed pull out with failure of bond slip as illustrated in Fig. 11(a). For EVA, ACL, PAE PCPs, pull-out tests showed bond slip along PCP joint for all the impregnant pretreated specimens. However, for SBR1 and SBR2 PCPs injected specimens, pretreated with impregnants or water, slightly higher bond strengths were observed, with some of the tests resulting in tensile fracture of reinforcing bars as shown in Fig. 11(b). This showed the superiority of SBR1 and SBR2 over other PCPs. 23.75% of pull-out tests resulted in fracture of reinforcing bar and 1.25% in brick failure.

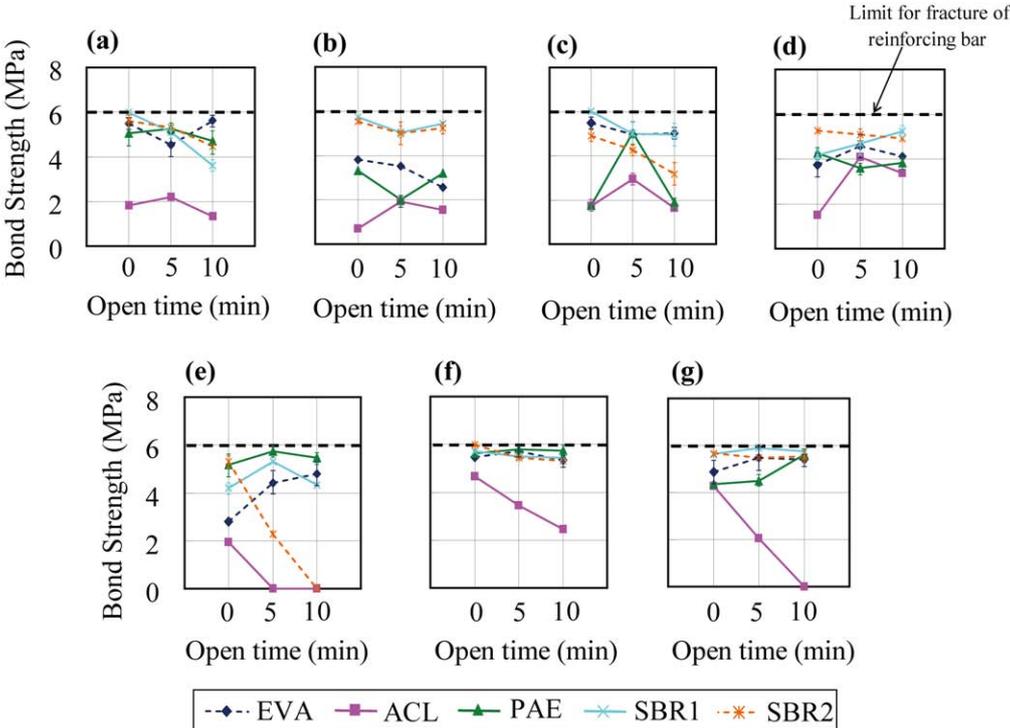
Fig. 12 Average bond strength from pull-out tests on specimens prepared at varying open times: (a) BPA-I, (b) BPA-II, (c) BPC-I, (d) Polymer-I, (e) Polymer-II, (f) Water treated, (g) Untreated

Plots, in Figs. 12(a)-(g), are made for the average value of pull out load recorded for 3 identical samples of specimens and the variations in the results are shown by the error bars, representing the standard deviation of sample data. A dotted line, representing the limit for fracture of reinforcing bar, is also shown, assuming the tensile strength of steel bar used to be 650 MPa and effective diameter of steel bar 5.5 mm. Pull-out test results are shown for specimens with three impregnants -- BPA-I, BPA-II and BPC-I, polymer treated, water treated and untreated. ACL and PAE PCPs showed the least of bond strength among the used PCPs. EVA, SBR1 and SBR2 showed comparatively better bond strengths. Also bond strength of each PCP was largely affected by other two factors -- open time and pretreatment agent. With an increase in

open time, average bond strength of PCP decreased in most of the cases. Better PCP would be the one which shows better bond strength even at longer open time, or the one which shows lesser variation of bond strength at variable open time sets. More detailed discussions on this aspect are presented later in Section 5. SBR PCPs injected specimens with pretreatments involving either impregnants or water showed superior bond strength as compared to other combinations.

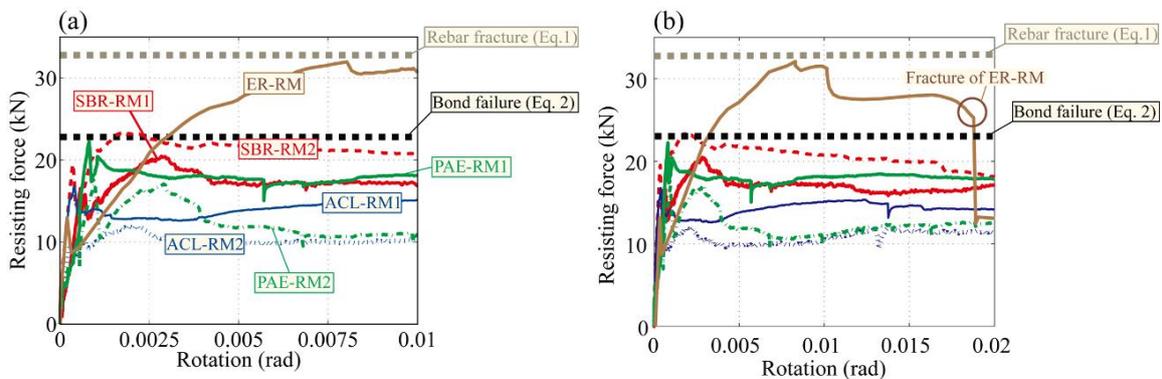
Fig. 13 Bending test results for all specimens: (a) Rotation angle < 0.01 radian, (b) Rotation angle > 0.01 rad

Test observations Fig. 13 shows the resisting force versus rotation angle plot for all the specimens. Fig. 13(a) shows the response up to rotation angle of 0.01 radian and Fig. 13(b) illustrates the response for larger deformation range up to 0.02 radian. For URM specimen, after the initiation of the first crack at around 15 kN of resisting force and very small deformation angle, the specimen cracked with no resistance shown afterwards. For ER-RM specimen, the maximum resisting force of around 32 kN was observed larger than for any of other specimens. This large resisting force was contributed by strength of epoxy resin itself, whose bond strength is relatively higher. However, for ER-RM specimen, large stress concentration possibly resulted in brittle fracture of the steel bar at relatively smaller rotation angle of 0.018 radian as shown in Fig. 13(b). Among the PCP bonded specimens, SBR-RM specimens showed comparatively better response, with no fracture of reinforcing bars. ACL-RM and PAE-RM specimens on the other hand showed relatively lower value of resisting force. The responses observed above in Fig. 13 have also been compared with theoretical computations as described below.

where L_1 , L_2 is the distance of reaction force from the point of rotation, n is the number of reinforcing bars, F_{reb} is the reinforcing bar tensile strength assuming fracture stress of 650 MPa, and L_{reb}^i is the distance of i th reinforcing bar from the point of rotation in the free body. Using Eq. (1), the value of predicted resisting force F_R for fracture of reinforcing bar is 33.27 kN which closely represents the resisting force observed for the ER-RM specimen in Fig. 13.

where τ_b^{avg} is the average bond strength for the bonding agent, m is the number of slip zones, L_{slip}^j is the slip length of the j th slip zone, L_c is the circumferential length of the bond slip zone, and L_j is the distance of j th slip zone from the point of rotation in the free body. Taking an average value of τ_b^{avg} equal to 5 MPa, the least value of predicted resisting force, F_R , among three failure mechanisms is computed to be 23 kN from Eq. (2). The theoretically computed resisting force is plotted and compared against the experimentally observed ones in Fig. 13.

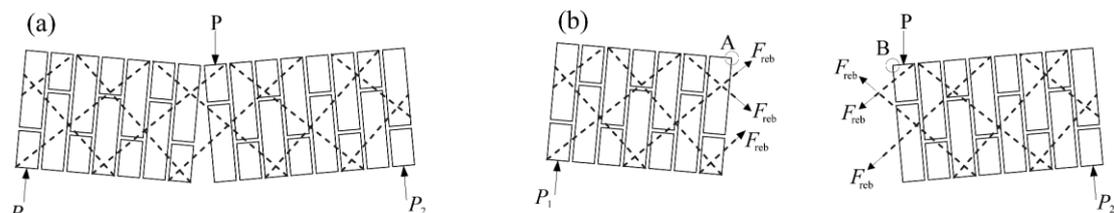
Fig. 14 Failure mode for ER-RM with fracture of reinforcing bar: (a) Deformed shape, (b) Free body diagram

Fracture mechanisms and theoretical predictions Cracks observed for the specimens were as shown in Figs. 14-15, varied in accordance with the reinforcing type of the specimens. ER-RM, SBR-RM1 and SBR-RM2 specimens showed “Mode-1” failure shown in Figs. 14 and 15 (left). For URM and ACL-RM1 specimens, “Mode-2” failure as shown in Fig. 15 (center) was observed. ACL-RM2, PAE-RM1 and PAE-RM2 specimens showed cracks at different place, at second mortar joint to right from the center shown as “Mode-3” failure in Fig. 15 (right). The prediction of crack in masonry is very difficult, mainly attributed by the fact that there exists large deviation in bond strength of mortar joints from specimen to specimen.

(a) Reinforcing bar fracture mechanism For ER-RM specimen, where failure mechanism was actuated by fracture of reinforcing bar, resisting force was predicted assuming a free-body as shown in Fig. 14(b), neglecting the bed-joint tensile strength. Equilibrium condition for the given free bodies can be expressed as follows:

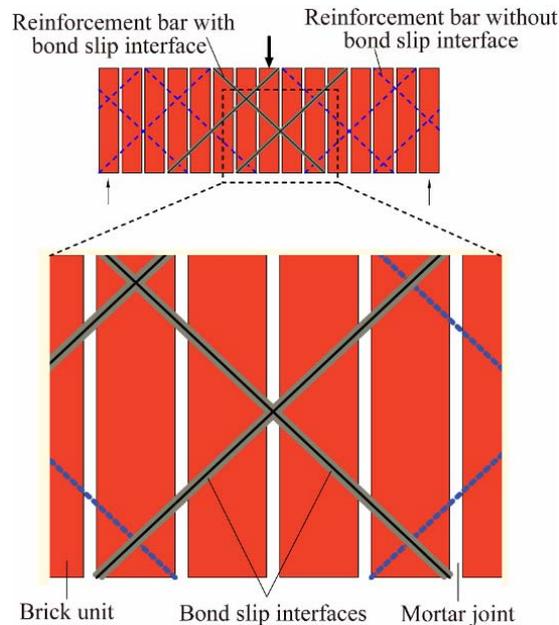
Fig. 16 FE model generation for bond-slip behavior of reinforcement bars

Special bond slip interface element shown in Fig. 16 was incorporated in the FE model. It should be noted that bond slip interface was modeled only for the pins inserted near the center of the specimen, where majority of cracks, reinforcement yielding and bond slips were observed during the experimentation. Another notable assumption was exclusion of horizontal mortar joint; only vertical mortar joints were modeled, since cracks were only observed in vertical mortar joints during tests. Main reasons for above assumption and confining of bond slip interfaces to certain zones were to reduce the model complexity and to get better solution convergence. Reinforcing bar truss elements with proper constitutive relations were used. The details of the elements used are described below.

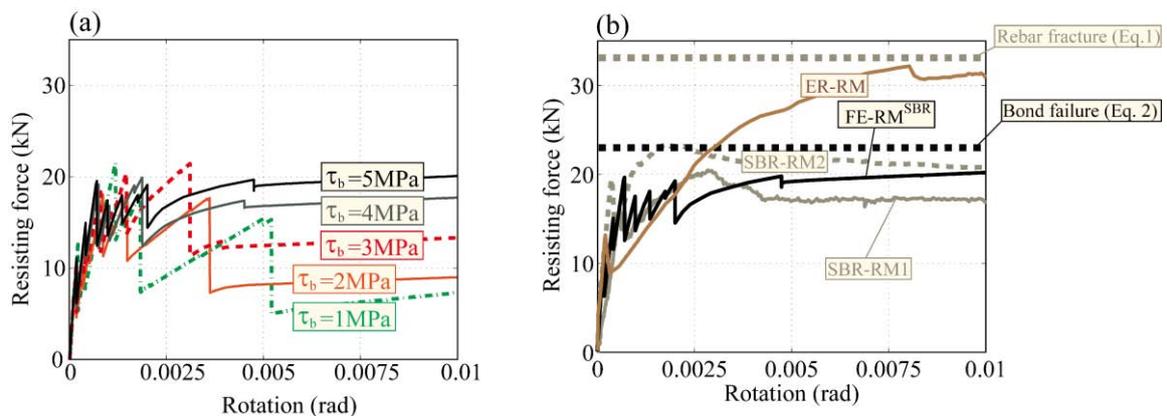
Fig. 17 Comparison on: (a) FE sensitivity study at varying bond strengths, (b) experimental and FE bending test results

Sensitivity with variation in bond strength Fig. 17(a) shows sensitivity results for FE models with slip strength τ_b equal to 1 MPa, 2 MPa, 3 MPa, 4 MPa and 5 MPa. Variation in bond strength directly influenced the resisting force characteristics, with larger bond slip strength corresponding to higher resistance and vice versa. Also for all models, almost constant restoring force was observed after initiation of slip at the bond slip interfaces. Similar failure mechanisms were observed for all the models, with slips at the bond slip interfaces as shown in Fig. 18. Here as a representative example, deformed shape for FE model with τ_b equal to 5 MPa has been presented, where dark regions highlighted by dotted markers represent the bond-slip zones. Since 5 MPa of average bond strength closely corresponds to the value observed for SBR PCPs, this particular FE model is represented as FE-RM^{SBR} from here onwards.

Comparison with experimental observations and theoretical predictions The failure mechanism observed during experimentation showed mortar cracking and subsequent bond slips in three different modes as described in Section 3.3 and Fig. 15. The FE model represented comparatively similar failure mode as shown in Fig. 18 just to the left and right mortar joint from the center of the specimen with slips at interfaces similar to the ones observed for experimental observations. Here, results have been plotted in Fig. 17(b), for FE-RM^{SBR} model with τ_b equal to 5 MPa, and compared correspondingly with SBR-RM specimens. FE result plotted against the experimental observations showed comparable response, with initial peak response corresponding to mortar tensile cracking and almost constant restoring force with initiation of slip at all critical bond slip zones. In both the cases, sharp decrement in resisting force measured was attributed to bond slip of interface element, followed by subsequent cracking of mortar

joint interface. Furthermore, for the selected FE model, the post peak response, with residual resisting force after initiation of slip, closely predicted the theoretically computed post peak resistance for average bond strength τ_b^{avg} of 5 MPa.

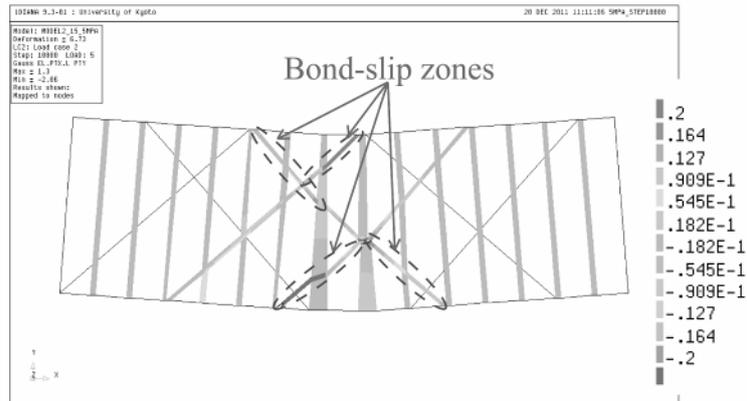
Fig. 18 FE deformed shape for τ_b equal to 5 MPa (FE-RM^{SBR})

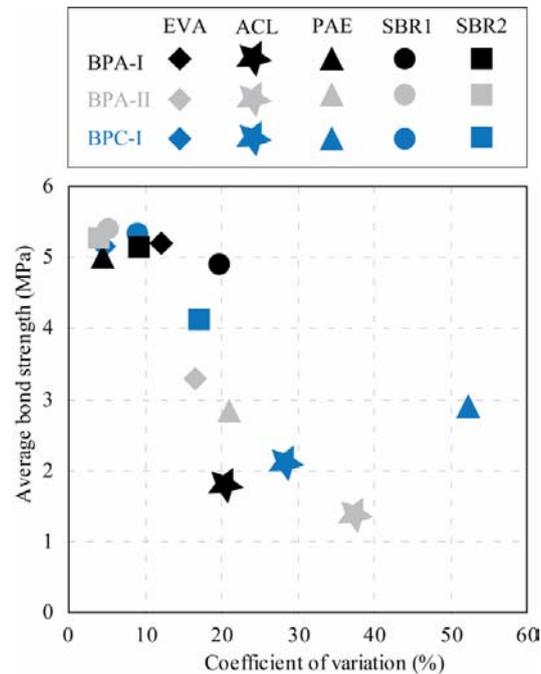
Fig. 19 Coefficient of variation of the pull-out test data on specimens

Fig. 19 shows the consistency of results from pull-out tests in terms of bond strength and its coefficient of variation at different open times for combinations of PCPs and impregnants. EVA, ACL and PAE specimens showed large variations in the test data with coefficients of variations for EVA up to 17%, ACL 38% and PAE 52% which shows strong uncertainty over the strength of these PCPs used in combination with impregnants. SBR1 and SBR2 specimens on the other hand showed relatively consistent bond strength data for the series of tests done. Hence, among the impregnants used, the best combination of PCP and pretreatment agent showing strong bond with minimum strength variation at different open times was attained for SBR PCPs with BPA-II as pretreatment agent.
