## **Assessing of Earthquake Performance of Nonstructural Components Considering 2018 International Building Code**

Memduh Karalar<sup>1)</sup>, Murat Çavuşli<sup>2)</sup>

*The 2020 World Congress on  
The 2020 Structures Congress (Structures20)*

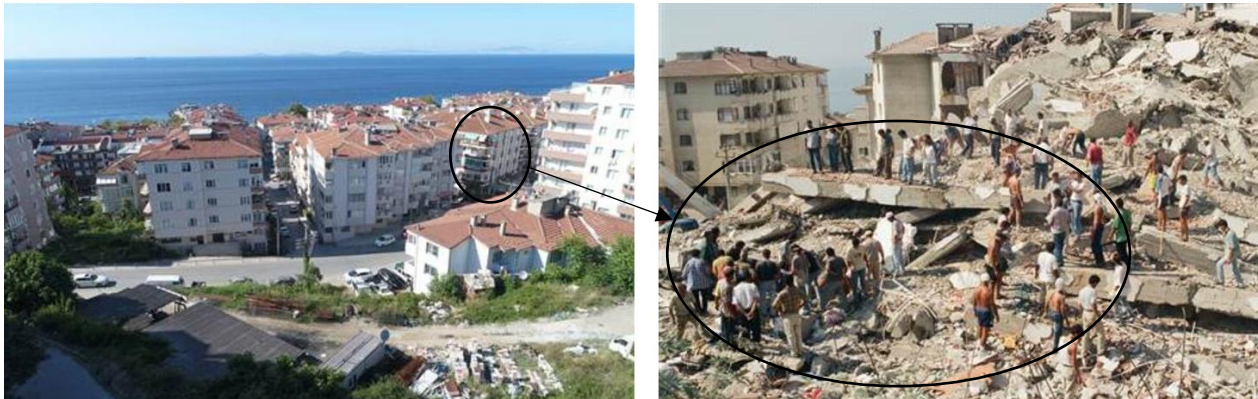
Fig. 1 Before and b) after views of collapsed RC structure.

most critical sections of these floors are shown in Fig. 2. Each floor has polygonal geometry and has two balconies. Foundation class of the structure is a B. This building was destroyed in a severe earthquake in 1999 and the appearance of the demolished structure is presented in Figure 1b. As a result of the examinations made after the building was destroyed, the most fragile and damaged columns of the building were identified. The building was first broken from 3 different sections during the earthquake, and after these three different areas were damaged, the building collapsed suddenly. In this study, A-A cross-section, B-B cross-section and C-C cross-section, which are the different regions detected, were examined. The location of these sections in the structure is presented in detail in the next section.

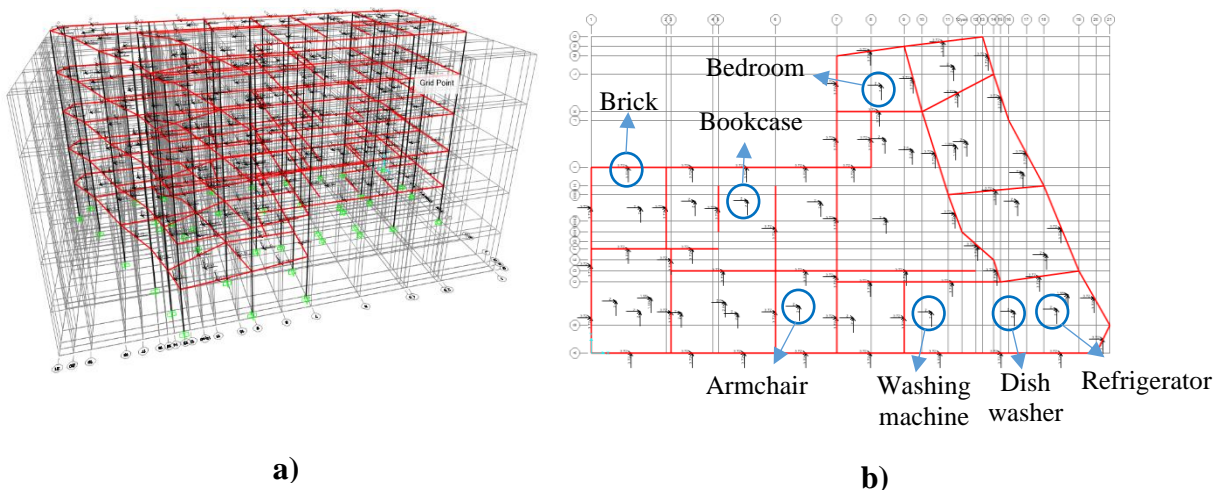
Fig. 4 Nonstructural component loads in the structure a) general view of nonstructural components b) nonstructural component loads of fifth floor .

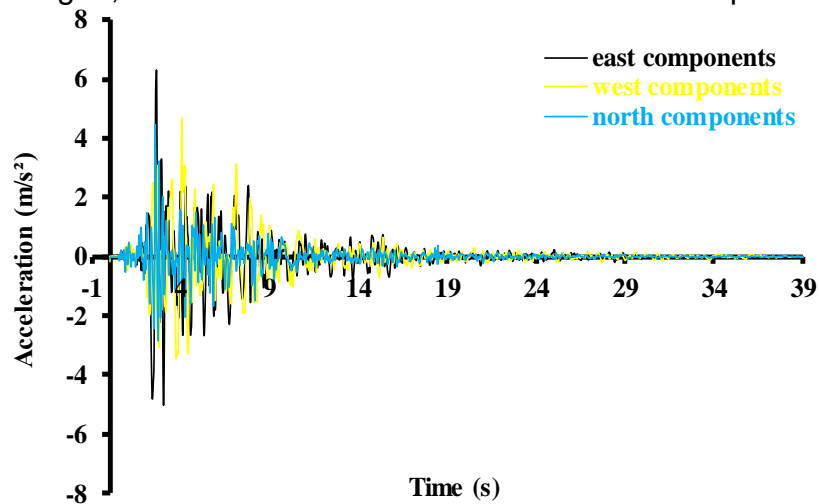
Fig. 5 Time History Graphics for Near Fault Ground Motions.

are totally 5 floors in the structure. Firstly, structural components are created according to original structure project and then, nonstructural components are defined to the structure. While modelling structural components, mass source is defined to software using dead and live loads. Rigid diaphragms are created in the structure considering constraint z axis. Nonlinear time history analyses are performed according to direct integration solution type. Hilber-Hughes-Taylor method is taken into account in the 3D analyses and its gamma and beta value is 0.5 and 0.25, respectively. G+Q+E combination is used in the time history analyses. 3D model of structure is shown in Fig. 3. Secondly, nonstructural elements (brick, bookcase, bedroom, armchair, washing machine, dish washer, refrigerator) are created according to original place of nonstructural building elements. Nonstructural component loads are calculated according to 5 different seismic design standards. After calculated these loads, nonstructural loads are defined to software considering original places of nonstructural components in the structure (Fig. 4). Calculated loads according to these design standards are presented in Table 1. Moreover, earthquake accelerations for far, middle and near fault ground motions were used in 3D earthquake analyses are shown in Fig. 5. According to Fig. 5, maximum acceleration for near fault earthquake is  $6.26 \text{ m/s}^2$ .

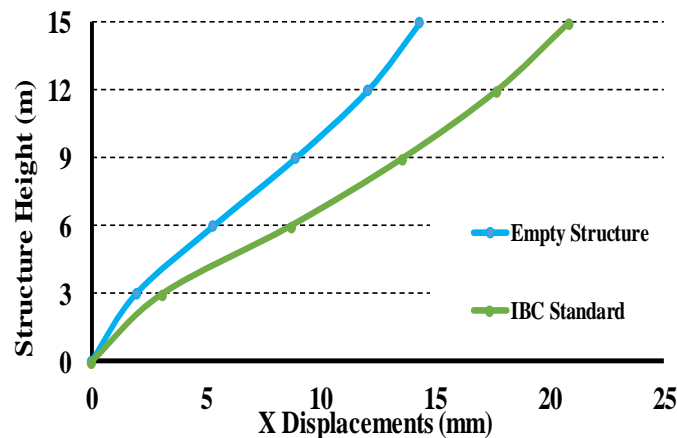
Fig. 7 Displacements along Axis A-A for Near-Fault earthquake.

Seismic displacement results observed along height of structure are graphically shown in Fig. 7. For Fig. 7, vertical column in the figure represents the building height and the horizontal column in the figure shows the seismic displacements obtained throughout building height. Besides, 3m, 6m, 9m, 12m and 15m of the height of the building represent Points A1, A2, A3, A4 and A5, respectively. According to Figure 7, the seismic effects of nonstructural elements on RC structures clearly appear. In Figure 7, seismic displacement results are presented graphically for the near fault earthquake. For near fault earthquake, it is clearly understood how nonstructural elements change the seismic displacement behavior of the structure (Fig. 7). According to Figures 8, the maximum

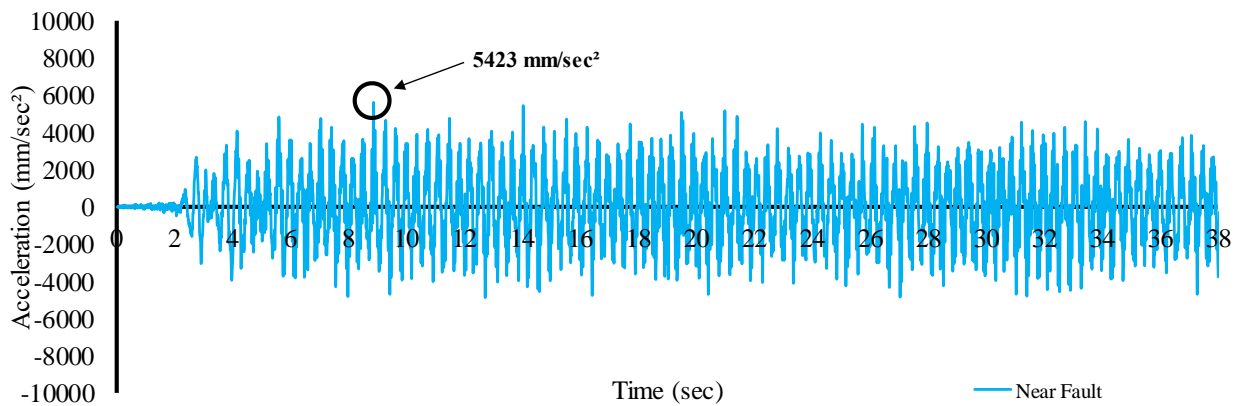
Fig. 10 Seismic accelerations on Point 11348 during near fault earthquake for structure without NSC.

nodal point selected on the A-A section (Fig. 9), are presented in Figs. 10-11. Accelerations occurred on Point 11348 are shown in Figure 10 for structure without nonstructural component. According to Figure 10, maximum acceleration ( $5423 \text{ mm/sec}^2$ ) is acquired for near fault earthquake and this value is observed in the 8.4<sup>th</sup> second of the earthquake. In case of nonstructural components are added to the structure, it is observed that the seismic acceleration values that occurred during the earthquake increased on the same nodal point. The acceleration values obtained by considering IBC standard for structure with nonstructural element are presented in Figure 11. According to Figure 11, it is understood that the maximum acceleration values on Point 11348 consisted in the near fault earthquake and this maximum acceleration value is  $9357 \text{ mm/sec}^2$ . If Figs. 10 and 11 are compared with each other, it is obviously seen how nonstructural elements change the seismic acceleration behavior of RC structures.
